Safety Recall

Code: 69PZ

Passenger Occupant Detection System (PODS)

Replace the PODS sensor mat and wiring harness.

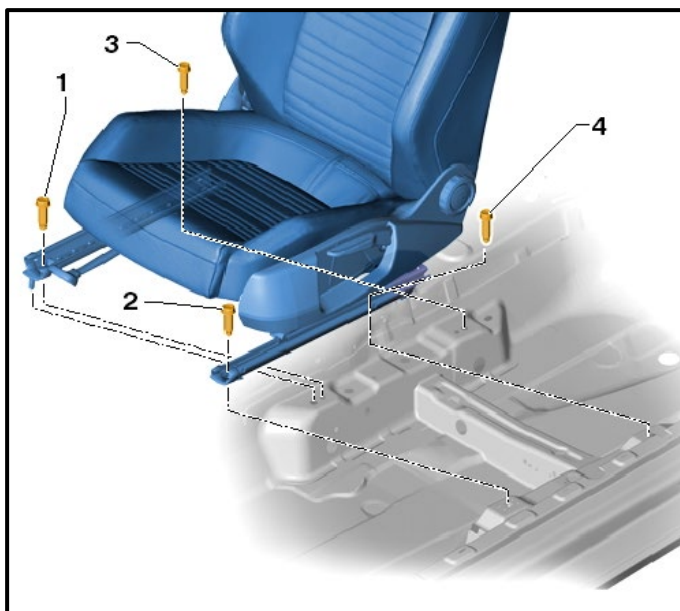
Unbolt passenger front seat:

- Move the seat as far forward as possible.
- Remove the bolts <3> and <4>.
- Move the seat as far back as possible.
- Remove the bolts <1> and <2>.
- Move seat to its highest position (if adjustable).
- Position the seat to where all four bolt holes are accessible.

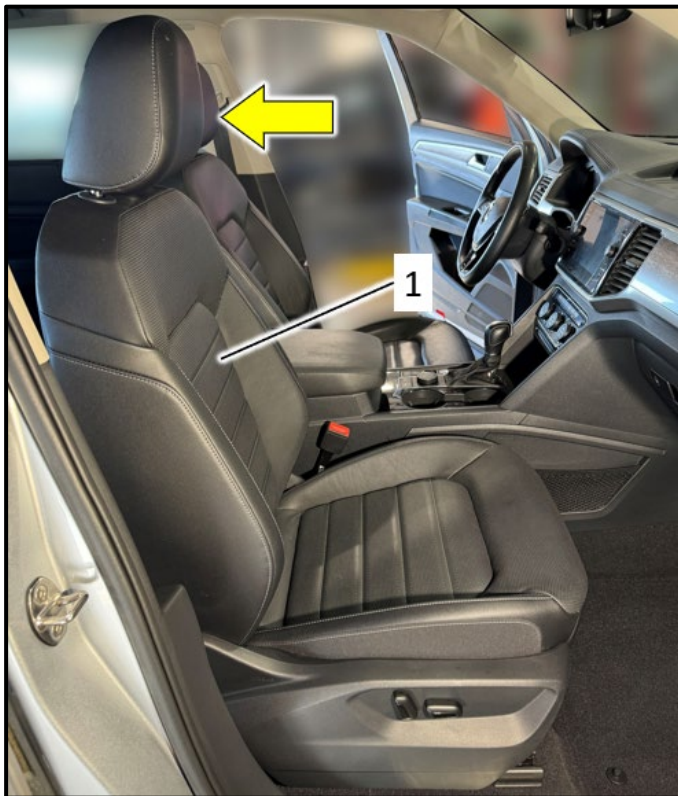
Disconnect connectors:

- Tilt the seat <1> towards the rear of the vehicle <arrow> to access the seat harness connections.

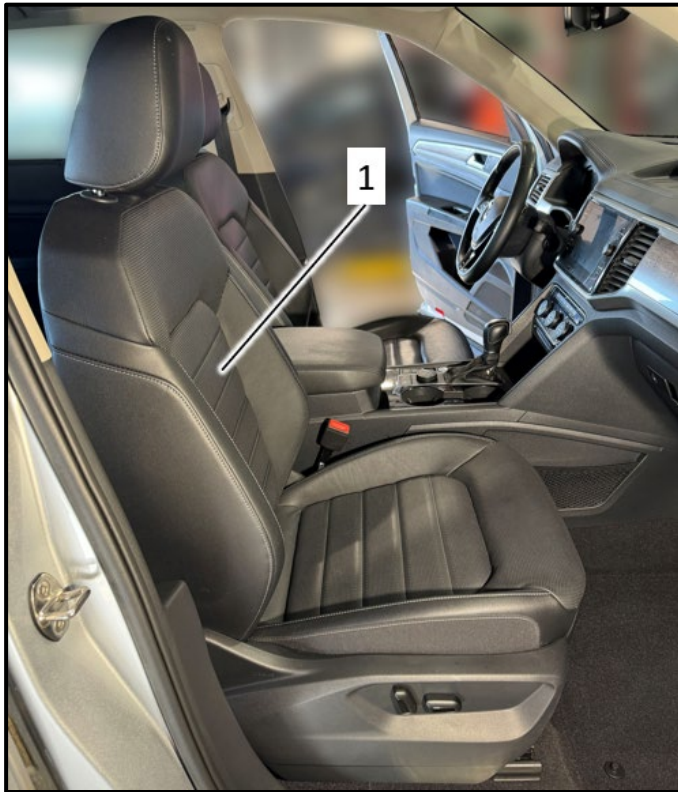
Remove passenger front seat:

- Remove the seat <1> from the vehicle.

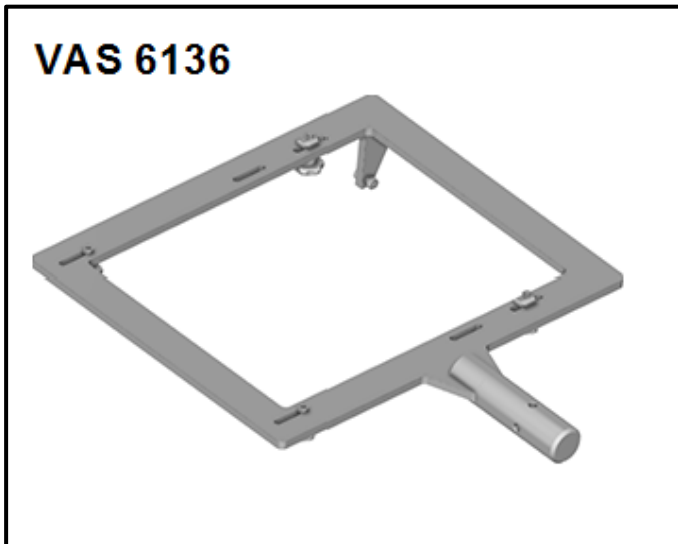
Attach seat to -VAS6136-:

- Attach the Seat Repair Fixture -VAS6136- to the Engine and Transmission Holder -VAS6095-.
- Fasten the front seat onto the Seat Repair Fixture -VAS6136-.

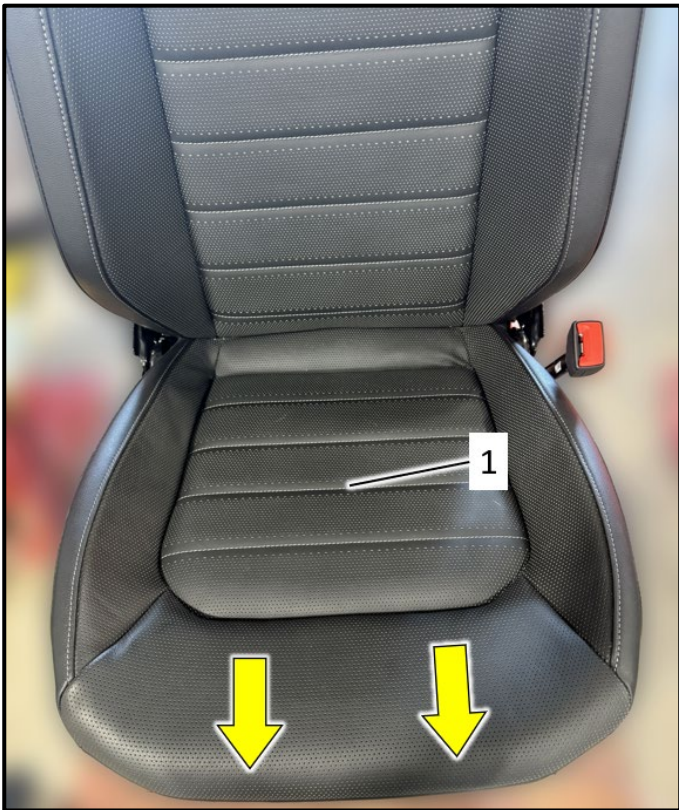
- Remove the seat cushion <1> from the seat frame in the direction indicated <arrows>.

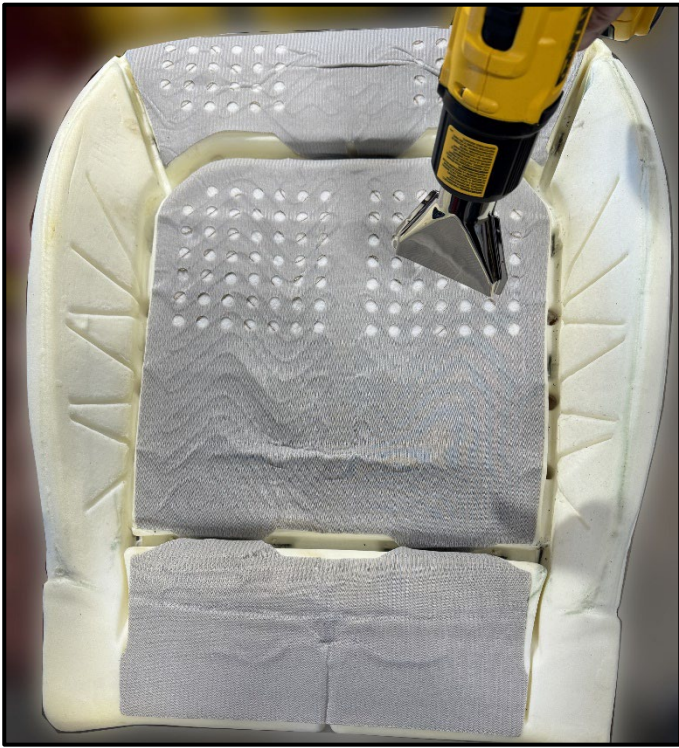
Removing occupancy detection mat:

Ventilated seat shown. Removal of the occupancy detection mat is similar for other seat variants.

- Use a heat gun set to Low/Medium heat.
- Alternately heat the seat occupancy mat surface still adhered to the seat cushion while carefully and slowly pulling the sensor mat away from the seat cushion.
- Only pull upward at a very slight angle.
- DO NOT pull up perpendicular to the seat cushion surface.
- Remove each section equally.
- Carefully pull wiring harness through the seat cushion.

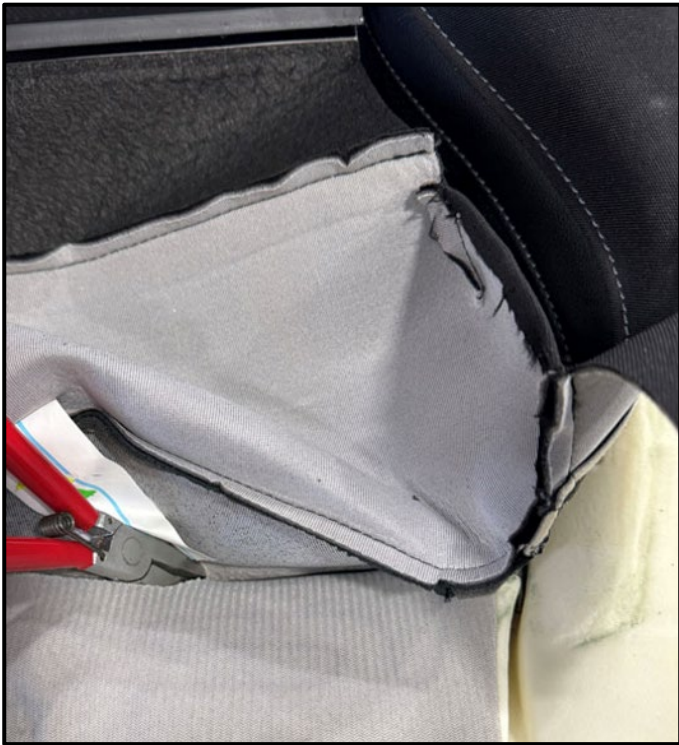
Reinstall seat cover:

Ensure the sensor mat is not damaged/pinched when installing clamps.

For non-ventilated seat variants, start at the center rows and work outward.
