# Safety Recall

## Code: 47UP

**Subject** Front Axle Brake Hoses

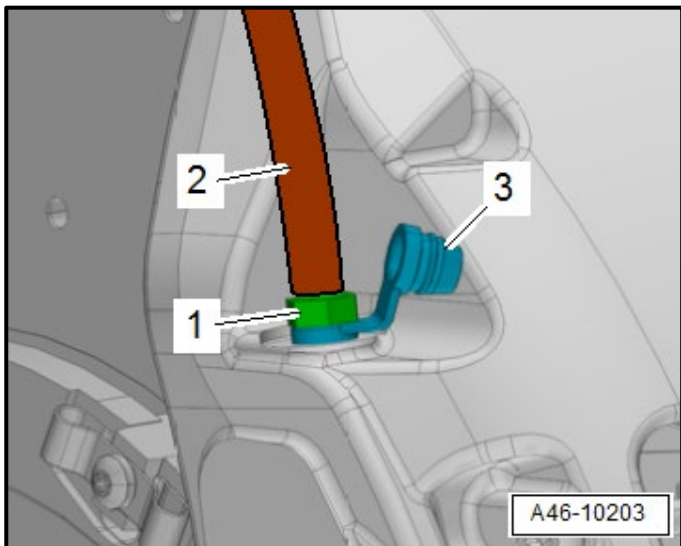
- Remove protective cap <3> from bleeder screw <1> on the driver front brake caliper.
- Connect the hose <2> from the bleeder bottle.
- Open the bleeder screw <1> to lower pressure in the hydraulic system.
- Close the bleeder screw <1> and remove bleeder bottle.
- Repeat these steps on the passenger front caliper.

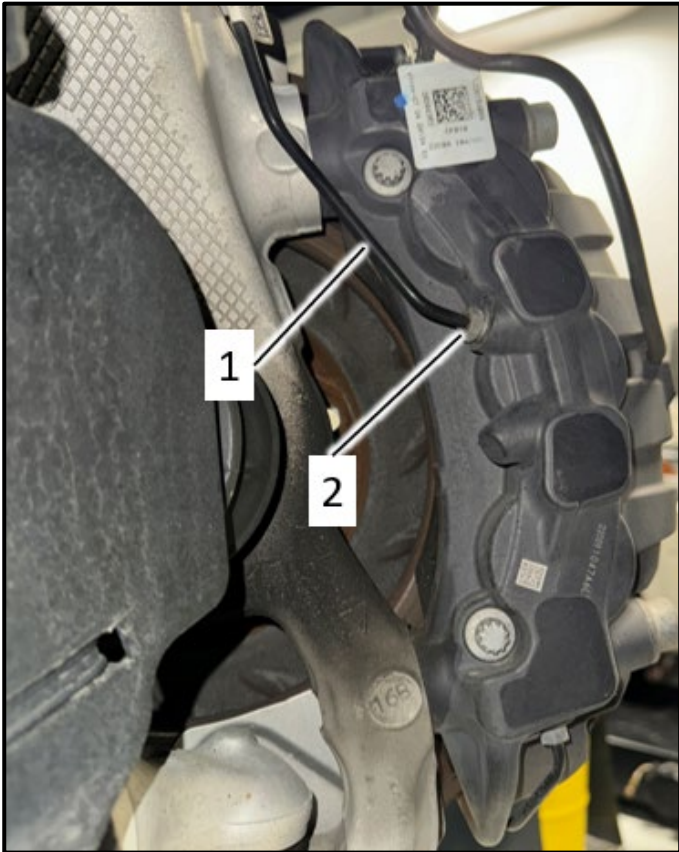
- Install the new brake hose <1>.
- Remove any sealing caps and/or plugs.
- Loosely thread the brake hose connection <2> into the caliper, but do not fully tighten.

Ensure the new brake hose is routed correctly. The brake hose must not be kinked, bent, or twisted. It should not contact the suspension or body when the vehicle suspension is loaded.

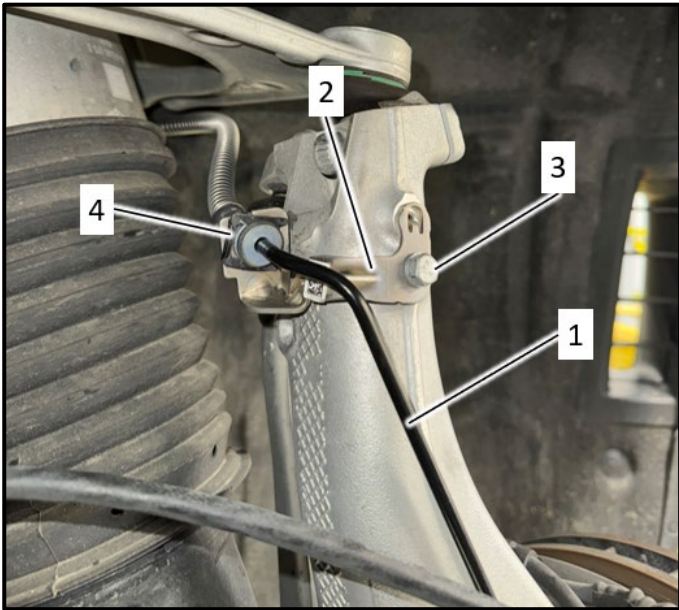
- Install the new bracket <1>.
- Loosely install a new bolt <3>.
- Install the previously removed spring clip <4>.

The new brake hose bracket <1> is an updated design. This will cause the new brake hose to sit in a slightly different position. This is normal.

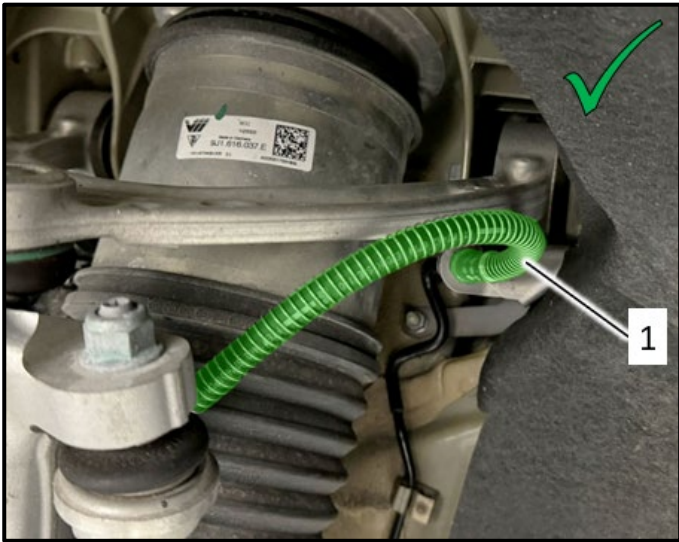
- The brake hose <1> is correctly installed and shown with the vehicle suspension extended.

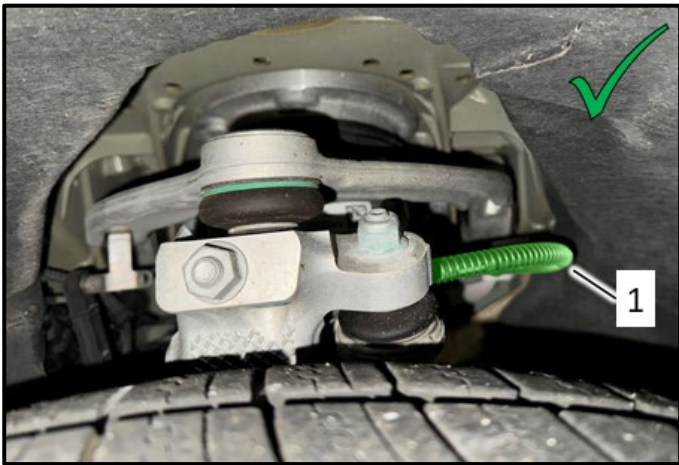
- The brake hose <1> is correctly installed and shown with the vehicle suspension loaded.

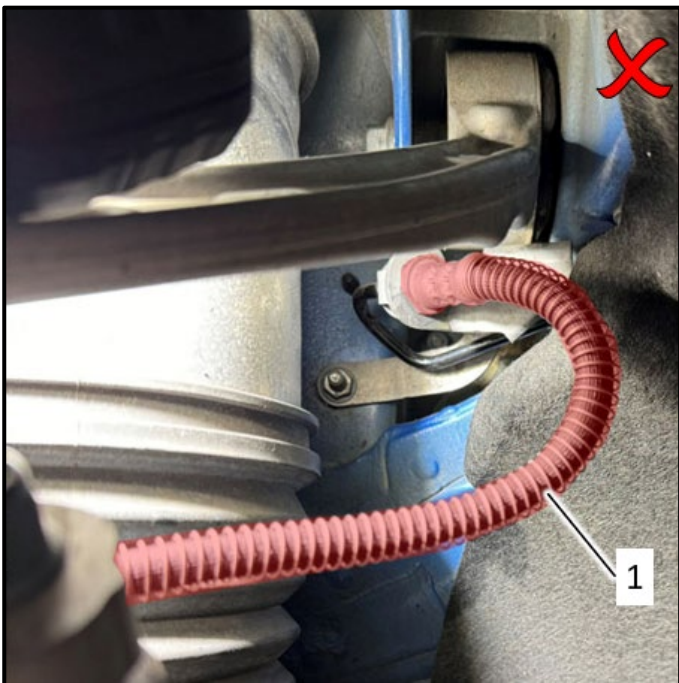
- The brake hose <1> was rotated counter-clockwise and is incorrectly installed.
