# Safety Recall

## Code: 47UP

<b>Subject</b>	<b>Front Axle Brake Hoses</b>																									
<b>Document History</b>	<table border="1"> <thead> <tr> <th>Date</th> <th>Summary</th> </tr> </thead> <tbody> <tr> <td>09/05/2024</td> <td>Updated work instructions to clarify direction brake hose fitting may have to be rotated.</td> </tr> <tr> <td>09/04/2024</td> <td>Updated work instructions and parts information</td> </tr> <tr> <td>07/30/2024</td> <td>Original publication</td> </tr> </tbody> </table>	Date	Summary	09/05/2024	Updated work instructions to clarify direction brake hose fitting may have to be rotated.	09/04/2024	Updated work instructions and parts information	07/30/2024	Original publication																	
Date	Summary																									
09/05/2024	Updated work instructions to clarify direction brake hose fitting may have to be rotated.																									
09/04/2024	Updated work instructions and parts information

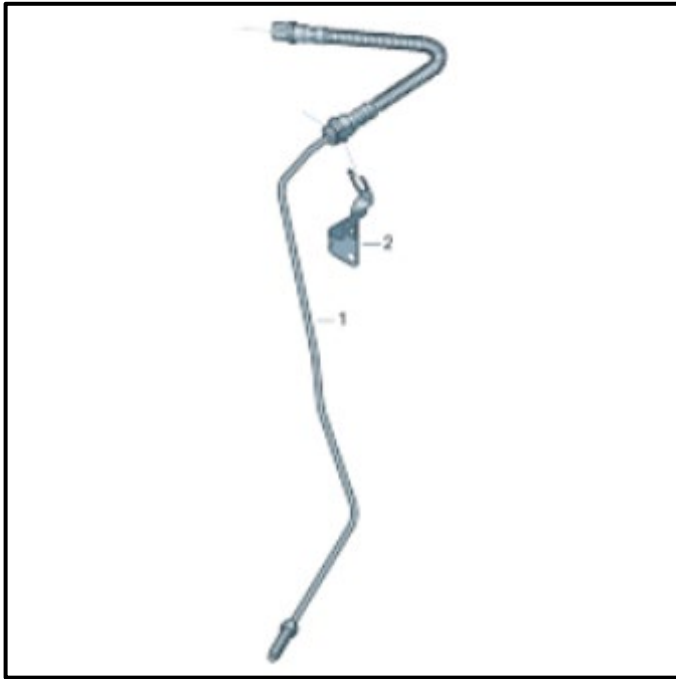
- Replace driver and passenger front flexible brake hoses and brackets.

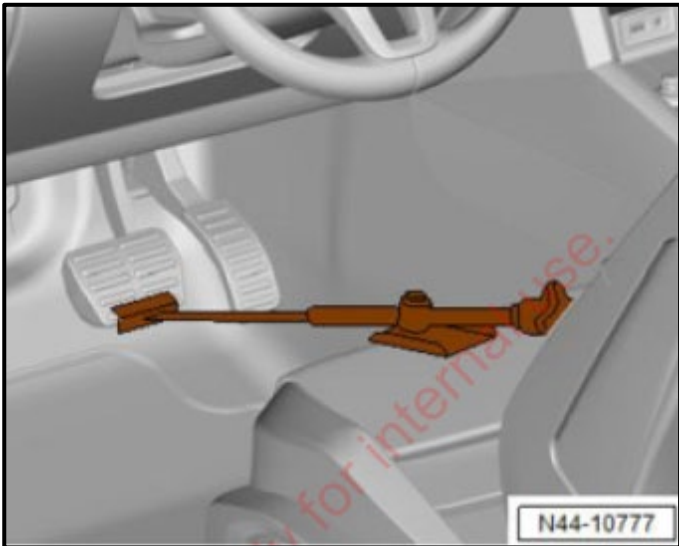
- Depress the brake pedal at least 60mm and install the pedal depressor -VAG1869/2-.

Do not remove the brake pedal depressor until instructed to do so.

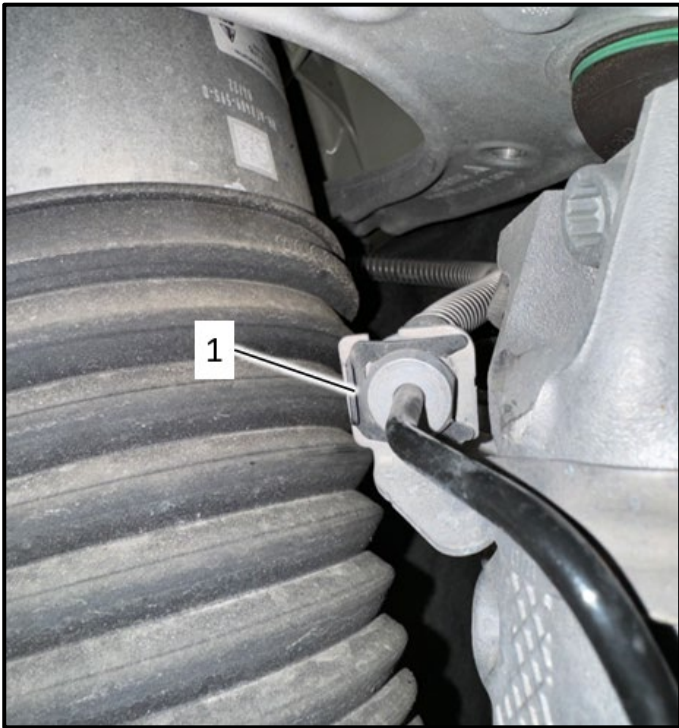
- Remove the spring clip <1> and set to the side as it will be reused.

The steps below outline the replacement of the driver front brake hose and bracket. Replacement of the passenger front brake hose and bracket is similar.

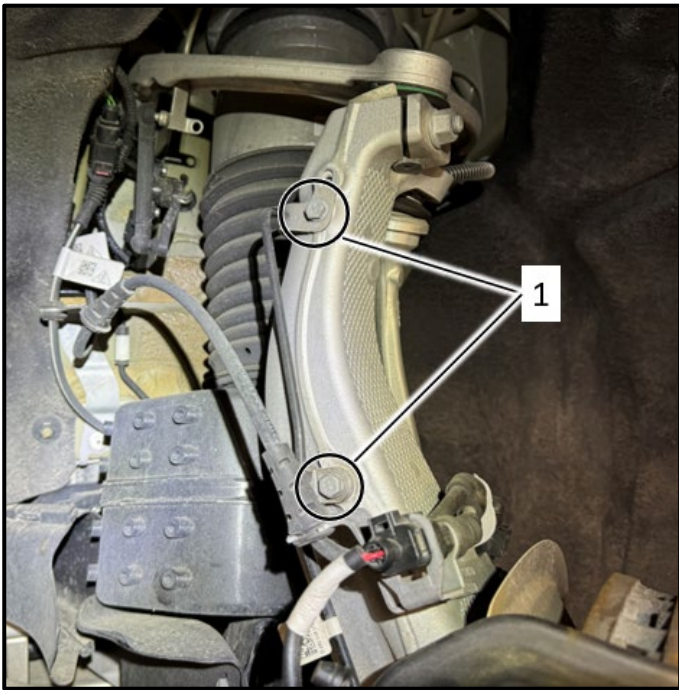
The bolts <1> are one time use fasteners and will not be reused.

- Remove the bolts <1>.

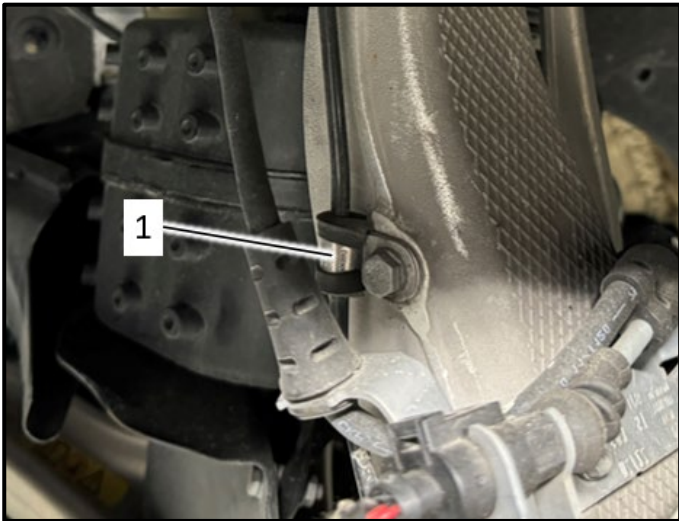
- Remove the bracket <1> and set to the side as it will be reused.

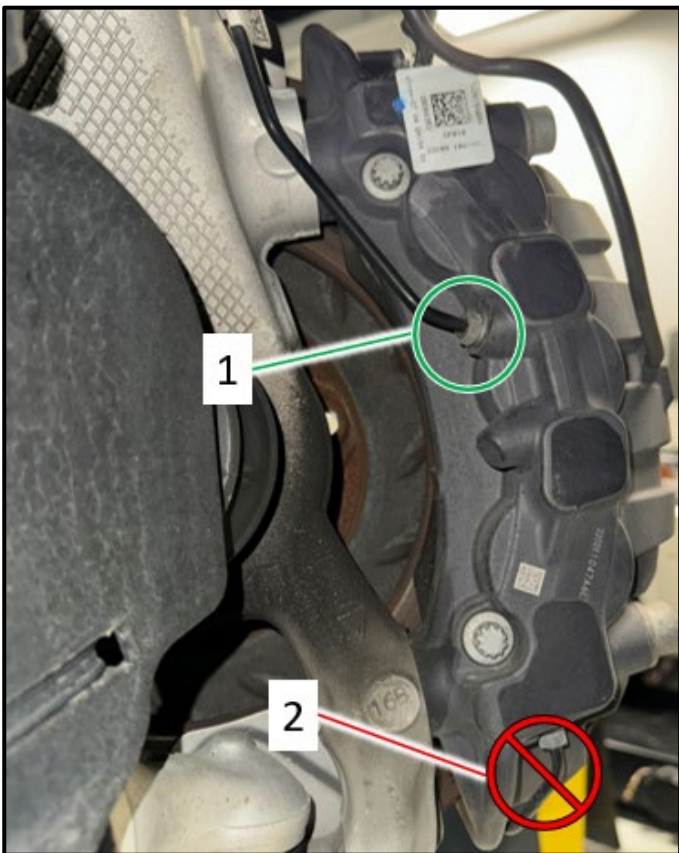
The lower brake line <2> is not removed during this repair. Do not loosen or disconnect this line.

- Place a lint-free cloth under the brake hose to catch any escaping brake fluid.
- Loosen the brake hose connection <1> and remove it from the brake caliper.
- Seal any open brake fluid circuit connection points using suitable caps or plugs that are clean and free of debris.

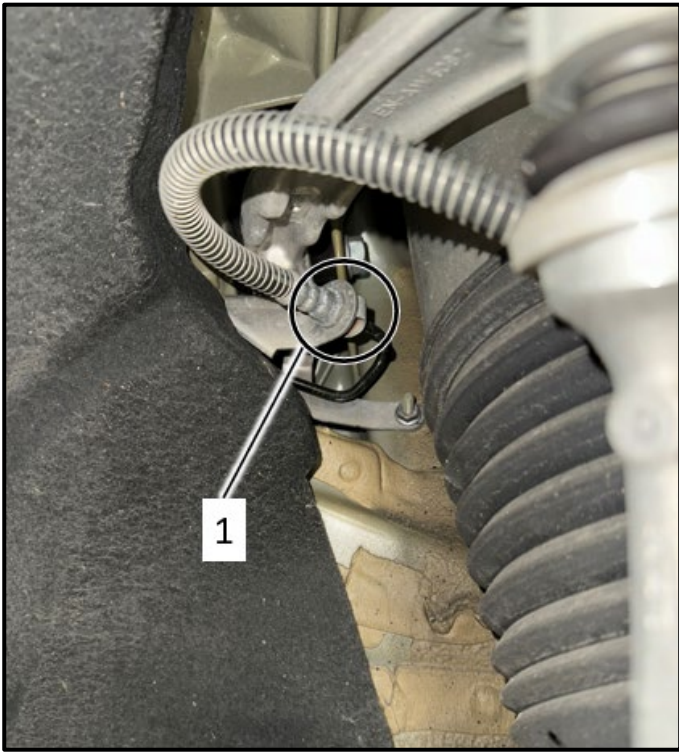
- Locate the upper brake hose connection <1> in the wheel well.

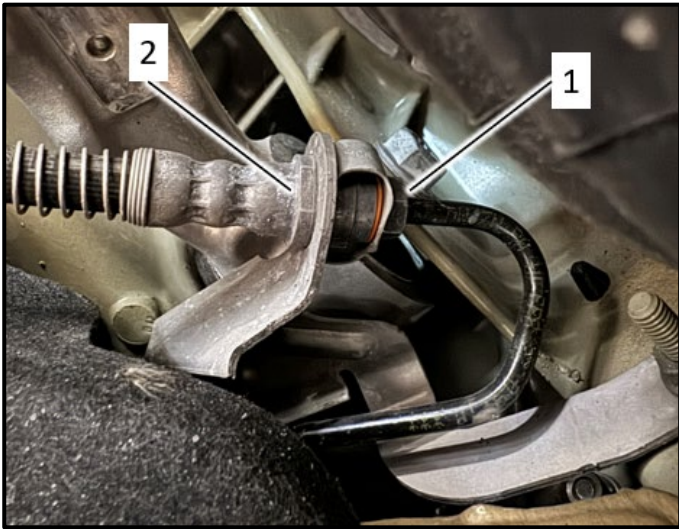
- Place a lint-free cloth under the brake hose connection to catch any escaping brake fluid.
- Loosen and separate the brake line connection <1> while counter-holding the brake hose connection <2>.
- Seal any open brake fluid circuit connection points using suitable caps or plugs that are clean and free of debris.

A 15 mm wrench will fit the brake hose connection <2>.

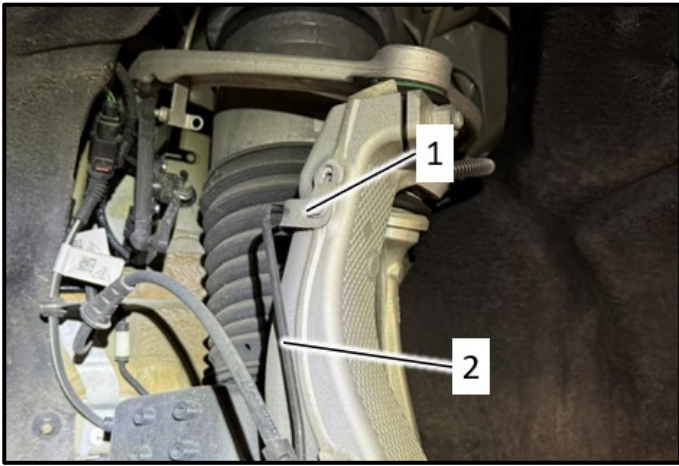
Prior to removing the brake hose, take note of the hose routing.

- Remove the bracket <1> and brake hose <2> from the vehicle.

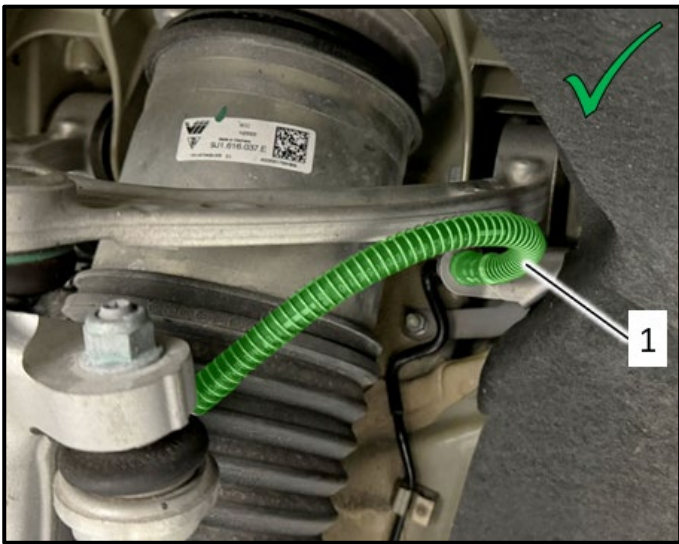
- The brake hose <1> is correctly installed and shown with the vehicle suspension extended.

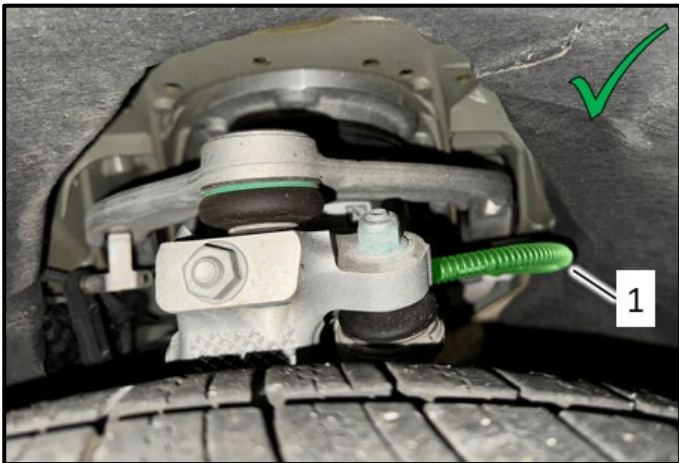
- The brake hose <1> is correctly installed and shown with the vehicle suspension loaded.

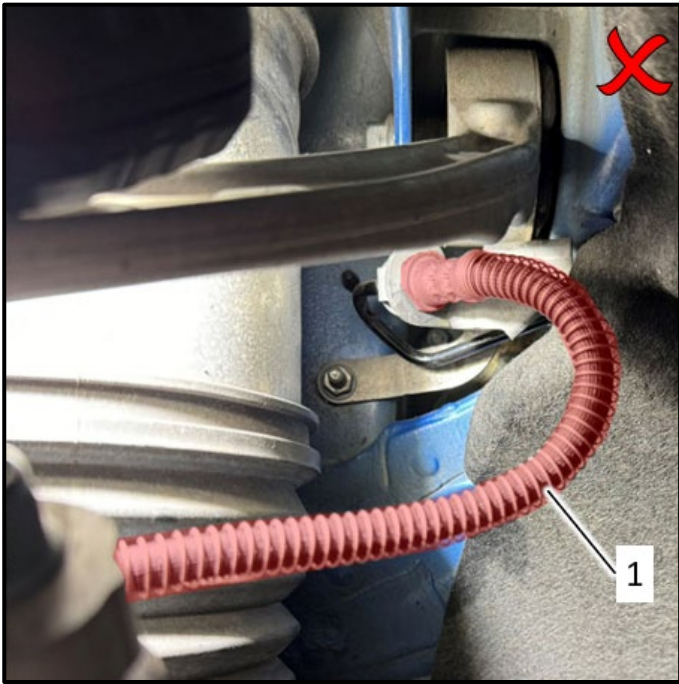
- The brake hose <1> was rotated in the wrong direction and is incorrectly installed.
