Safety Recall SR-24-04-0

Coolant Heater May Fail to Defrost Windshield

Model: Air

Rev. 1

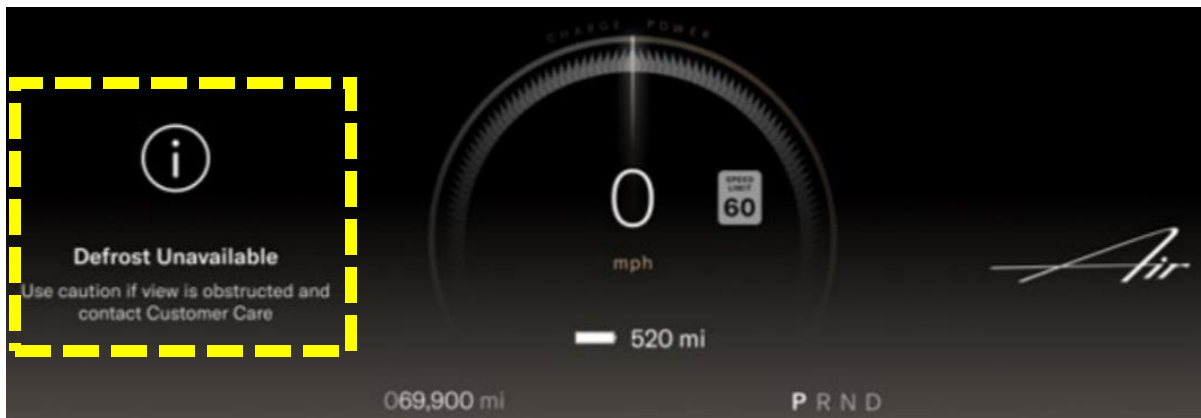
3. Does the message “Defrost Unavailable” appear? (example below):

YES: Proceed to **Section X. COOLANT HEATER REPLACEMENT**

NO: Proceed to **Step #4**

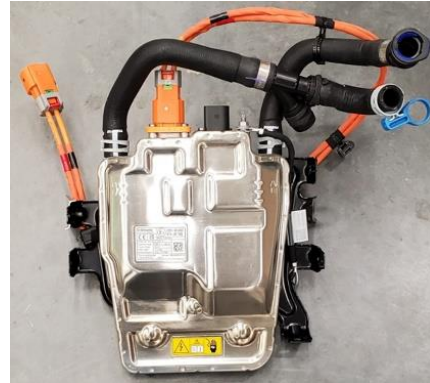
1. Replace Coolant Heater Assembly

Follow the instructions in the Service Manual to replace the Coolant Heater Assembly.

Service Manual / Climate Control and Thermal / Coolant System / [Water Heater HVH70 GEN1.5 Remove and Replace](#)

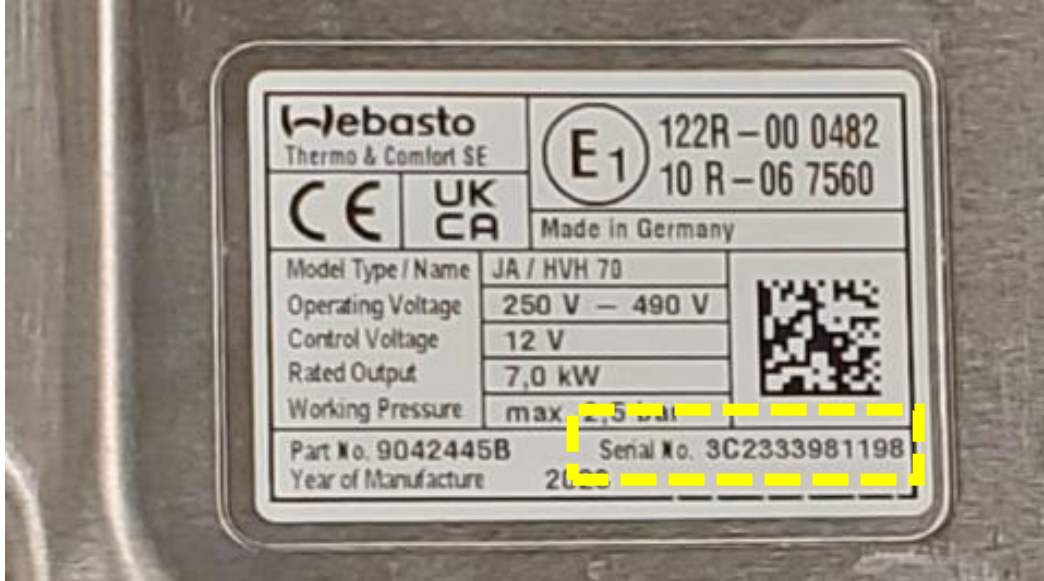
2. Record and take photos of the SERIAL NUMBERS for both ORIGINAL “out” and NEW “consumed” coolant heaters. Clearly mark/identify the serial numbers as ORIGINAL “out” and NEW “consumed” on the work order.
