# Keystone RV Company

## SAFETY ADVISORY # 24-456

### Loose Sidewall Metal

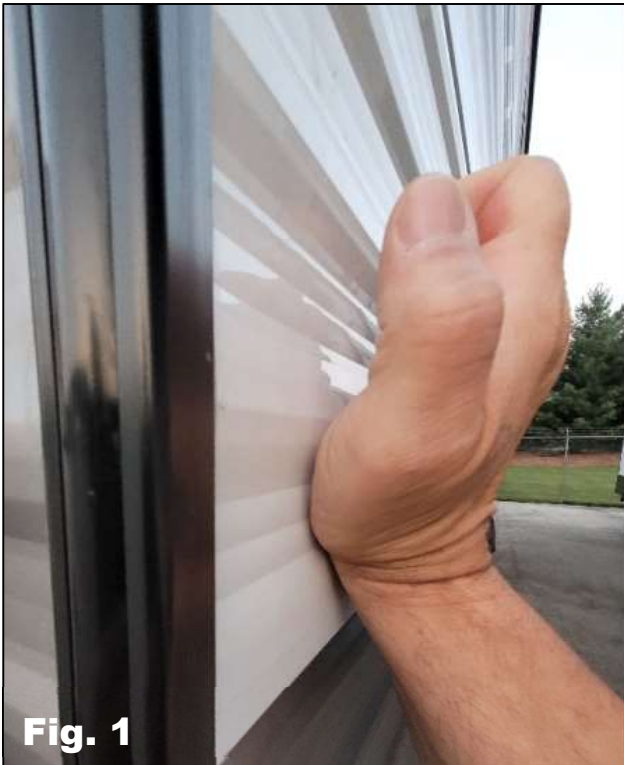
For each model view the pictures for vertical location of each logo, then check the measurements and press gently on the valley of the sidewall metal to feel for the stud with the palm of your hand, see Figure 1. Then place a small mark on each measurement. Be sure the mark is on the seam where the sidewall metal locks together as all screws will go through both pieces of sidewall metal at the seams.

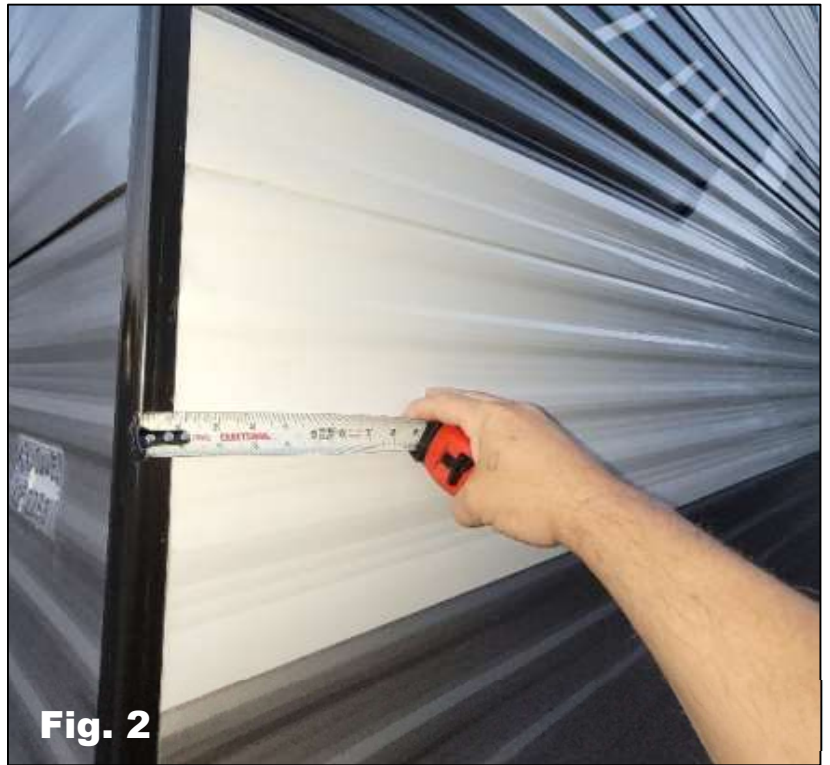
All measurements are to be done with the tape measure hooked on the front corner of the molding, see Figure 2.

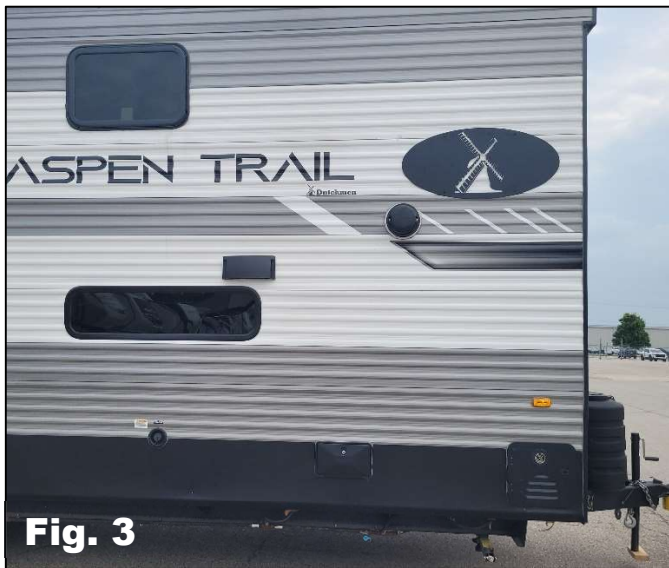
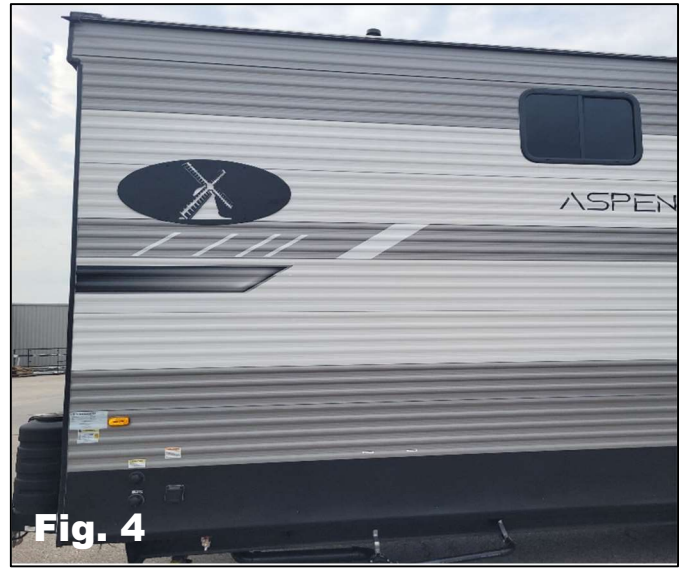
On Aspen Trail model **260 THLOFT**, see Figures 3 and 4 for mounting locations.

On the Door Side, the first screw measures 16" and the second screw is 32".

On the Off Door Side, the first screw measures 18 ½" and the second screw is 34 ½".

Make sure the logo is faced the correct direction, place butyl tape over each of the 4 holes on the back of the logo. Then add the 4 screws at the marked locations.

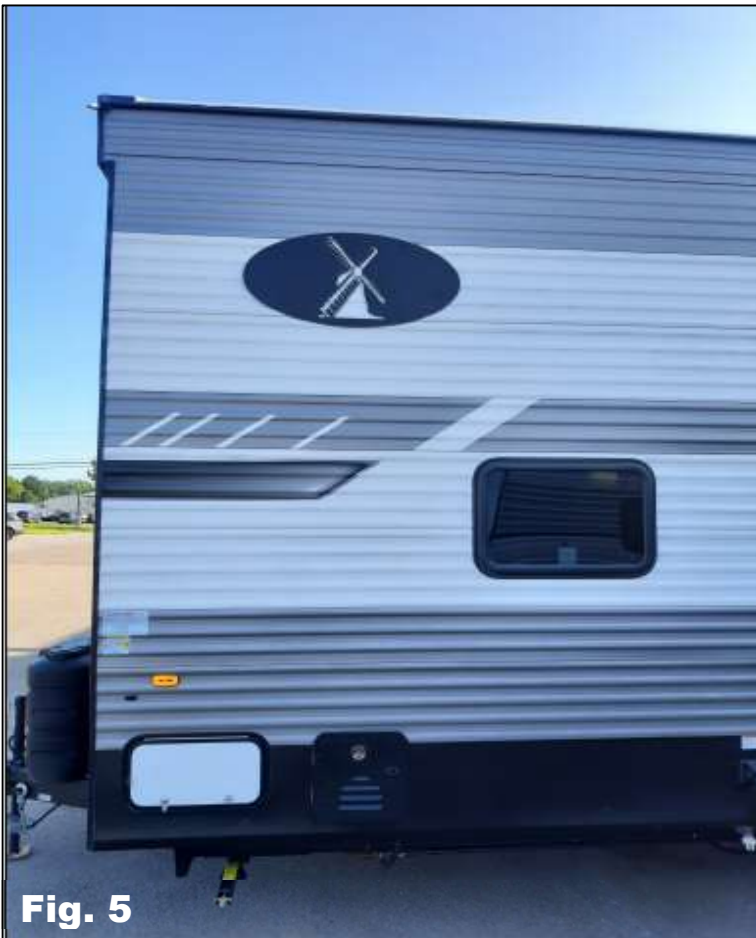
Both the **Colorado 360THCLOFT** and **Aspen Trail 360THLOFT** will only get one logo, it will be on the Off Door Side, see Figure 5

The measurements are the first screw 32" second screw 48"

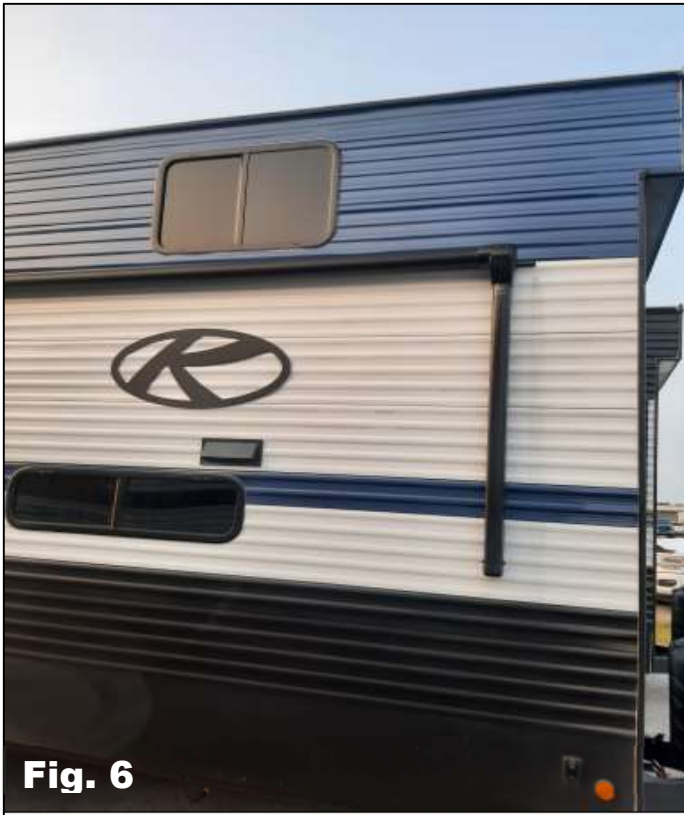
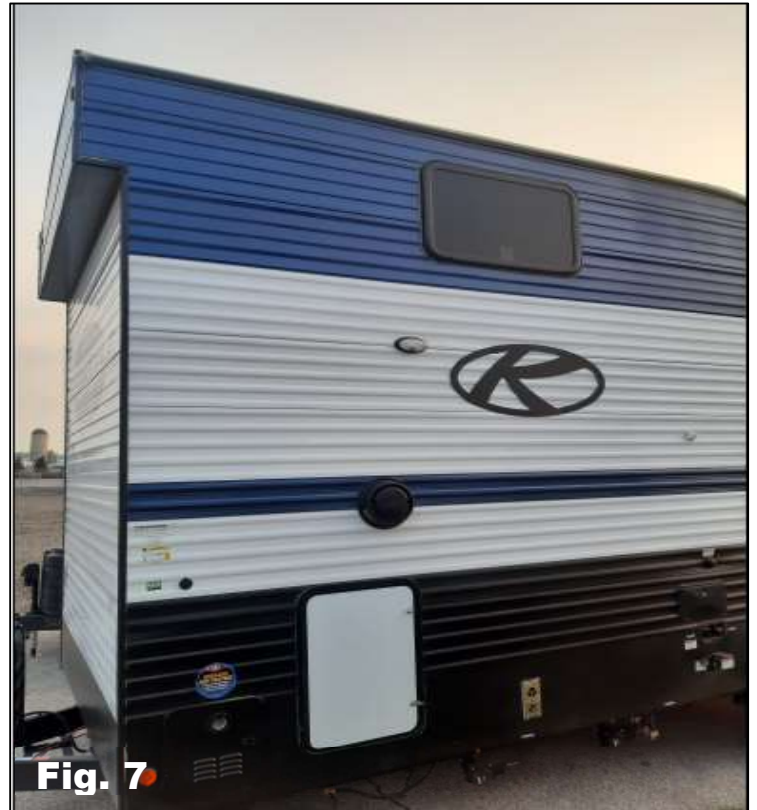
The **Hideout 24LOF** and **Springdale 245ML** logos will be in the same locations, see Figures 6 and 7

Door Side: for the first screw there is a stud that is located at the middle of the outside microwave vent. Press gently on the valley of the sidewall metal to feel for the stud with the palm of your hand. The second screw will be 16" behind that screw and will fall in the hole of the logo.

Off Door Side first screw is 66 1/2" second screw is 82 1/2"
