## Technical Service Bulletin

**GROUP****RECALL****NUMBER****24-01-076G****DATE****SEPTEMBER 2024****MODEL(S)****G70 (IK)****SUBJECT:** ECU UPDATE AND DTC P0088 INSPECTION/REPAIR (RECALL 023G)**★ IMPORTANT**

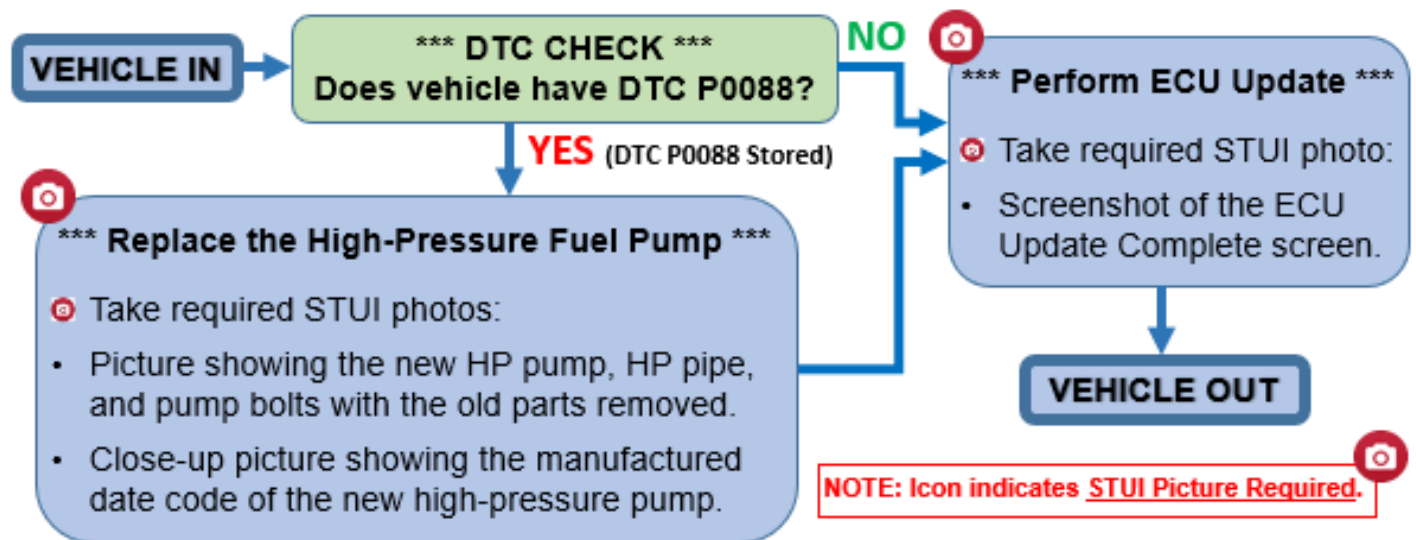
**Inspection and Service Procedure Overview:**

1. Using a GDS scan tool, inspect to confirm if vehicle has DTC P0088 (or P008800).
  - **If vehicle has DTC P0088/P008800**, then follow the next step to replace the high pressure pump and perform the ECU Update.
  - **If NO DTC P0088** (or P008800) is found, then **skip to Step 10** to perform ECU Update.
2. Follow the Shop Manual to release the residual fuel pressure in the fuel line.
  - Engine Control / Fuel System > Fuel Delivery System > Repair Procedures > Release Residual Pressure in Fuel Line

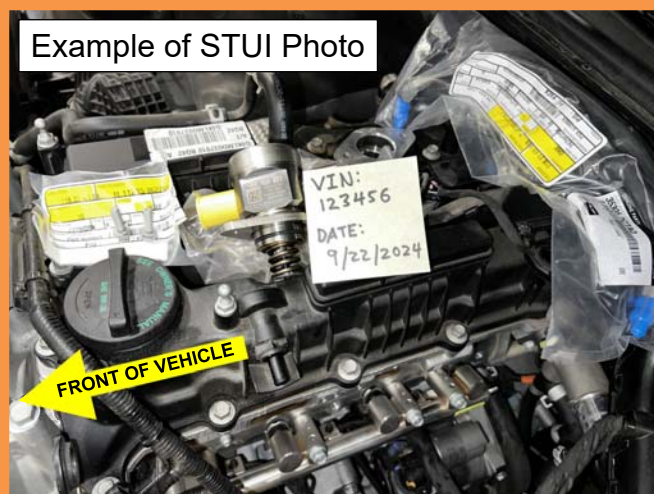
Example of STUI Photo

7. Take the following 2 STUI photos of the new parts to be installed after removing the old parts.
- Include in the 1<sup>st</sup> photo, the new High Pressure Pump, new 2 new Pump Bolts, and the new High Pressure Pipe **from the driver side of the vehicle** with the intake manifold still removed.
  - Include in the 2<sup>nd</sup> photo, close up of the new High Pressure Pump **serial number** and **date code**.

Using STUI, take photos of the new parts to be installed with last 6 digits of VIN and date of repair on a piece of paper.

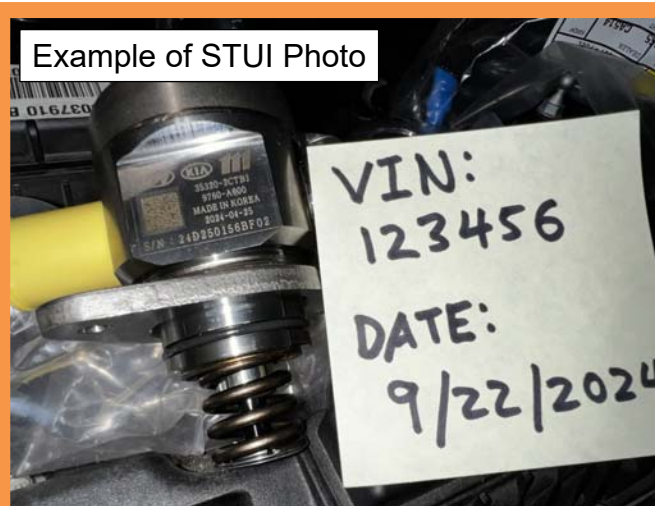
Example of STUI Photo

Ensure the picture is in focus and VIN with date of repair are legible. Upload the photo to STUI.

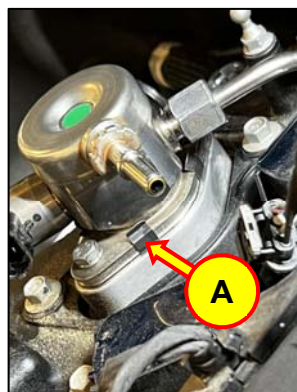
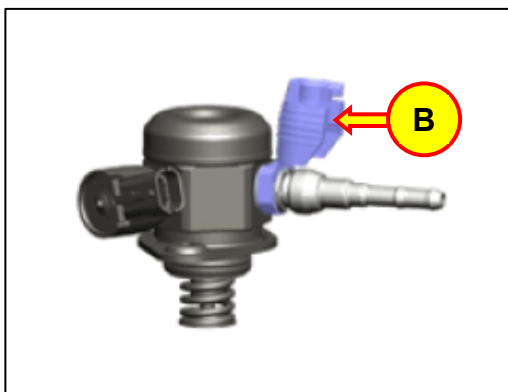
Be sure to transfer the (A) shim-type metal Pump Gasket and the (B) low pressure fuel hose quick connector clamp (if equipped) over to the new High Pressure Fuel Pump.

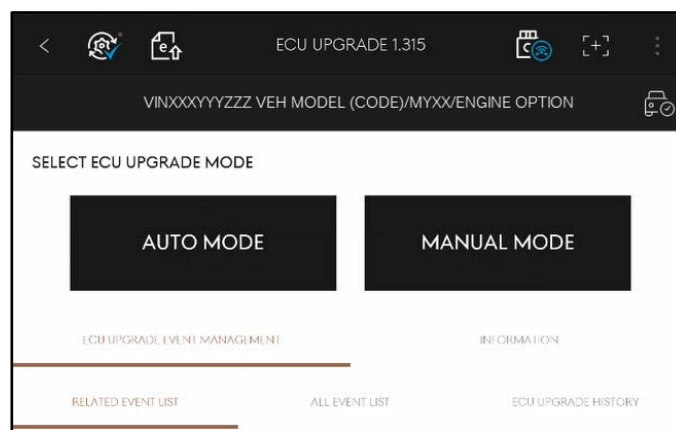
Use the Auto Mode ID Check to verify the ECU ROM ID before updating the software.

Refer to **TSB # 24-GI-016G**, “ECU Update Procedure for Tablet-Based Genesis-Smart”, for additional information.

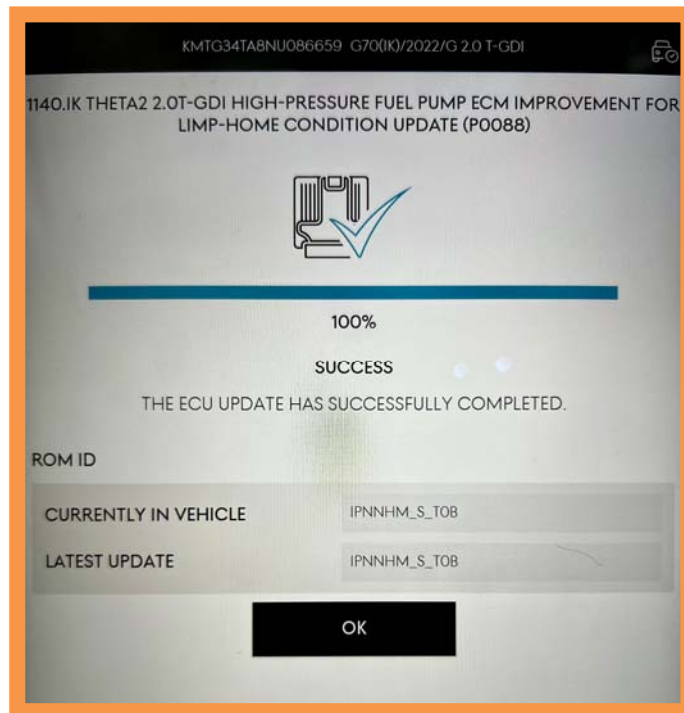
Take a screenshot of the ECU update complete screen using your tablet and upload to STUI.
