SAFETY RECALL CAMPAIGN 3A03 **2023 & 2024 V-STROM 800DE/800DE Adventure** **Rear Tire Replacement Recall Service**

Affected Models:	2023 & 2024 V-STROM 800DE and 800DE Adventure motorcycles, (DL800DERCM3, DL800DERCAM3, DL800DERCM4, & DL800DERCAM4)
Affected Departments:	Management, Service, Warranty, Sales, Parts, Accessories
Attachments:	Customer Notification Letter 1 (July 29, 2024) & Letter 2 (September 20, 2024)
Reference:	V-STROM 800/800DE (DL800/800DE) Service Manual (99500-25L02-03E), Service Bulletin TL/SV/DL No. 70 (V-STROM 800DE Recall Initial Information), & Sales Bulletin 24-067R (V-STROM 800DE/800DE Adventure STOP SALES)

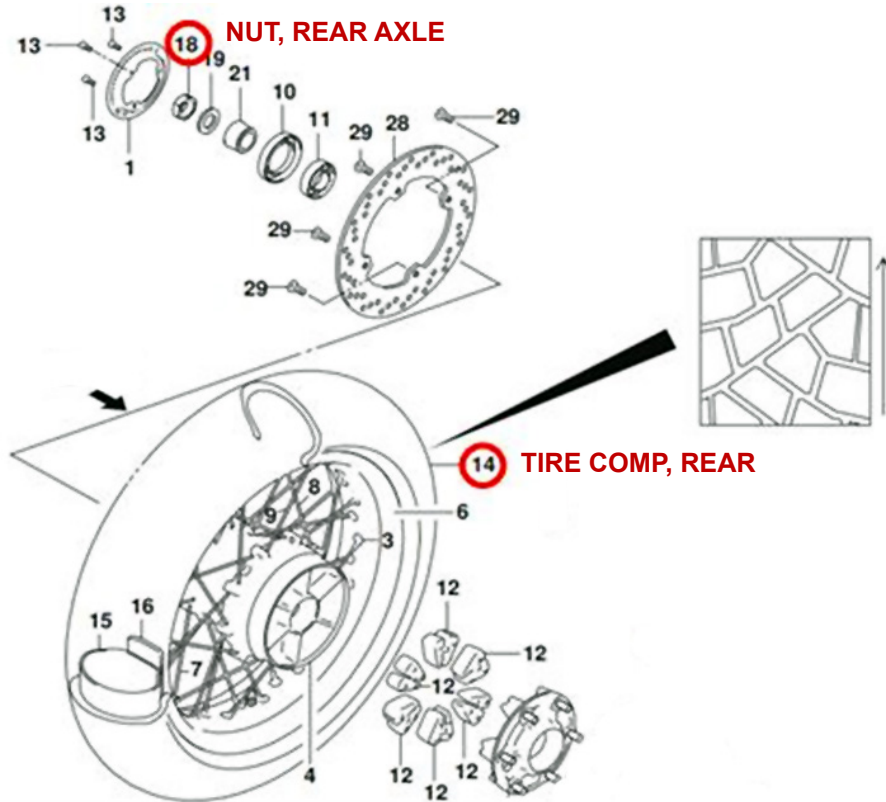
Original Part (tire)	Countermeasure Part (tire)
65110-25L30	65110-25L30-RX0
Tire manufacturing serial number before the 28th week of 2024	Tire manufacturing serial number after the 29th week of 2024

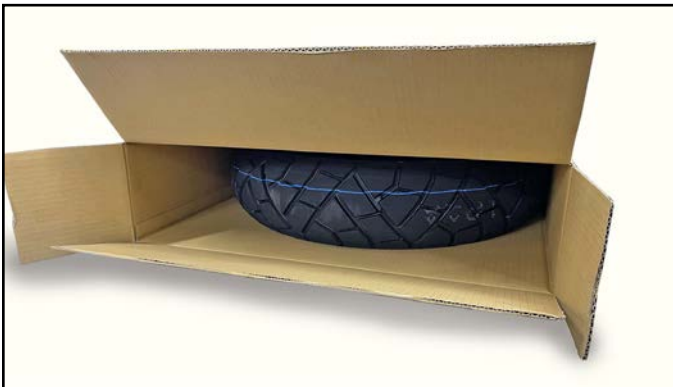
1. Open the shipping box and remove the new tire.

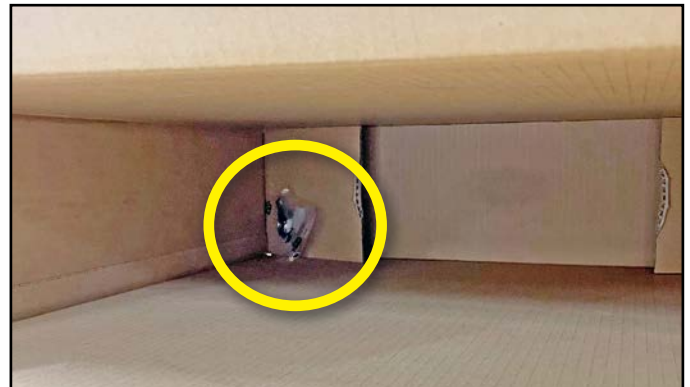
2. Taped to the interior of the shipping box, in a poly bag, is the new rear axle nut.

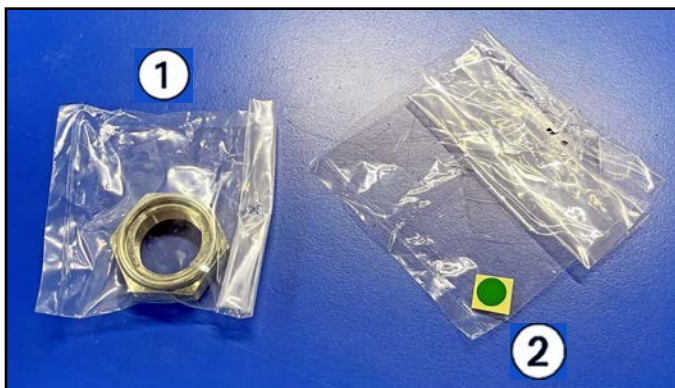
3. In addition to the new rear axle nut ①, is a small, green dot decal ② that is not used for this recall service. Dispose of the decal properly.

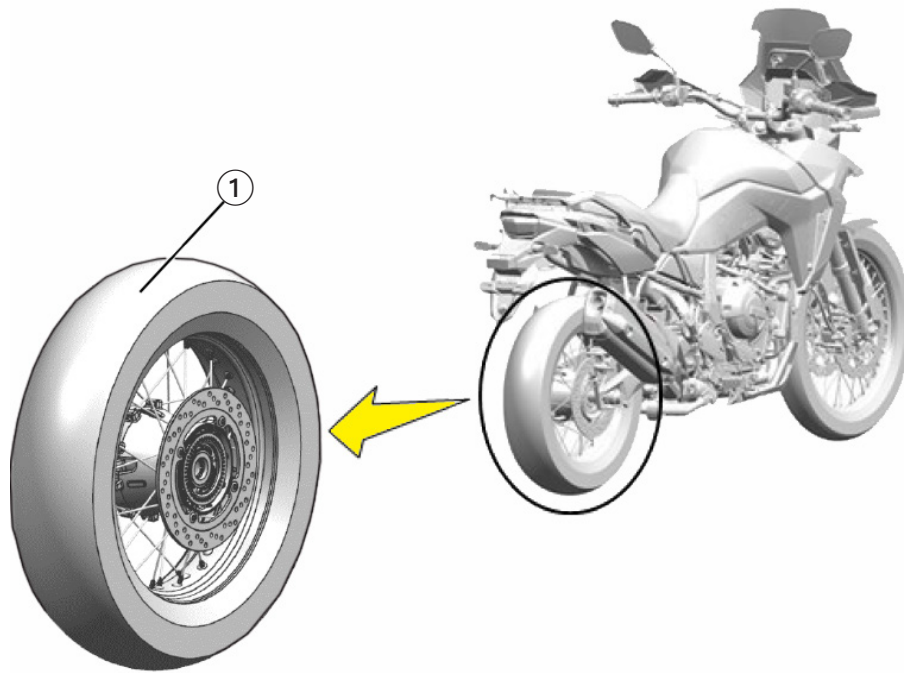
- Follow the repair procedure listed on the following pages install a new, countermeasure tire ① on the rear wheel of the motorcycle.

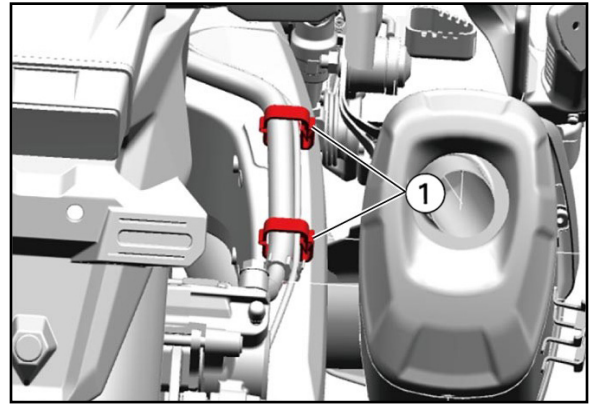
1. Release the rear brake hose from the clips ① on the swingarm.

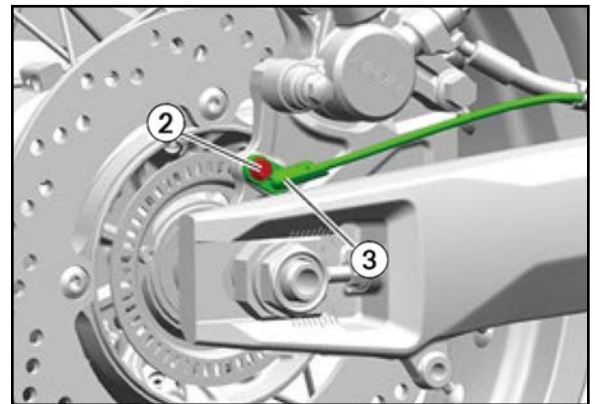
2. Remove the rear wheel sensor bolt ②.

3. Remove the rear wheel speed sensor ③ from the brake caliper stay.

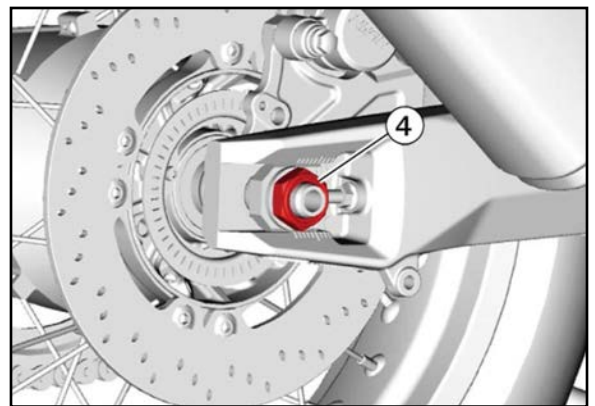
4. Loosen the axle nut ④.

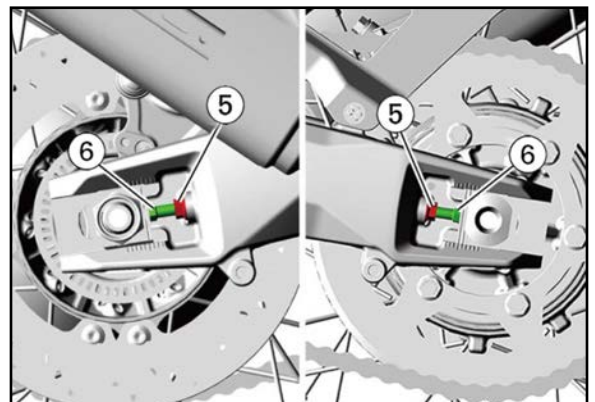
6. Loosen the left and right chain adjuster lock-nuts ⑤ and rotate the chain adjuster bolts ⑥ into the swingarm to reduce the tension from the drive chain upon the driven sprocket.

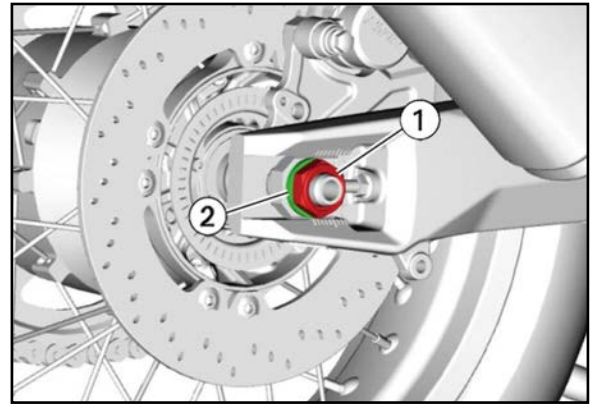
7. Remove the axle nut ① and washer ②.

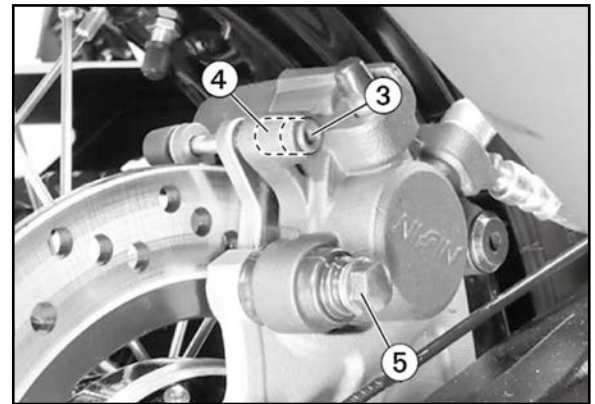
8. Remove the rear brake pad mounting pin plug ③ from the brake caliper, and remove the rear brake pad mounting pin ④.
9. Remove the rear brake caliper mounting bolt ⑤ from the brake caliper.

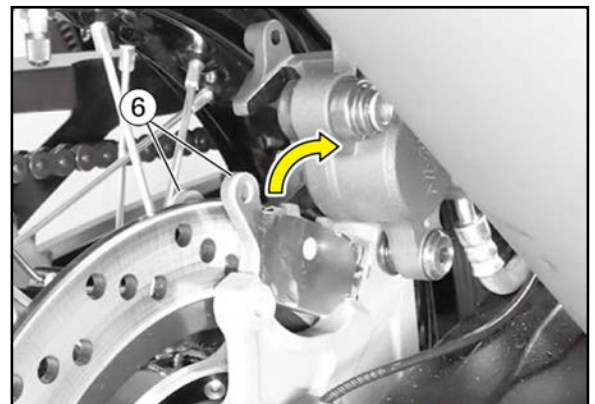
10. Rotate the brake caliper forward and then remove the brake pads ⑥ from the brake caliper bracket.

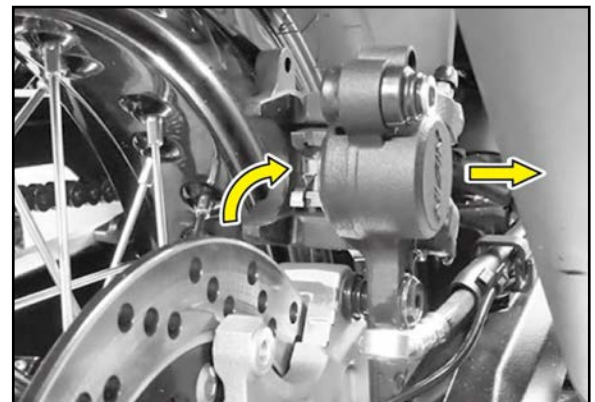
11. Pivot the caliper up and remove it from the caliper bracket.

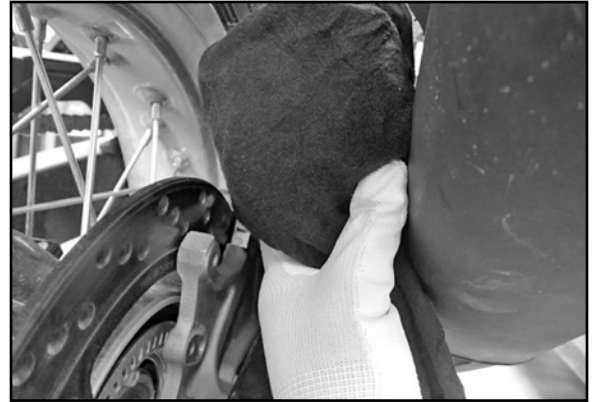
12. Protect the rear brake caliper and other parts on the motorcycle from damage by wrapping the caliper with a soft rag.

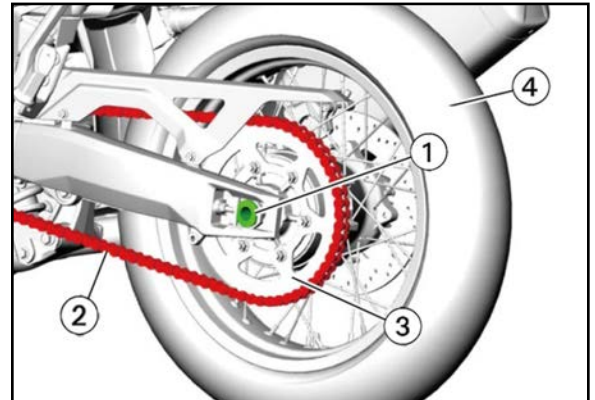
13. Remove the rear axle ①.
14. Remove the drive chain ② from the rear wheel sprocket ③.
15. Remove the rear wheel ④ and the brake caliper bracket from the motorcycle.

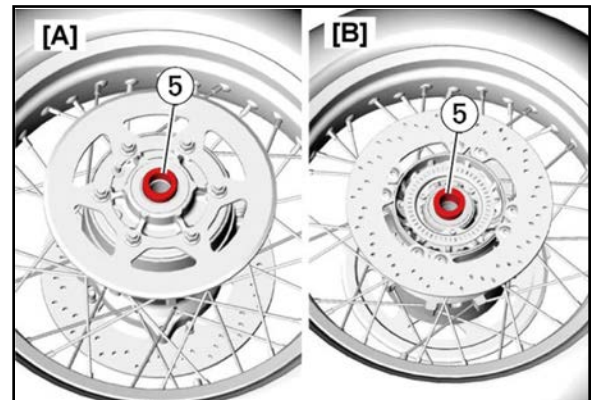
16. Remove the left- and right-side spacers ⑤ from the rear wheel assembly.

[A]: Left side

[B]: right side

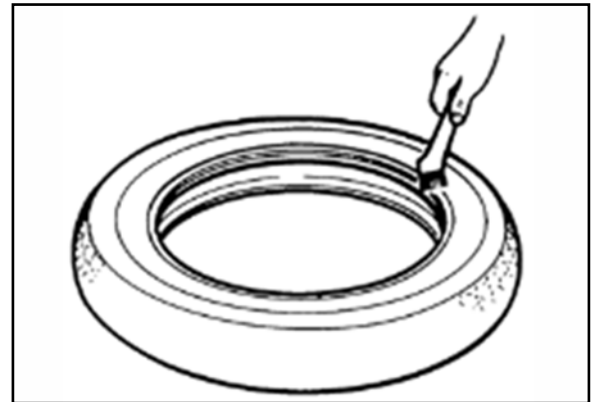
5. Apply tire lubricant generously to the tire bead of the countermeasure tire.

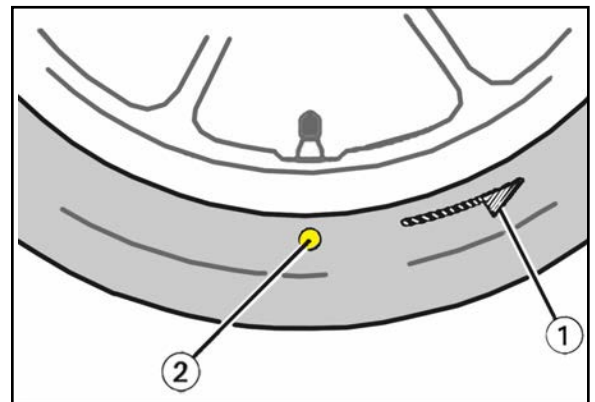
6. When installing the countermeasure tire onto the wheel, align the arrow ① on the side wall with the direction of wheel rotation.

Align the light point mark ② on the tire side wall with the valve stem position.

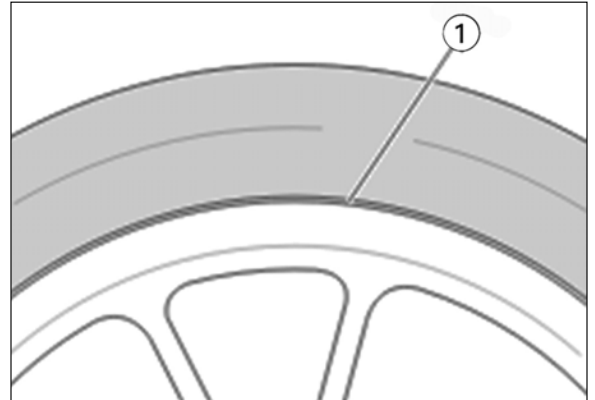
- At this point, check the "rim line" ① molded into the tire side walls. This line must be equidistant from the wheel rim all around the tire, and fully on both sides.
- If the distance between the rim line ① and wheel rim varies, this indicates that the bead is not properly seated. If this is the case, deflate the tire completely and unseat the bead for both sides. Coat the bead with a good amount of lubricant and fit the tire again.

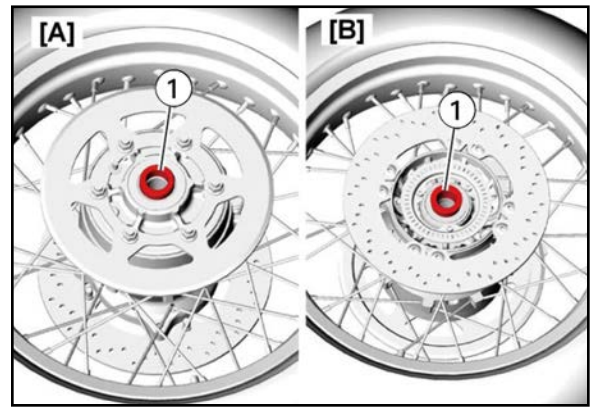
1. Clean any old grease and residue from the wheel spacers ① and then apply a light film of new grease on the spacers where they will fit into the seals of the wheel hub. Install the spacers into the proper side of the rear wheel assembly.

"A": Grease 99000-25100 (SUZUKI SILICONE GREASE)

[A]: Left side

[B]: right side

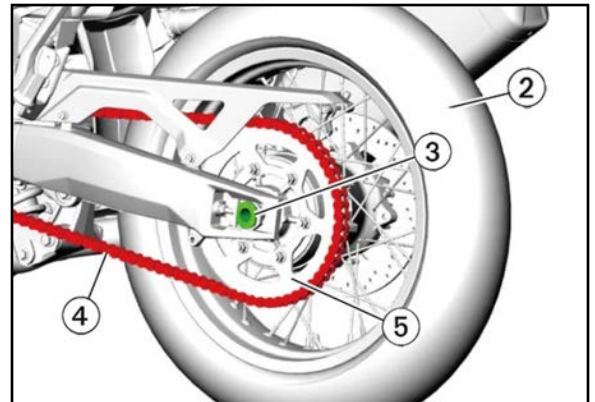
2. Remount the rear wheel ② and the brake caliper bracket to the swingarm and install the rear axle shaft ③.
3. Install the drive chain ④ to the drive chain sprocket ⑤.

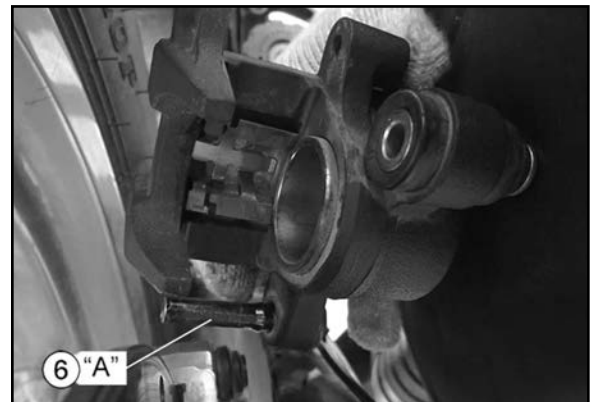
4. Remove the rag protecting the brake caliper.
5. Apply grease [A] to the rear caliper sliding pin ⑥.

"A": Grease 99000-25100 (SUZUKI SILICONE GREASE)

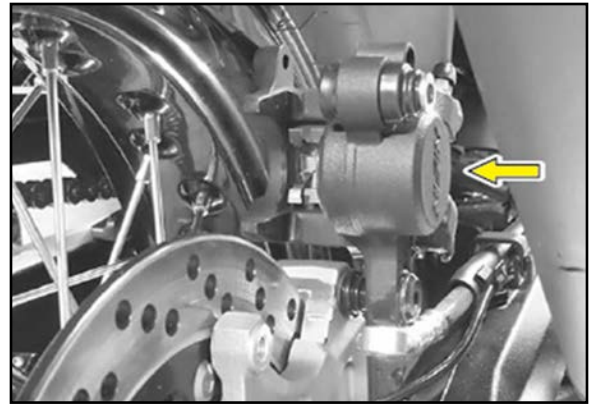
6. Install the rear brake caliper onto the rear brake caliper bracket.

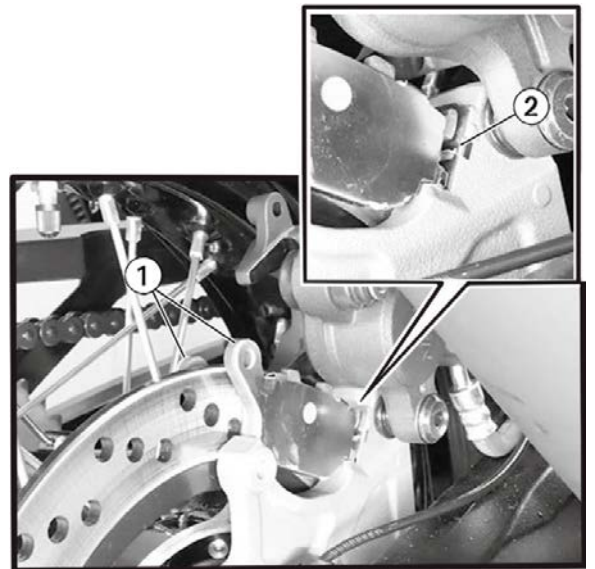
7. Install the brake pads ①.

- Pushing back the caliper piston into the caliper will facilitate installation of the brake pads. As the piston is pressed into the caliper, watch the reservoir tank fluid level so it does not exceed the upper line.
- Make sure that the detent of the pad is seated onto the corresponding retainer ② on the caliper bracket.

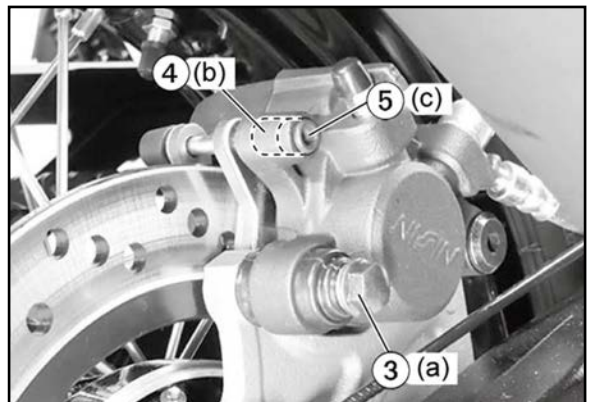
8. Tighten the rear brake caliper mounting bolt ③, the rear brake pad mounting pin ④, and the rear brake pad mounting pin plug ⑤ to the specified torque.

Rear brake pad mounting pin (b): 12.5 lbf-ft (17 N·m, 1.7 kgf-m)

Rear brake pad mounting pin plug (c): 1.85 lbf-ft (2.5 N·m, 0.25 kgf-m)

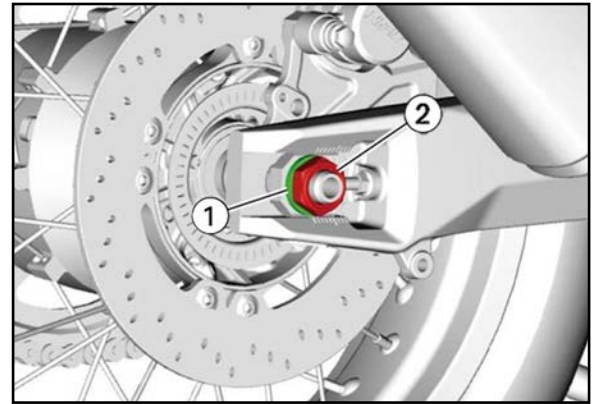
- Install the washer ① and temporarily tighten the new rear axle nut ② until it is lightly seated against the swingarm.

Use the new rear axle nut (64721-13K00-RX0) supplied in the REAR TIRE SET. See page 4 of this bulletin.

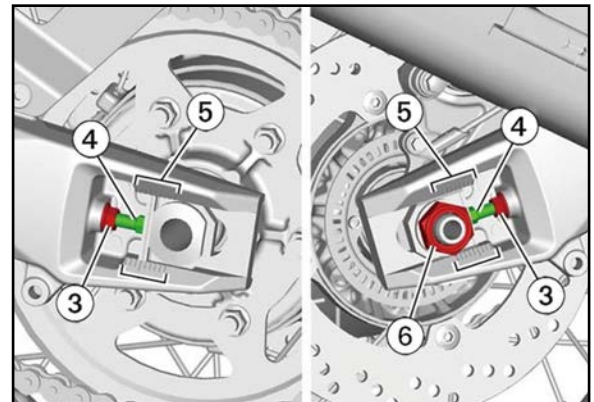
- Place the motorcycle on the side stand.
- Loosen both chain adjuster bolt nuts ③ and then loosen or tighten both chain adjuster bolts ④ evenly until there is slack "a" at the middle of the chain between the chain roller and rear sprocket.

The reference marks ④ on both sides of the swingarm and the edge of each chain adjuster must be aligned to ensure that the front and rear wheels are correctly aligned.

③: Chain adjuster bolt lock-nuts
④: Chain adjuster bolts
⑥: Rear axle nut (new from the REAR TIRE SET)

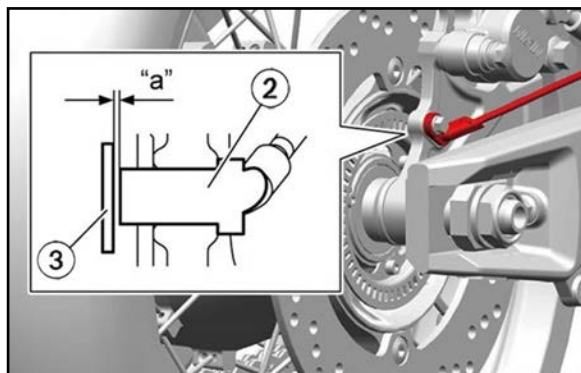
16. Check the clearance "a" between the rear wheel speed sensor ② and the sensor rotor ③ using a thickness gauge.

Rear [Standard] 0.015 - 0.061 in (0.38 - 1.55 mm)

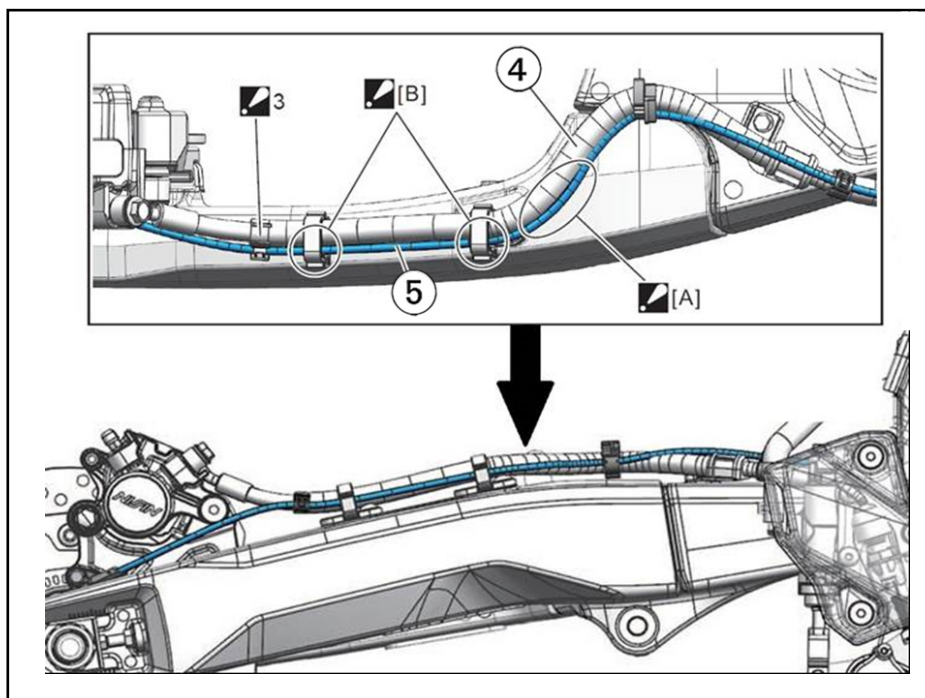
17. Secure the rear brake hose ④ and the rear wheel sensor lead wire ⑤ with the plastic clamps on the left swingarm beam.

▣[3]: Clamp - clamp the rear wheel speed sensor lead wire at the ride side of the brake hose protector end.

Orient the open portion of the clamp upwards.

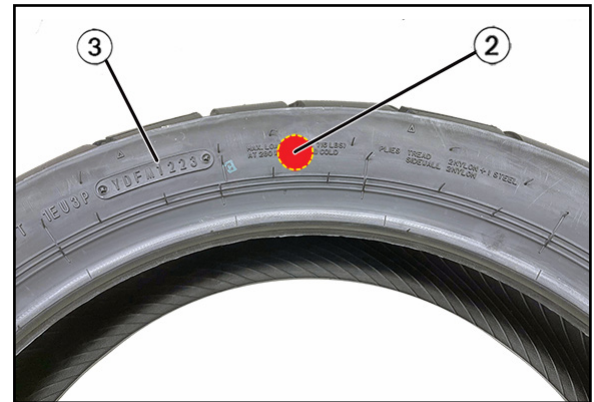
2. **The original, replaced tire must be disabled so it cannot be used on a vehicle in the future.** Use a hole saw to drill a hole ② into the tire's sidewall (as shown in the image at right). Position the hole to the right of the tire's manufacturing serial number ③. Follow these steps with the replaced tire:

- Drill a 1.0 - 2.0 in (25.4 - 50.8 mm) hole in the sidewall of the tire as recommended.
- Download a Warranty Parts Tag (99903-09822-005) from the Suzuki CONNECT > Technical Library > Warranty Manuals & Forms page.
- Complete all of the fields on the Warranty Parts Tag and affix it securely to the tire (if tape is used, use clear tape and wrap it around the tire so the tag will remain visible and in place).
- Store the tire in a secure place until you are notified via a Suzuki Service Bulletin of your TSPM that you can recycle the tire.
- **Per Federal Regulations, you MUST use licensed and certified tire recycling agency. You and your dealership could face penalties if a recall-related tire is disposed of improperly.**
