Safety Recall: 2024 Prologue Right Front Lower Control Link Inspection

Supersedes 24-102, dated July 19, 2024, to revise the parts information

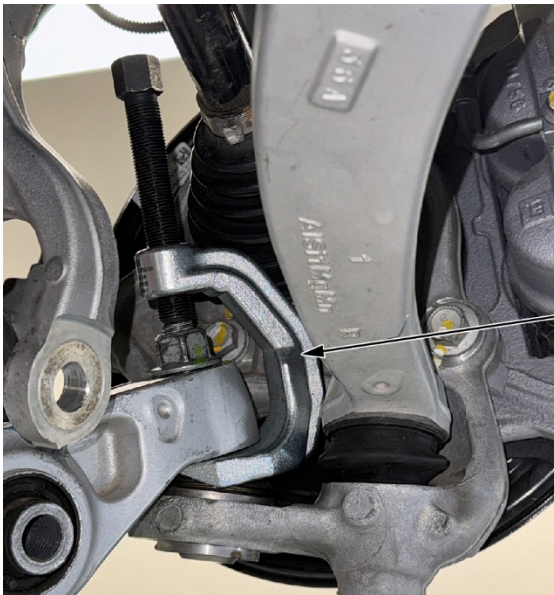
**BALL JOINT
SEPARATOR
P/N 07-J-43631**

- Using the 07-J-43631 Ball Joint Separator, separate the front lower control front link from the steering knuckle.

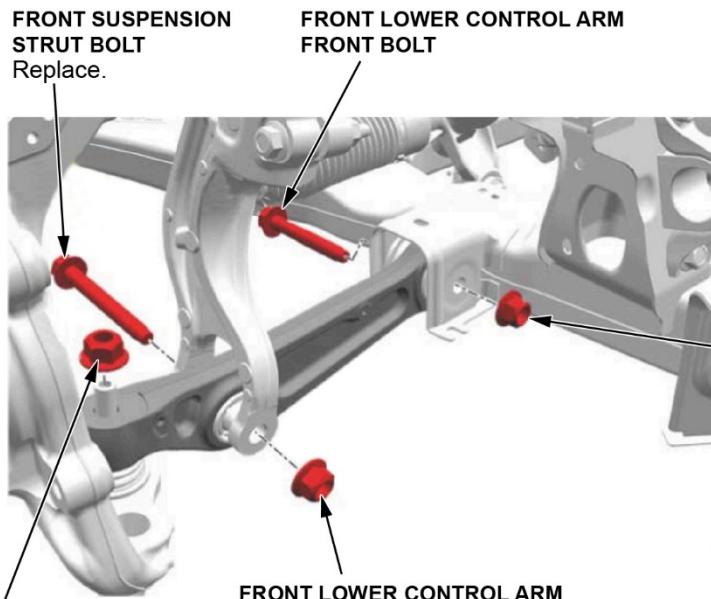
**FRONT SUSPENSION
STRUT BOLT**
Replace.

**FRONT LOWER CONTROL ARM
FRONT BOLT**

**FRONT LOWER CONTROL ARM
FRONT NUT**
First Pass: 240 N·m (177 lb-ft)
Final Pass: 45 – 60 degrees

STEERING KNUCKLE NUT
First Pass: 150 N·m (111 lb-ft)
Final Pass: 30 – 45 degrees

- Remove and discard the front lower control front link.
 - Do Removal Procedure steps 36–37, *Front Lower Control Front Link Replacement (24 XFD, XRD)* ([Click Here](#))
- Install the replacement front lower control front link.
 - Do **Installation Procedure steps 1–11**, *Front Lower Control Front Link Replacement (24 XFD, XRD)* ([Click Here](#))
