**HYUNDAI**
Technical Service Bulletin

GROUP RECALL	NUMBER 24-01-063H-2
DATE OCTOBER 2024	MODEL(S) SANTA FE (MX5A) SANTA FE HYBRID (MX5A HEV)

SUBJECT: FLOOR WIRING HARNESS INSPECTION, HARNESS SECUREMENT, AND HARNESS REPLACEMENT (RECALL 265)

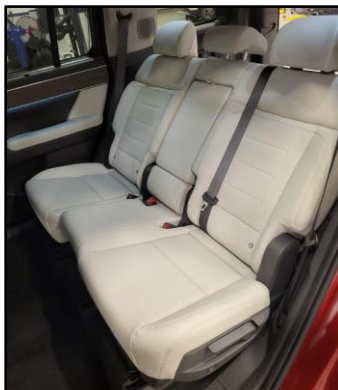
Description: The main floor wire harness used in certain Santa Fe (MX5A) and Santa Fe Hybrid (MX5A HEV) could become damaged due to contact with the passenger-side, second-row bench seat’s folding hinge assembly. A damaged main floor wire harness could result in illumination of the air bag warning light, inadvertent air bag deployment, and/or an inability to deploy the air bags during a crash, increasing the risk of injury to occupants.

Follow the procedures in this TSB to inspect the floor harness for damage, and if damage is found, replace the floor harness and secure in place. If no damage is found, the floor harness must be secured properly in place.

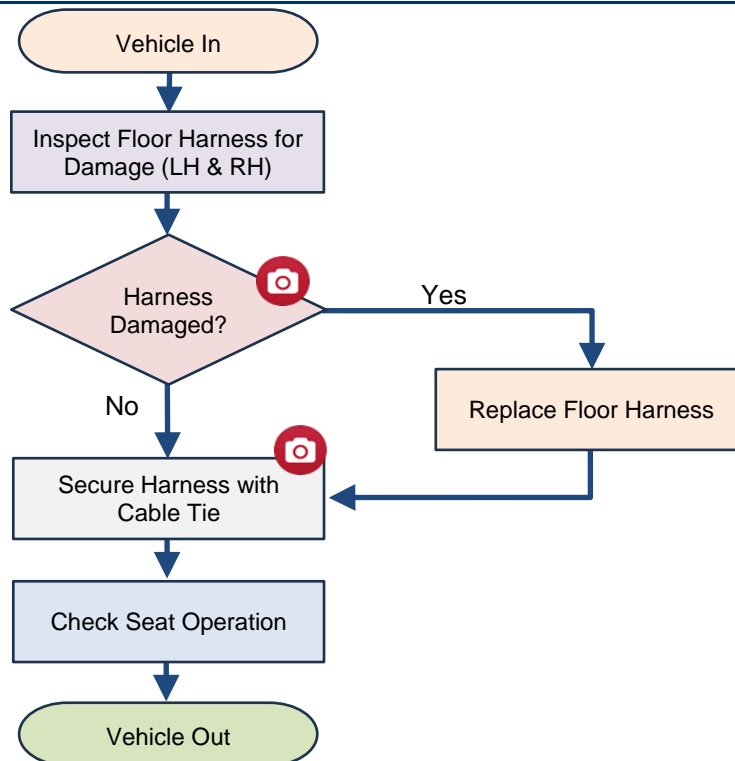
Service Procedure Flowchart:

This procedure applies **only** to vehicles designed for 7 passengers, it does **NOT** apply to 6-passenger models.

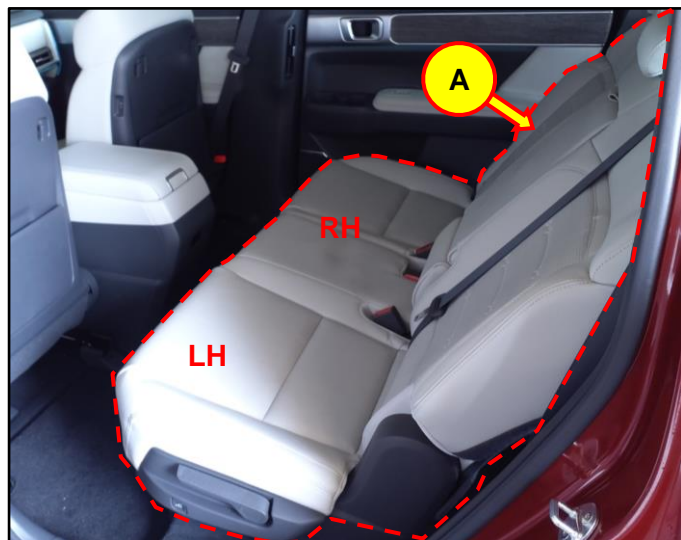
Slide second row seats forward as shown in figure (A) to get better view of the floor wiring harness.

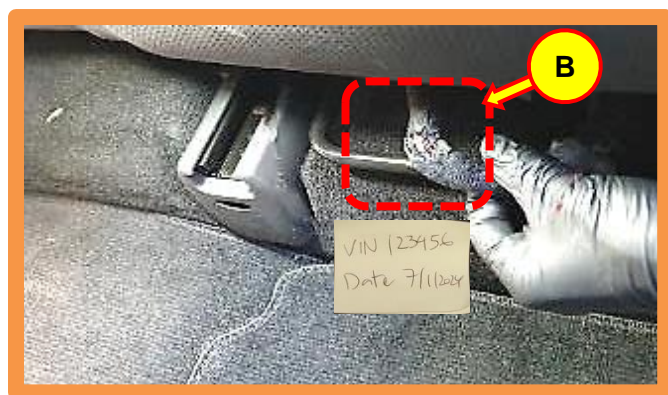
2. Inspect the floor harness wiring under the seat for signs of damage. Please note that exposed wiring qualifies as damage here.

- If wiring is **not damaged**, proceed to **Section B - Securing RH (Passenger Side) Second Row Seat Floor Wiring Cable** and **Section C - Securing LH (Driver Side) Second Row Seat Floor Wiring Cable** on **pages 13-14** to secure the floor wiring with a zip tie.
- If wiring is **damaged** as shown (B), take a STUI photo of the damaged harness then proceed to the next **section A** for replacing the floor wiring assembly and securing second row seat harness.

Take a picture of the damaged wiring harness alongside a piece of paper with the last 6 digits of the VIN and the date of repair on a piece of paper. Upload the photo to STUI.

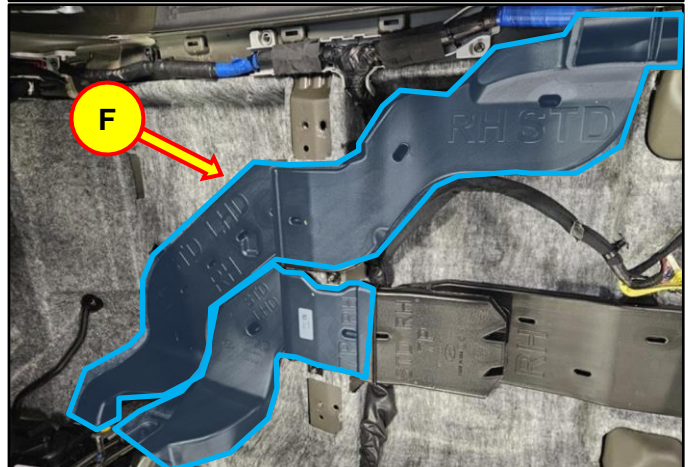
5. Remove the LH/RH front heating ducts (E) and (F) to access the harness underneath.

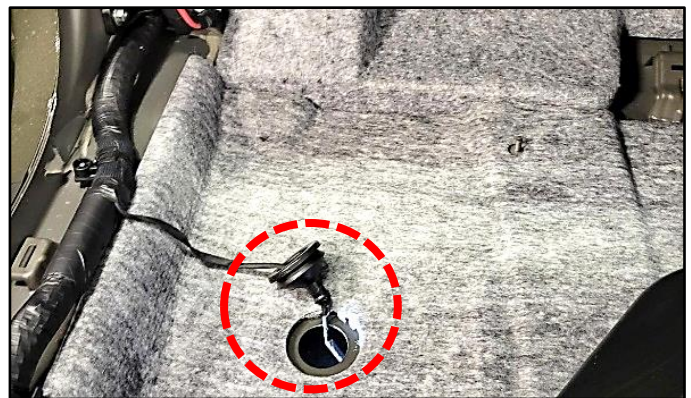
12. Disconnect canister close valve (CCV) connector (I) from underneath the body of the vehicle.

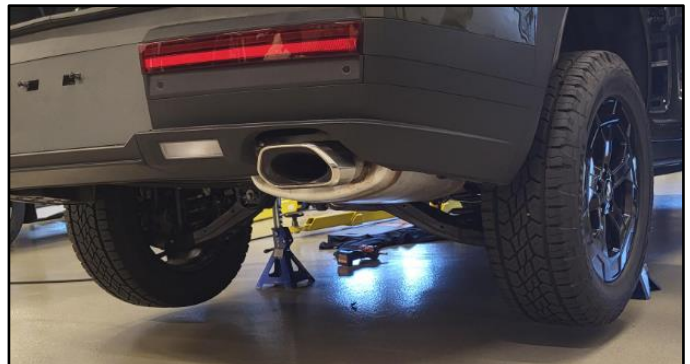
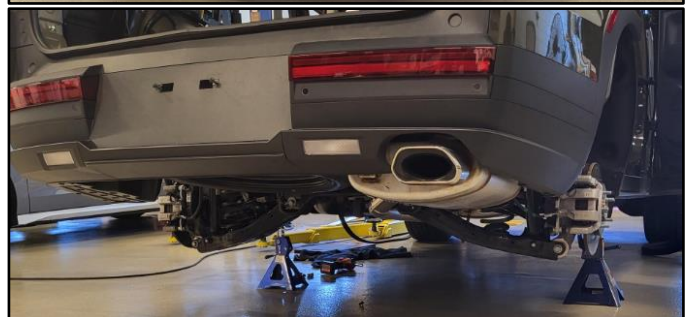
14. Remove LH and RH rear wheels and wheel guards to access exterior connections.

Place the rear of the vehicle on jack stands for stability.

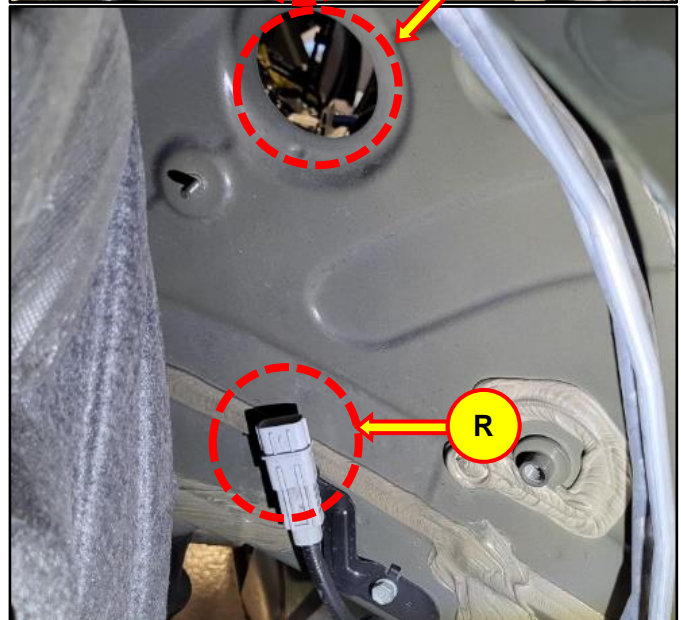
17. Floor wiring harness (Q) on passenger's rear wheel is routed to the exterior of the vehicle with one exterior connector (R) found inside the rear wheel guard.

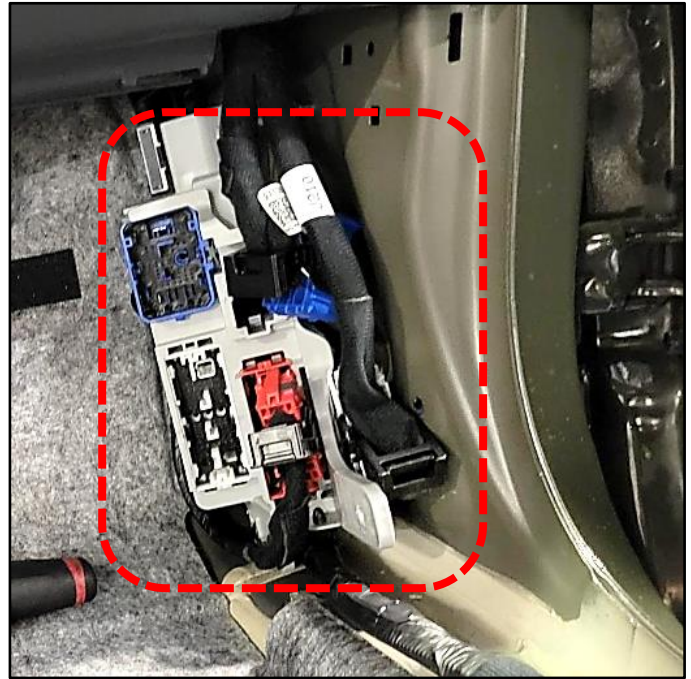
18. Disconnect the main wiring connectors located in the passenger's side kick panel area.
