# SAFETY RECALL

## 2nd Row Child Tether Anchor Weld

Reference: 85B / NHTSA 24V-586

Remedy available for  
2024 (WL) Jeep Grand Cherokee L

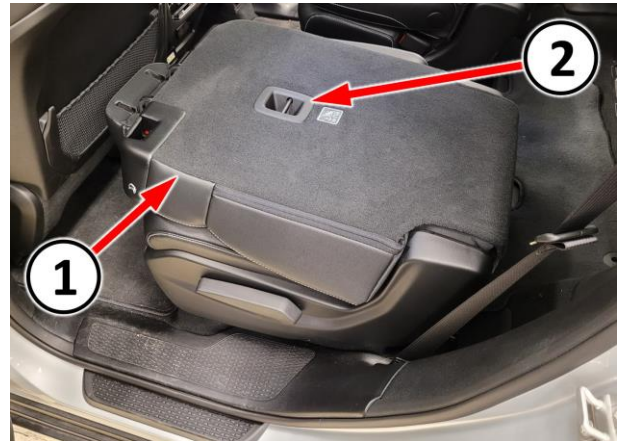
**Figure 1 – Child Tether Anchor Access**

1. Fold down the left side second row seatback (Figure 1).

2. Using a trim stick or equivalent, remove the child tether anchor bezel by prying it up (Figure 1).

**NOTE:** Expect the bezel retaining tabs to break. A **NEW** bezel is supplied with the campaign parts.

1 - Seatback

2 - Child Tether Anchor and Bezel

6. Install the **NEW** child tether anchor bezel (Figure 1).

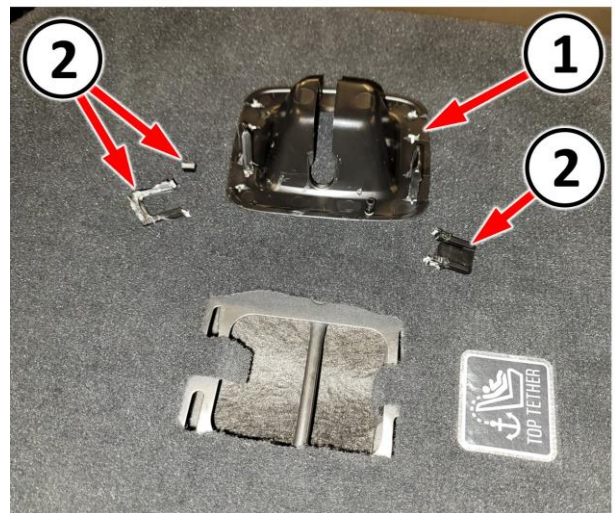
**Figure 2 – Child Tether Anchor Bezel**

3. Retrieve any broken bezel pieces and **DISCARD** (Figure 2).

1 - Child Tether Anchor Bezel

2 - Bezel Broken Pieces

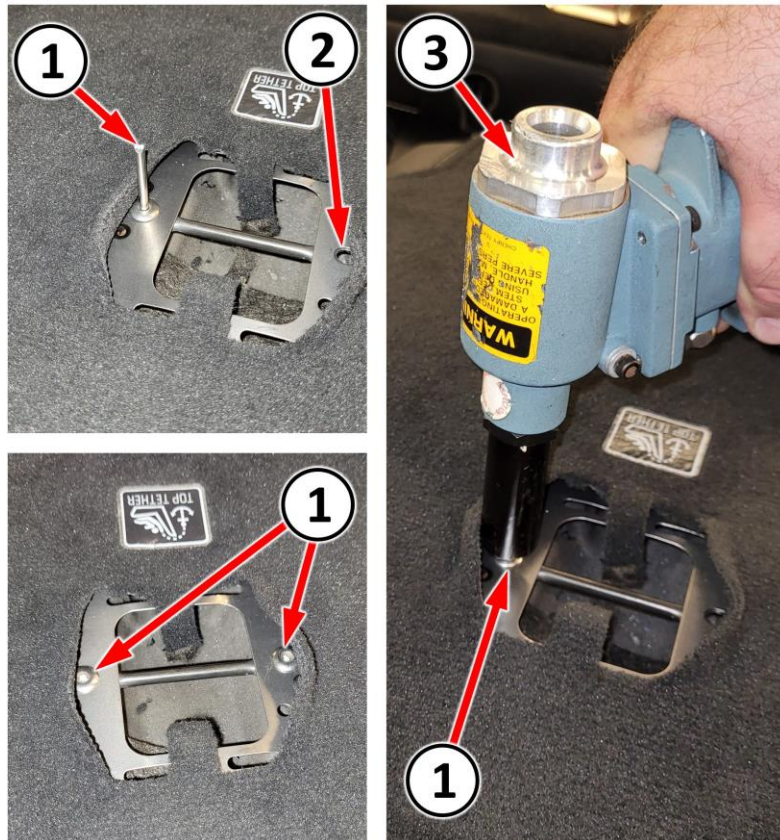
**Figure 3 – Installing Rivets to Child Tether Anchor**

**NOTE: Ensure carpeting does not get trapped under the rivet head.**

4. Insert one rivet in each pre-existing hole on either end of the child tether anchor (Figure 3).
5. Using an appropriate rivet gun, secure both rivets (Figure 3).

- 1 - Rivet
- 2 - Child Tether Anchor Pre-Existing Hole
- 3 - Rivet Gun

Install rivets to reinforce the existing child tether anchor structure on the left-side 2<sup>nd</sup> row seat back frame.

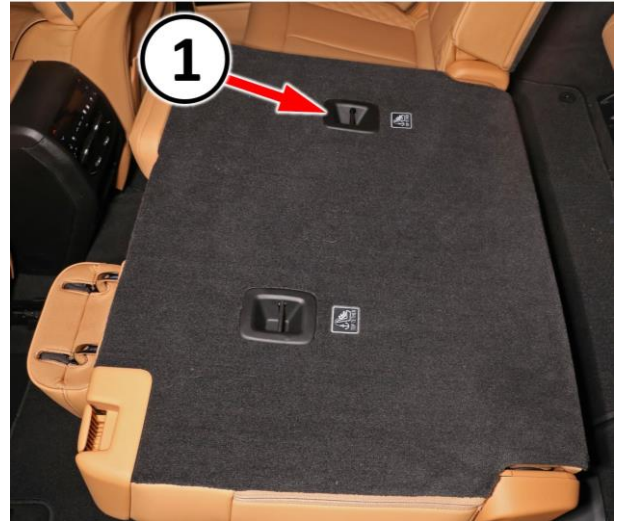
**Figure 4 – 60/40 Split Bench Seat**

7. Vehicles equipped with 7-passenger 60/40 split bench (sales code CF1), also perform **Steps 2-6** for the center child tether anchor (Figure 4).

1 - Center Child Tether Anchor
