# Recall Bulletin 240812REV

<b>RECALL BULLETIN:</b> <b>240812REV</b>	<p>The purpose of this Recall Service Bulletin is to inform REV Recreation Group dealers of the need to inspect and install a GFCI protection device on certain 2019-2025 Fleetwood: Flair, Flex, and Holiday Rambler: Admiral, Eclipse motorhomes. A list of affected motorhome serial numbers appears at the end of this bulletin. There are a total of 622 motorhomes affected by this recall.</p>
<b>YEAR(S) AFFECTED:</b> <b>2019-2025</b>	
<b>PRODUCT(S) AFFECTED:</b>  <u><b>FLEETWOOD</b></u> <b>FLAIR</b> <b>FLEX</b>  <u><b>HOLIDAY RAMBLER</b></u> <b>ADMIRAL</b> <b>ECLIPSE</b>	<p><b><u>CONDITION:</u></b>                  On motorhomes affected by this recall campaign the exterior patio electrical receptacle can be energized by inverter power, shore power or generator power. Only the inverter power source provides Ground Fault Circuit Interruption (GFCI) protection for the receptacle. The receptacle is not GFCI protected when energized by shore cord power or generator power. Without GFCI protection a ground fault may occur when someone is in contact with a live circuit while in wet or damp conditions. Risks of personal injury

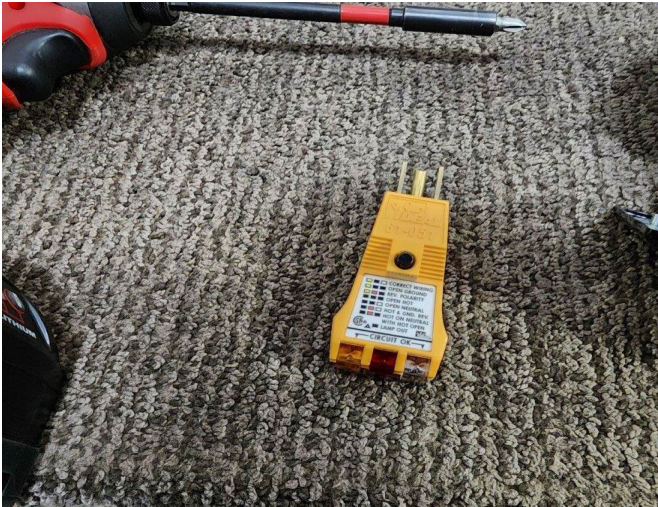
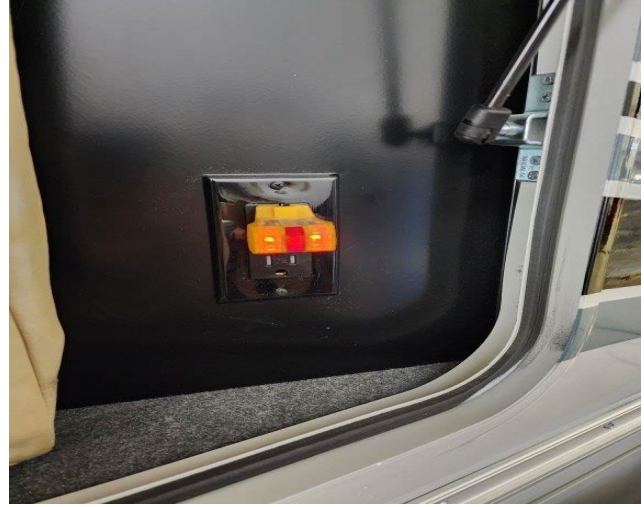
- 2) Use Caution - Test the system – with coach plugged into shore power, open the exterior TV door and locate the receptacle in the compartment. Using GFCI tester, plug into receptacle and see if the tester will trip the GFCI receptacle. If the test does not trip the GFCI, proceed with the repair procedure below. Look to determine if the GFCI receptacle is already located near the inverter. If the GFCI trips or if you have questions, contact **Dealer Tech 800-816-9825**

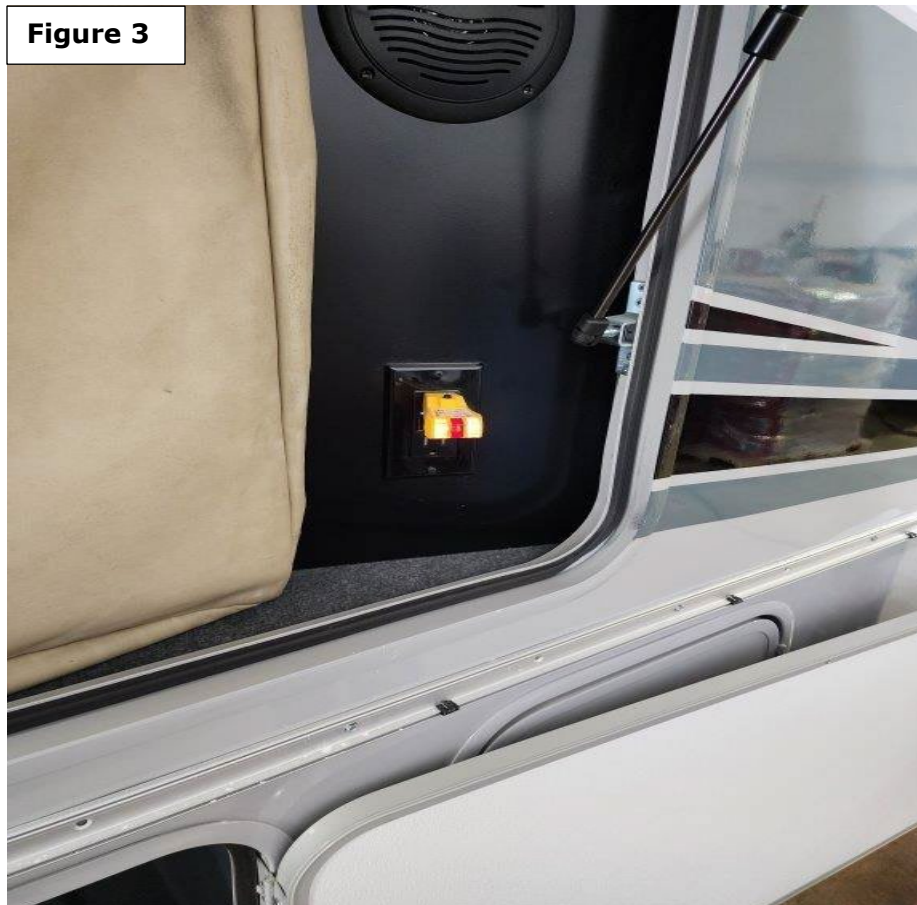
- 12) Plug coach back into shore power.
- 13) Open the exterior TV compartment and locate the receptacle in compartment. Using GFCI tester, plug into receptacle and check for polarity, see if the tester will trip a GFCI receptacle. **See figure 3** Reset the dead face GFCI. If the GFCI does NOT trip review the procedure and check your wiring connections or contact Dealer Tech

- 14) Unplug coach from shore power.
- 15) Turn on the rotary disconnect switch going to inverter. Turn on the inverter remote switch.
- 16) Test the receptacle in TV compartment by using GFCI tester. Plug tester into receptacle and see if the tester will trip a GFCI receptacle on the inverter. **See figure 3** If it trips, reset the GFCI on the inverter. If the GFCI does NOT trip review the procedure and check your wiring connections or contact Dealer Tech.
- 17) Once testing is complete make sure the area is clean and restore the contents.
