Safety Recall Code: 46P6

Brake Booster

Problem Description

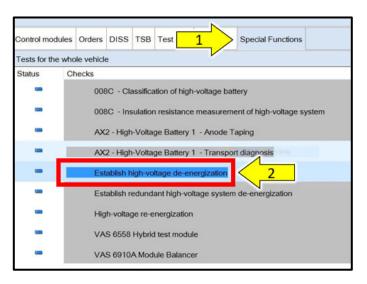
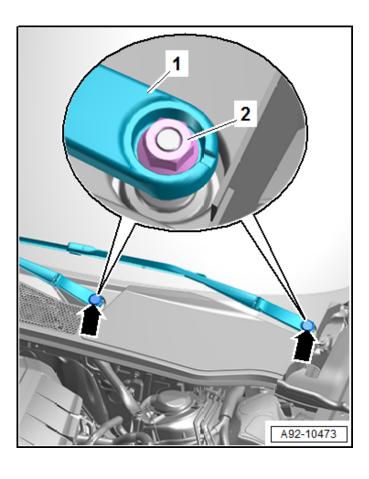
De-energize HV system:

- Follow the GFF test plan for disabling the high voltage system:
 - Perform a diagnostic scan of the vehicle.
 - Select the "Special Functions" tab<1>.
 - Perform the "Establish high-voltage de-energization" test plan <2>.
- Pay close attention to the test plan instructions when de-energizing the high-voltage system.
- The test plan will guide you through all of the de-energization steps. READ EACH SCREEN CAREULLY!!
- Refer to the Function Description tabs if necessary.
- Save the diagnostic session.

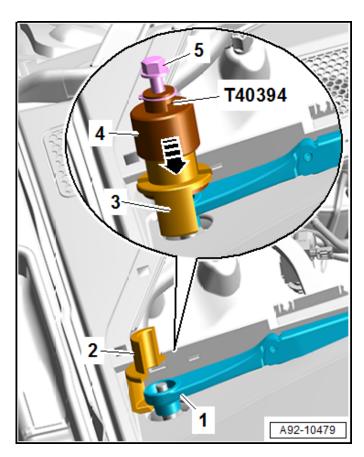
Remove windshield wiper arms:

- Mark the current position of the wiper arms with masking tape, for example.
- Pry off the caps <arrows>.
- Remove nuts <2>.

- Position the hook <2> on the windshield wiper arm <1>.
- Position the -T40394- on the opposite side of the windshield wiper arm and latch the pivoting hook <3>.
- Push the locking ring <4> downward in direction of <arrow>.
- Turn the bolt <5> clockwise until the windshield wiper arm is removed from the windshield wiper axle.
- Remove the windshield wiper arms.

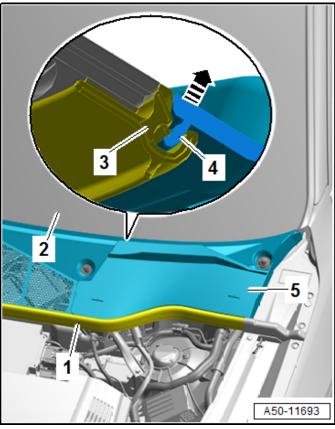
Remove plenum chamber cover:

- Remove the seal <1>.
- Coat the transition between the windshield
 2> and the plenum chamber cover <5> with soapy water.
- Starting at the glass edge, carefully remove the plenum chamber cover from the windshield retainer by lifting it vertically upward.
- Remove the plenum chamber cover <5> by carefully removing the plenum chamber cover tab <4> in the direction of <arrow> from the windshield mount <3>.

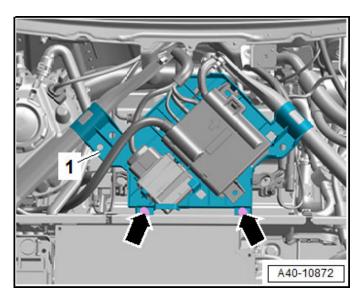
Remove left (driver side) tower brace:

Remove the expanding clips <arrows> and remove the bracket <1> for Windshield Washer Pump Control Module -J1100-.

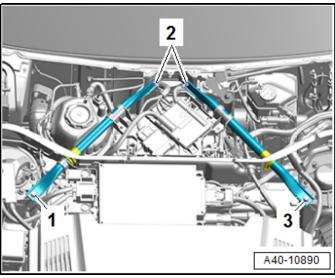
Remove the bolt <3> and nut <2> (left side) and remove the left (driver side) tower brace.

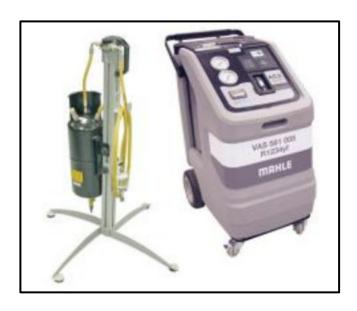
Open refrigerant system valves:

- Follow the test plan for opening the refrigerant system valves:
 - Open the Guided Functions menu for Thermal Management by right clicking on Address 00C5.
 - Perform the test "00C5 Discharge A/C circuit, evacuate and charging" <1>.

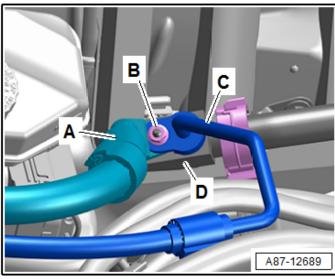
Unbolt refrigerant lines:

- Remove nut .
- Remove lines <A> and <C>.

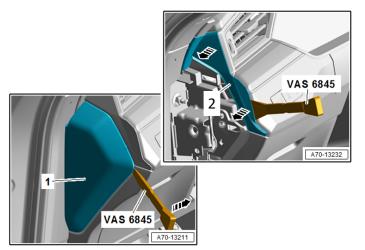
Remove instrument panel side covers:

Carefully pry off instrument panel side covers
 1> and <2> using the -VAS6945-.

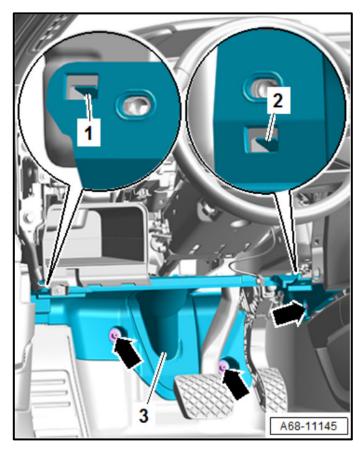
Remove driver side footwell cover:

- Remove two nuts and one bolt <arrows>.
- Release the catches <1 and 2> using a flathead screwdriver and remove the footwell cover on the driver side <3> downward.
- Disengage the diagnostic connection on the footwell cover.
- Equipped on some models: disconnect the connectors for the footwell lamp, parking aid speaker and the emergency call speaker.
- Remove the footwell cover on the driver side toward the rear.

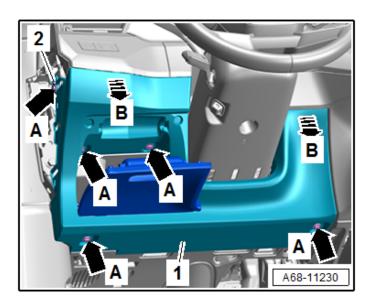
Remove driver side instrument panel cover:

- Open the storage compartment.
- Remove the bolts <A arrows>.
- Disengage the instrument panel cover on the side at the pin <2>.
- Unclip the driver side instrument panel cover
 1> by hand or with the -3409- from the instrument panel <B arrows>.
- Remove the driver side instrument panel cover.

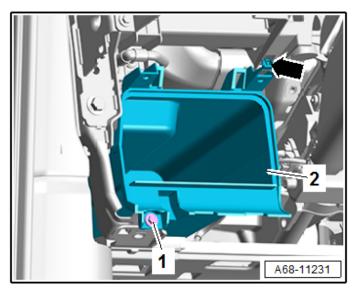
Remove storage compartment:

- Remove the bolt <1>.
- Release the catch <arrow> using a flat-head screwdriver and disengage storage compartment <2> downward.
- Remove the storage compartment toward the rear.

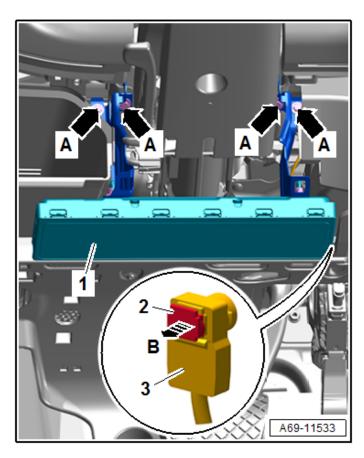
Remove knee airbag:

- Move the steering wheel as far up and backward as possible to be able to use the entire steering column adjustment range.
- Remove the bolts <A arrows>.
- Disengage the knee airbag <1> with the brackets on the crossmember.
- Carefully remove the knee airbag with the brackets, until the connector <3> can be disconnected.
- Release the connector lock <2> with a small flat-head screwdriver <arrow B>.
- Disconnect the connector from the knee airbag igniter.

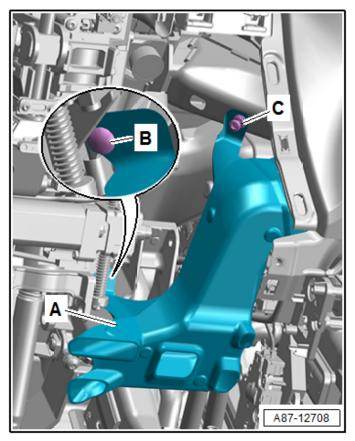
Remove footwell vent:

- Remove the expanding rivets <B and C>.
- Remove the left footwell vent <A> from the heater and A/C unit.

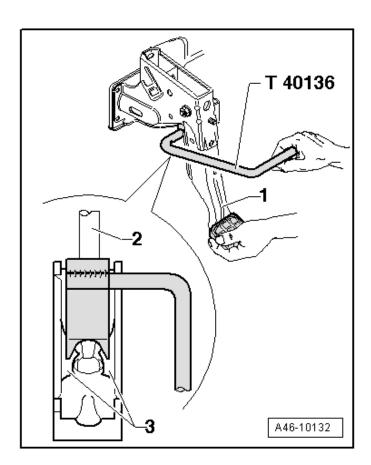
Disconnect brake pedal from brake pressure unit:

- Press and hold the brake pedal in the direction of the brake pressure unit.
- Insert the Brake Servo Release Tool -T40136and pull in the direction of the driver seat while counterholding at the brake pedal <1> so that it does not move backward. While doing so, the mount retaining tabs <3> will be pushed out of the pushrod ball head <2>.
- Pull the Brake Servo Release Tool -T40136and the brake pedal together toward the driver seat. This will pull the brake pedal off the pushrod ball head.

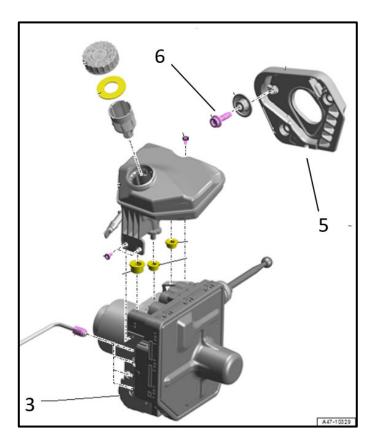
Install the new brake pressure unit in the reverse order of removal:

- The brake pressure unit surface on the bulkhead must not be damaged or deformed.
- Replace attaching element <6> and torque to 24 Nm.

The brake pressure unit <3>, adapter <5> and attaching element <6> must all be sent back for analysis.

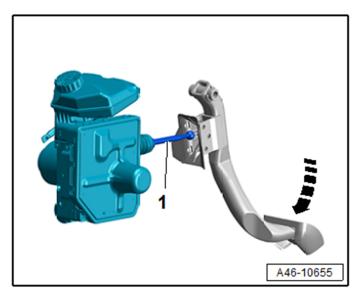
Reconnect brake pedal:

Hold the pushrod ball head <1> in front of the mount and push the brake pedal toward the brake pressure unit <arrow> until the ball head engages audibly.

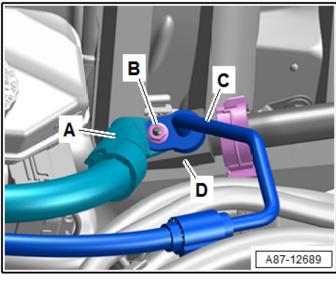
Re-install refrigerant lines:

• Install new seal on lines <A> and <C>.

- Coat new seals with refrigerant oil.
- Install lines and torque nut to 8 Nm.

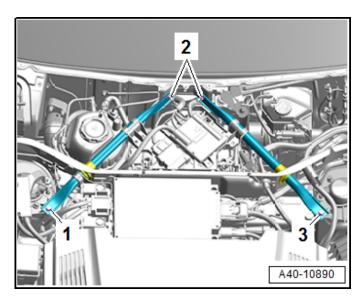
Reinstall tower brace and windshield washer pump control module:

- Installation is the reverse order of removal.
- Torque bolts <3> and nuts <2> to 24 Nm.

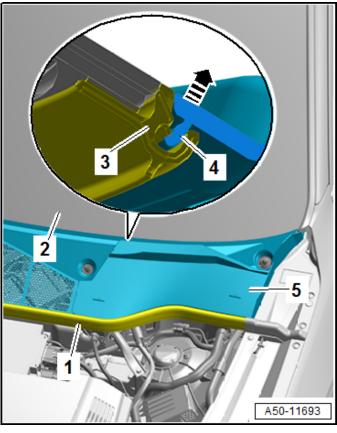
Reinstall plenum chamber cover:

- Installation is the reverse order of removal.
- The plenum chamber cover tab must be completely engaged in the windshield frame.

If the plenum chamber cover is damaged or mounted incorrectly, water can flow into the fresh air intake duct. This can lead to complaints regarding odor coming from the heater/A/C system and/or moisture in the vehicle interior.

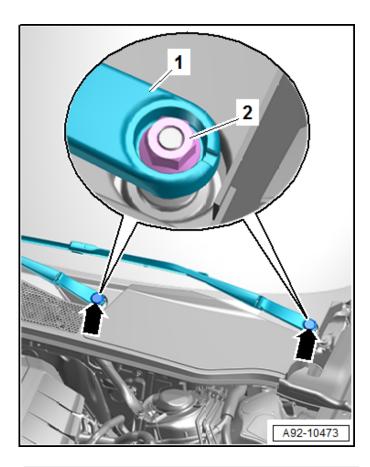
Reinstall wiper arms:

- Installation is the reverse order of removal.
- Reference previously made marks when installing wiper arms.
- Torque nuts <2> to 32 Nm.
- Install caps <arrows>.
