Safety Recall

Code: 57J9

Subject Door Handles

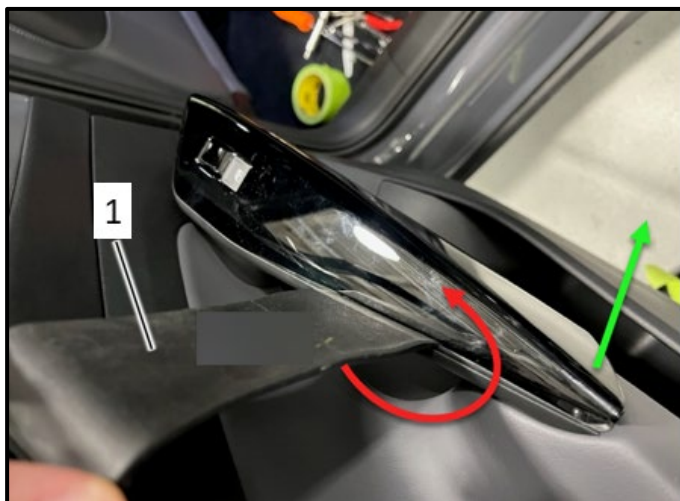
When removing the button trim, it can release suddenly resulting in damage to the window switch. Use extreme care when removing the button trim.

- After the rear section of the button trim is loose, rotate the wedge in the direction indicated <red arrow> while carefully pulling the trim in the direction indicated <green arrow>.
- Driver's rear door shown. Procedure for all doors is similar.

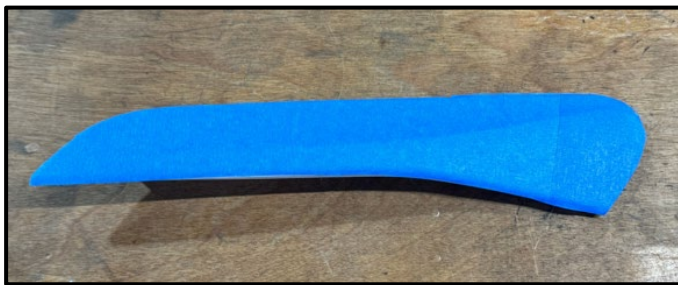
- Take note of the areas to be modified on the door handle cover <arrows>.

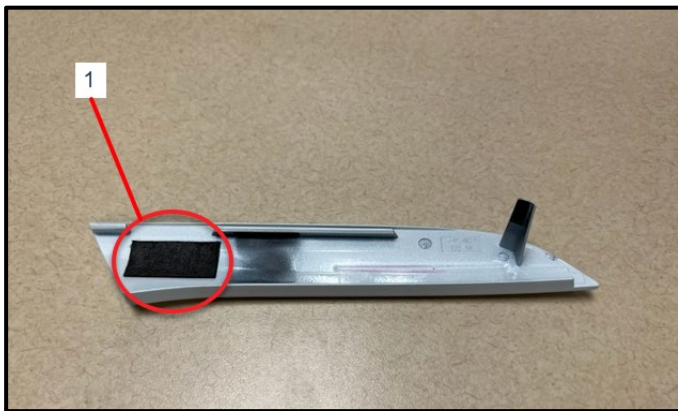
- Remove the old foam tape <1> from the front door handle covers.

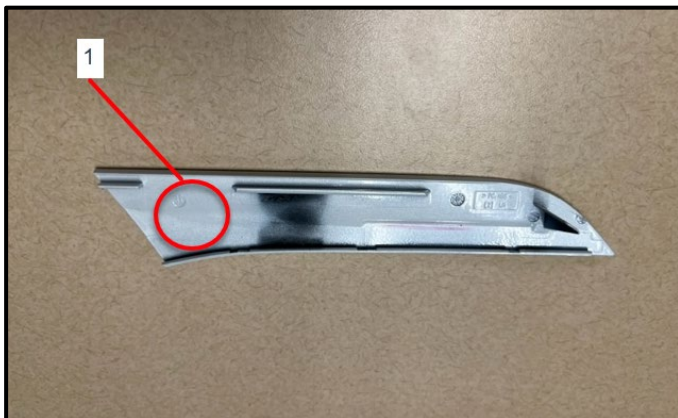
- Using isopropyl alcohol and a lint free cloth, clean the area <1> where the foam tape was.
- Ensure no residue remains.
- Allow the cleaner to dry completely.

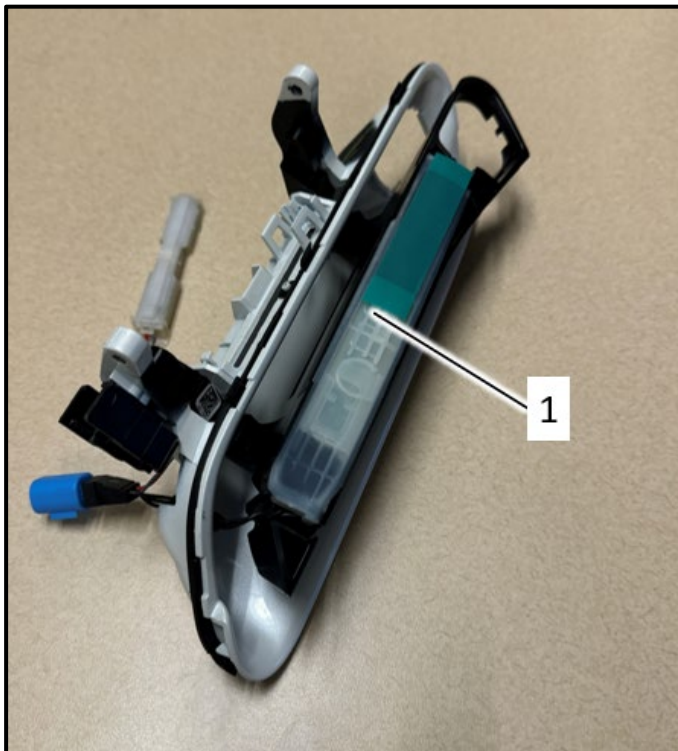
- Insert the new door handle <1> into the carrier in the reverse order of removal.
- Install the connector and lamp back into their retainers in the carrier.

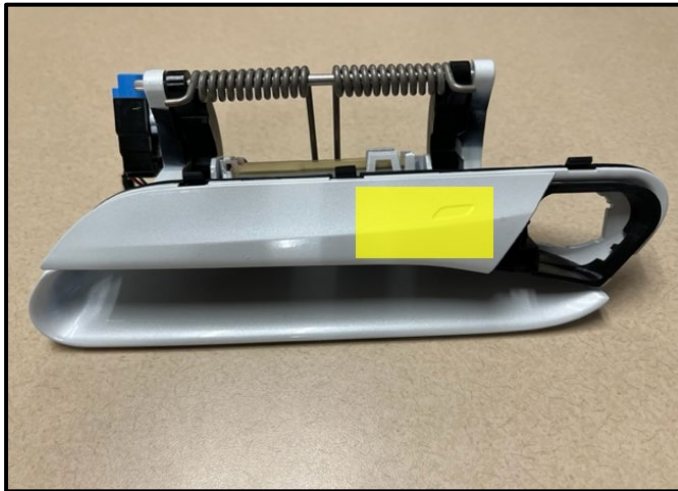
- Reinstall the door handle cover.
- Ensure it's fully clipped into place.
- Front door handles only: Press firmly in the area shown to adhere the foam pad to door handle cover.
