Recall Repair Instructions

NHTSA Recall # 24V-669

Tiffin Motorhomes Recall # TIF-142

Models Involved: 2022 – 2025 Allegro Bay Motorhomes

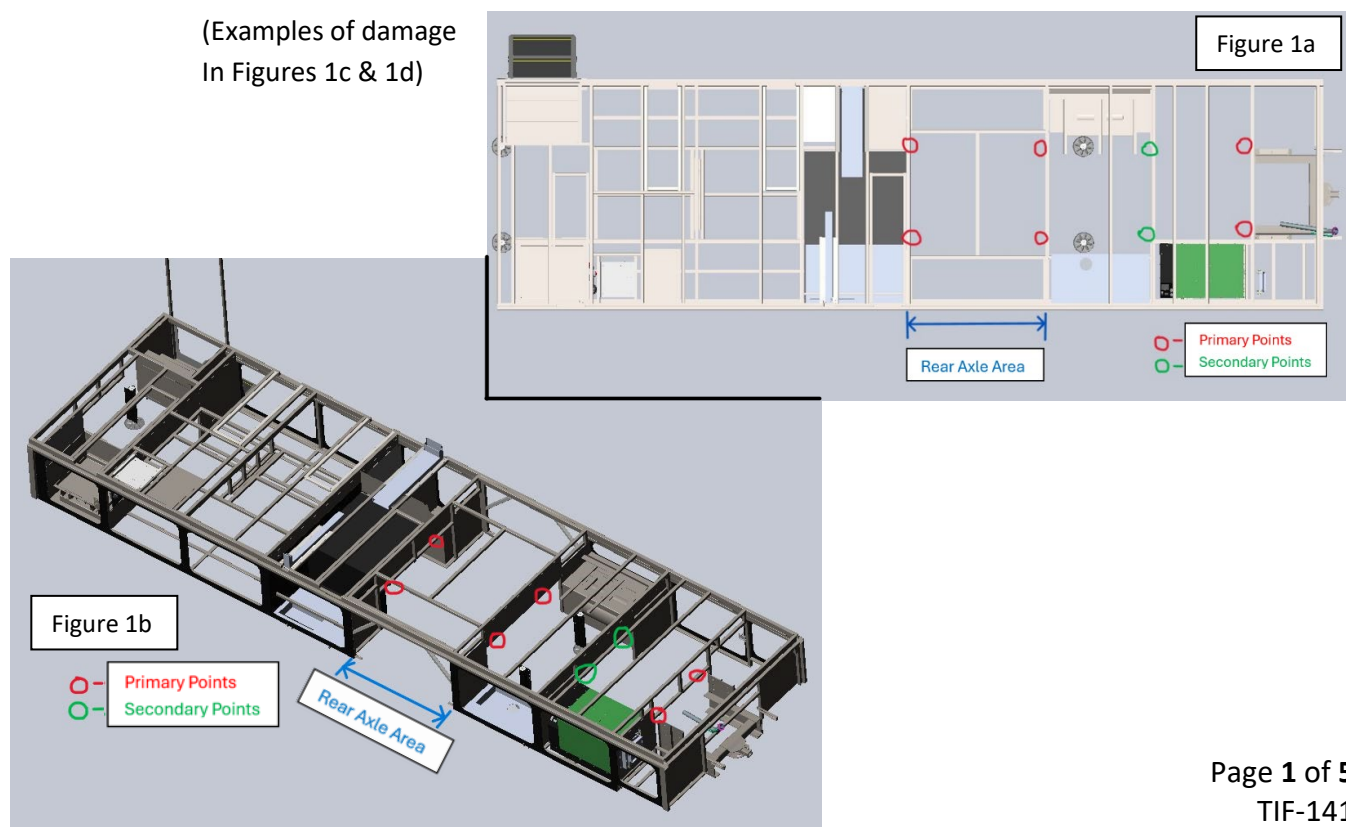
1. Put motorhome on a motorhome lift and raise the lift to a comfortable height to visually inspect the trusses, Figure 1c, on each side of the rear axle and next to the last truss as indicated on Figure 1a & 1b.

- For units with damage, jack stands will need to be set up. A section of 1 ½" x 1 ½" 11-gauge tubing will need to be placed between the outside edge of the subfloor structure, just below the beltline extrusion and the top of the jack stand as shown in figures 3a and figure 3b. There will need to be one jack stand on each side of the coach beside the truss to be worked on at that time. Start on the next to the last truss as shown in Figure 1a & 1b above.

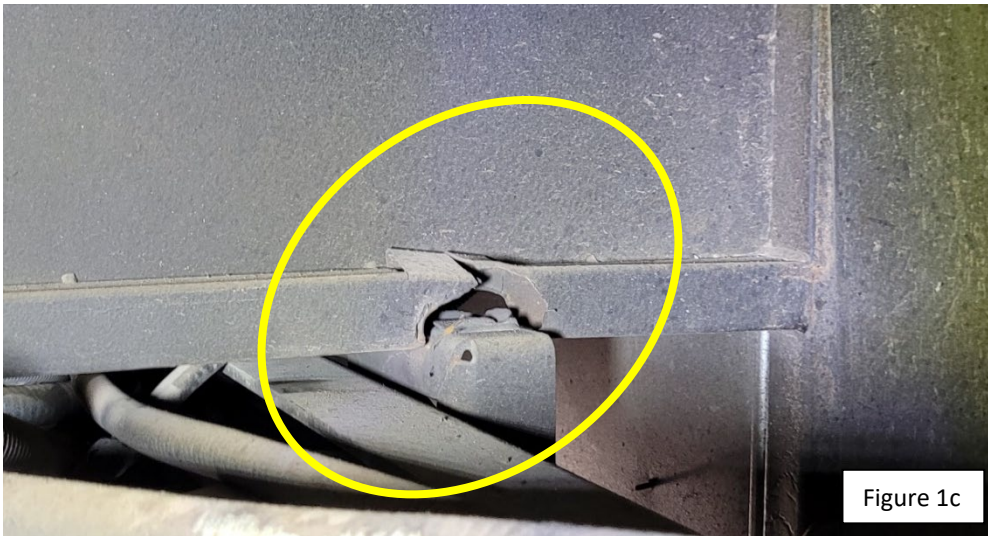
Figure 1c

Example of Damage to Truss

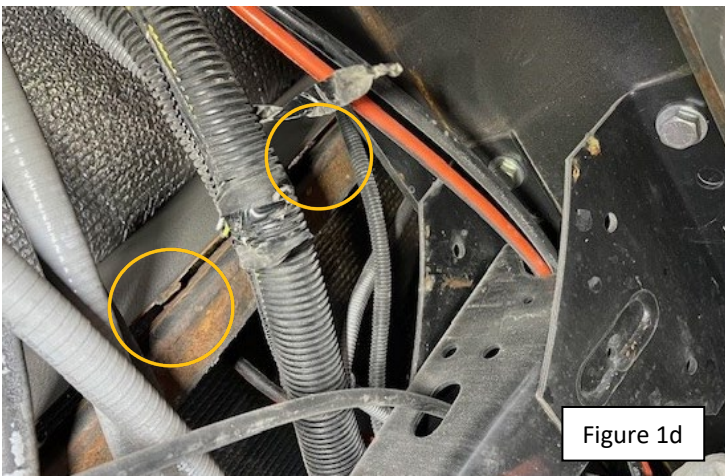
Figure 1d

Broken Welds between sheet metal face and tube truss.

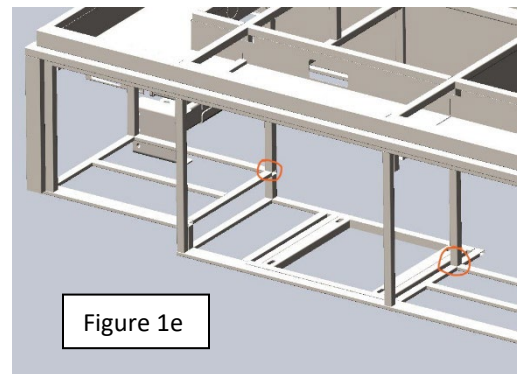
Figure 1e

2. Check the horseshoe (Figure 2 above) for damage. The picture above shows one example of a horseshoe, depending on the location, it can look different from the picture below.
3. Check the welds on the generator rack down tubes to the trusses. (Figure 1e)
4. If damage is found, proceed with step 1 of the repair procedure.

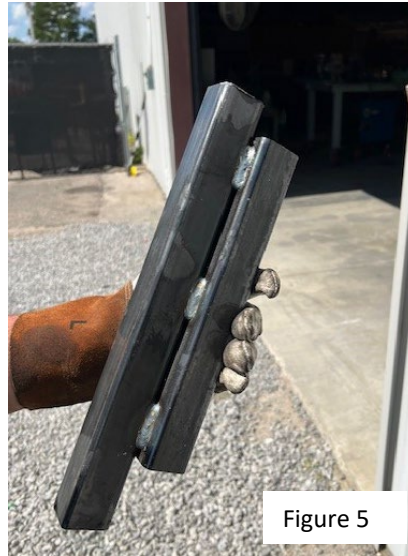
Figure 5

4. Build the tube assembly with the 1 ½"x 1 ½" and 1 ½" x 3" tubing. Use measurements from step 3 to fabricate the brace as shown in figure 5.
Note: Offset the 1 ½" x 1 ½" tube by 1 ¼" above the top of the 1 ½" x 3" tube.

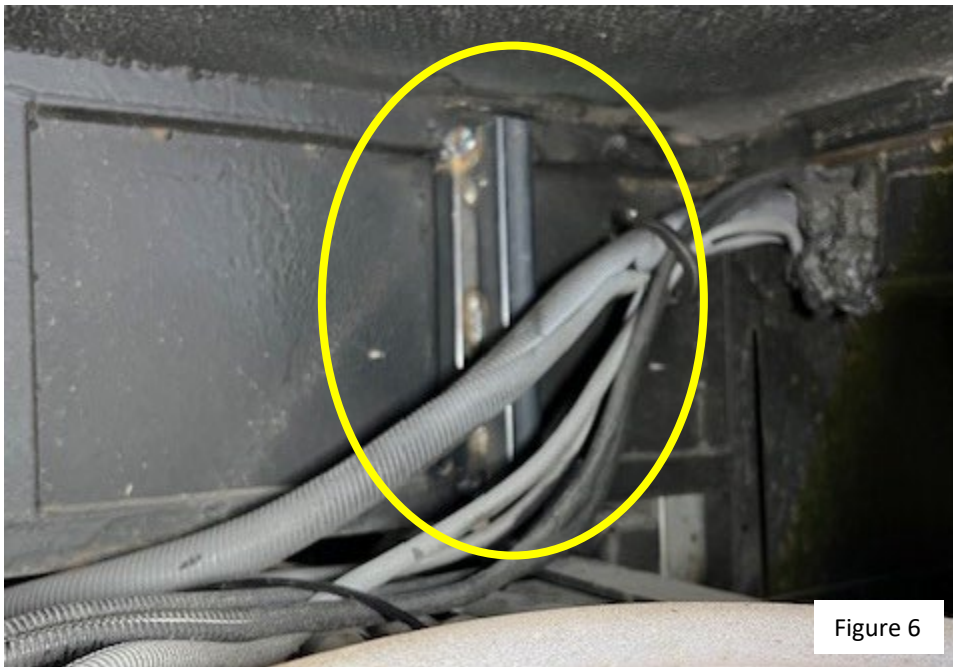
Figure 6

5. Set the fabricated brace in place on top of the chassis rail with the body of the 1 ½" x 3" tube going between the upper and lower tubes of the truss as shown in figure 6.
Note: It is recommended to begin the reinforcement at the rear most position and work your way forward on the motorhome.

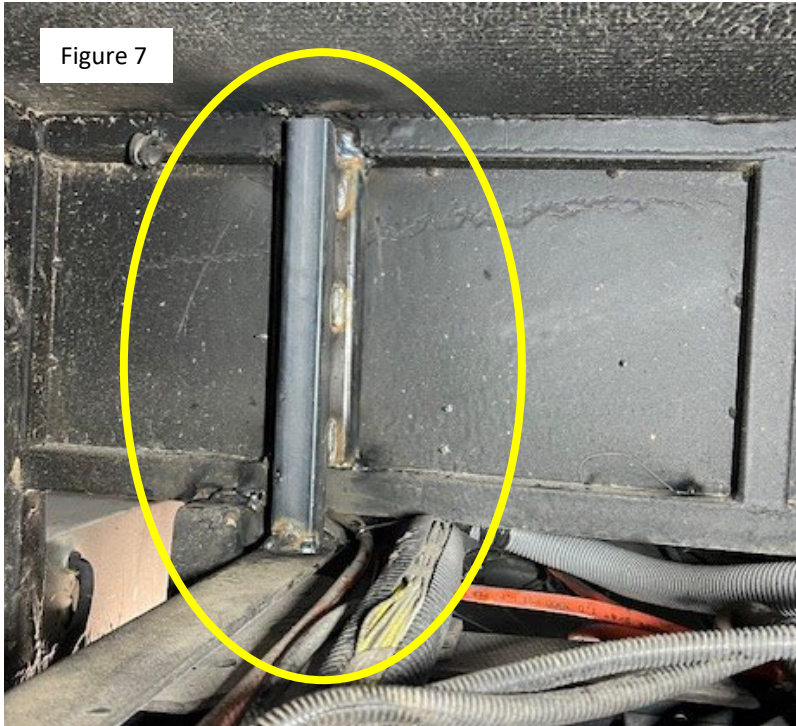
7. Weld the fabricated braces into place by welding the body of the 1 ½ x 1 ½ tube where it contacts the side of the upper and lower tube of the truss, the top of the chassis rail, and the 1 ½" x 3" tube where it contacts the upper and lower tube of the truss. See figure 7.
