HYUNDAI Technical Service Bulletin

GROUP RECALL	NUMBER 24-01-078H
DATE SEPTEMBER 2024	MODEL(S) TUCSON (NX4M)

SUBJECT: SRS WARNING LABEL APPLICATION FOR GLOVE BOX
(RECALL 268)

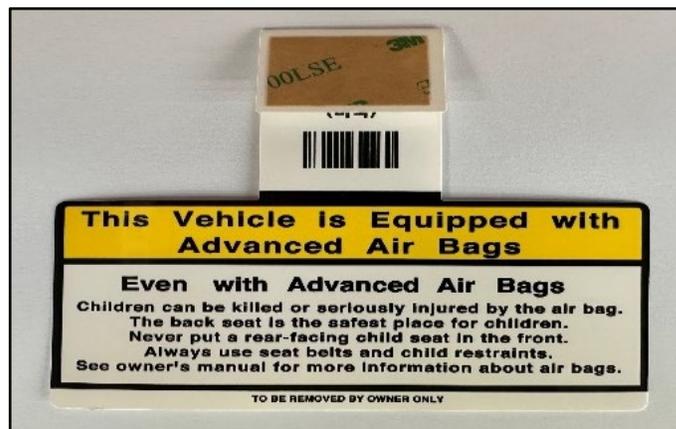
1. Locate the SRS warning label (A).

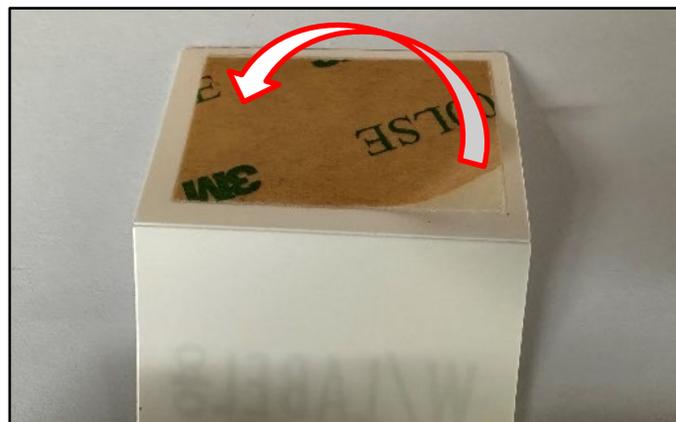
2. Remove the tape cover.

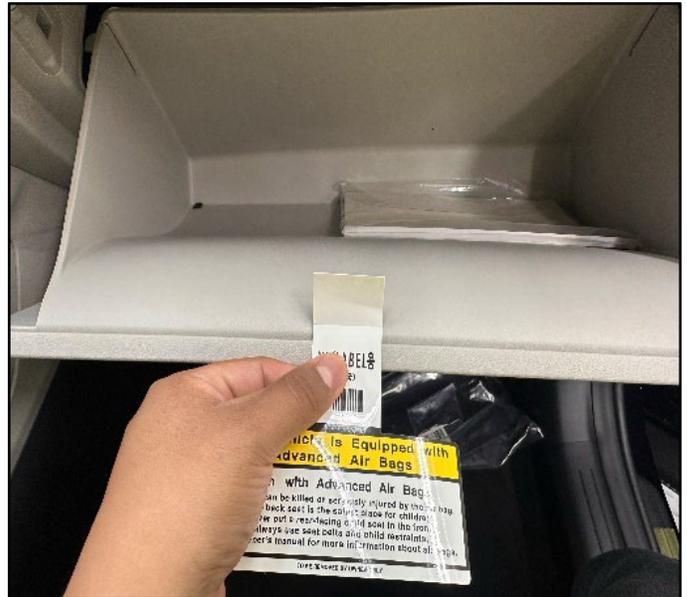
3. Apply the label to the center edge of the glove box.

Press firmly to ensure the label properly adheres.

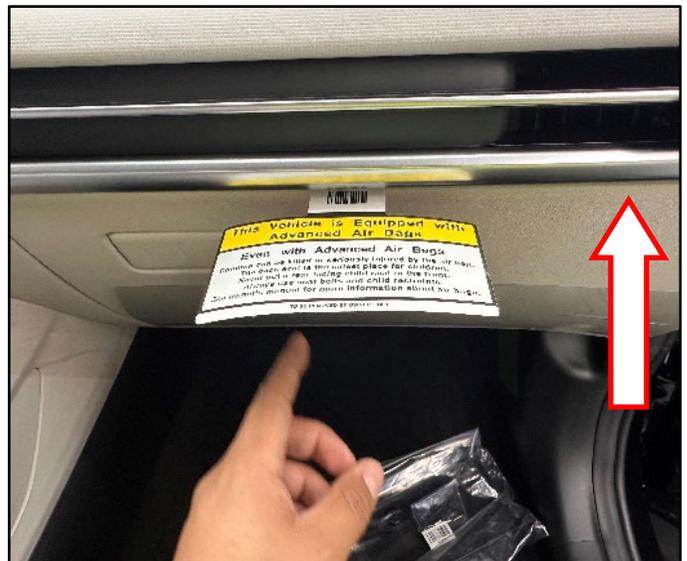
4. Close the glove box.

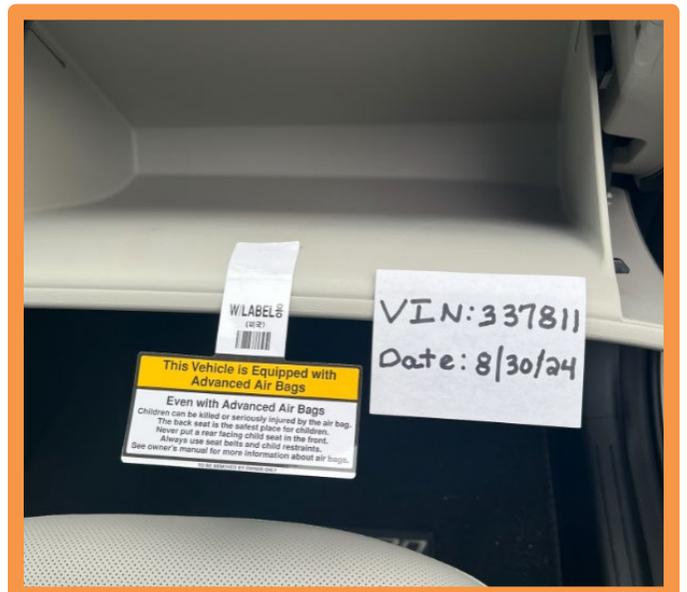
Using STUI, take a photo of the warning label installed with the last 6 digits of the VIN and the date of repair on a piece of paper.

Upload the photo to STUI.
