[Section B: Repair Procedure Recall 6924I](#) ..... 7

**SUBJECT VEHICLES RECALL 6924I**

REPAIR PROCEDURE  
SAFETY NON-COMPLIANCE RECALL 6924I

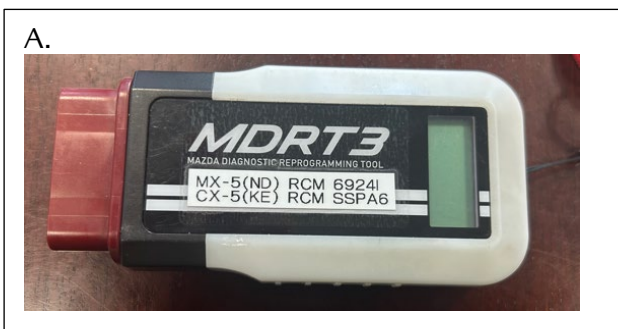
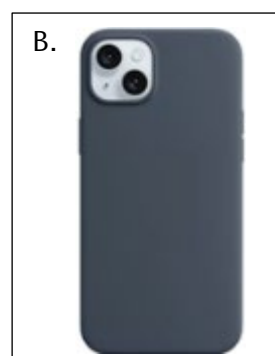
Tools Required
A. 6924I MDRT Tool from Drawer #15 (tool is black or blue) This tool can also be used for campaign SSPA6 (2016 CX-5 Passenger Airbag Module Update)
B. Digital camera or Cell Phone with camera that has very good resolution (12MP , e.g., iPhone 8 or Samsung Galaxy 23 or above) – Dealer supplied <b><i>A PHOTO IS REQUIRED AND MUST MATCH EXACTLY AS DESCRIBED IN THE PROCEDURE</i></b>
