# Safety Recall

## N242466950 Potential Brake Line Leak

**Release Date:** February 2025

<b>Condition</b>	General Motors has decided that a defect which relates to motor vehicle safety may exist in certain 2013 – 2019 model year Chevrolet Express Cutaway and GMC Savana Cutaway vehicles with optional GM-provided body mounts (RPO BNC). The brake lines in these cutaway vehicles may not meet the recommended clearance to the GM-provided body mounts. If brake lines contact the body mounts, the brake line may experience wear or damage that could lead to a brake fluid leak. A brake fluid leak can result in reduced stopping performance or inoperative service brakes, increasing the risk of a crash.
<b>Correction</b>	Dealers will inspect and, if necessary, replace the brake lines.

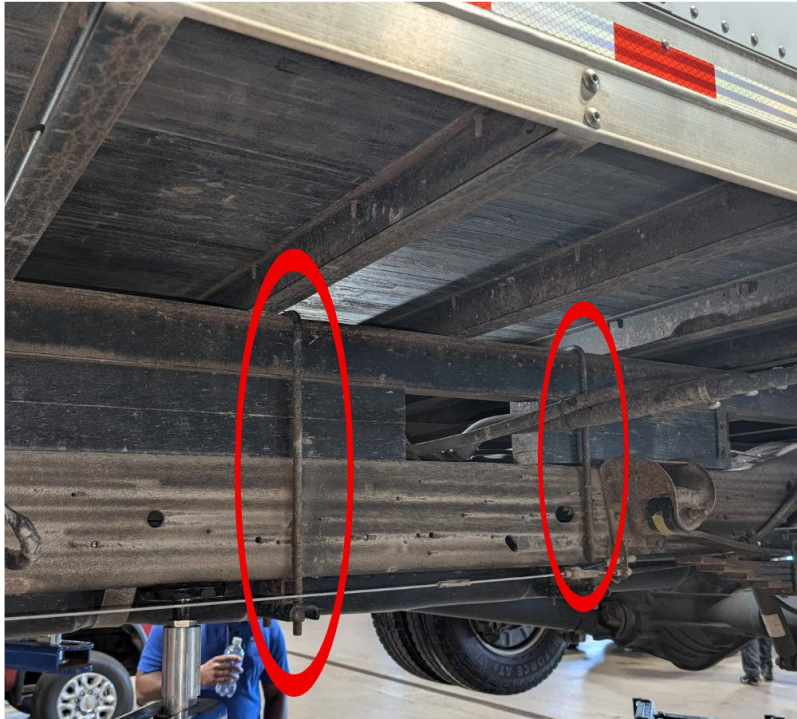
1. Inspect the vehicle to see if it uses U-bolt style rear body mounts.
  - If the vehicle uses U-bolt style rear body mounts, no further action is required. Close the field action using the “Inspect Only – Vehicle Passed – Does not use GM-supplied body mounts” labor op.
  - If the vehicle DOES NOT use U-bolt style rear body mounts, proceed to step 2.
2. Lift the vehicle. Refer to *Lifting and Jacking the Vehicle* in SI.
3. If the vehicle is equipped with fuel tank mounted along the driver’s side frame drop the fuel tank. Refer to *Fuel Tank Replacement (Chassis Cab, Front Tank)* in SI.
  - 3.1 To drop the tank, it will be necessary to remove the driveshaft. Refer to *Front and Rear Propeller Shaft Replacement (Chassis Cab with M5U) / Front and Rear Propeller Shaft Replacement (Chassis Cab with MYD)* in SI.

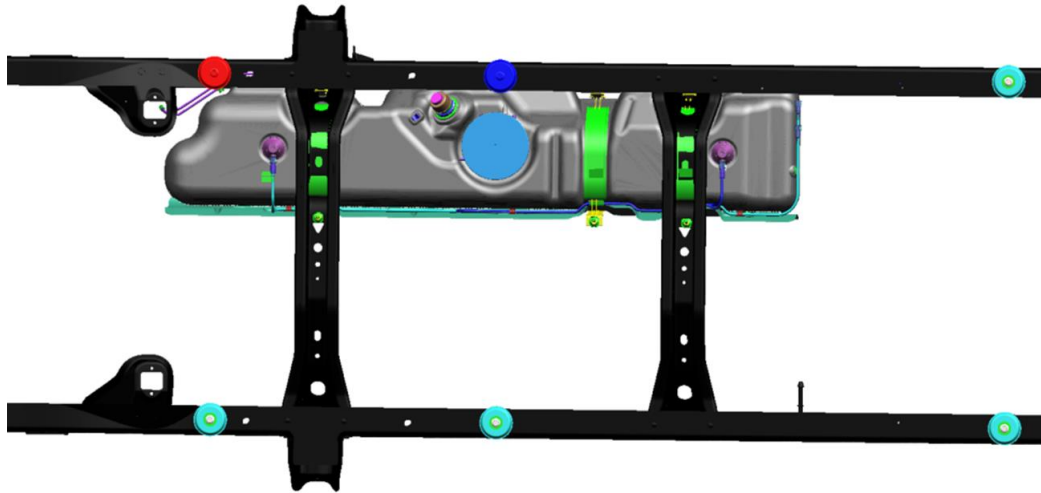
6737783

4. Inspect the brake lines near the forward body mount (indicated by the color blue in the above pictures) and ensure that there is at least ½ inch (13mm) of clearance between the body mount and the brake lines.
  - 4.1 If there is NOT at least ½ inch (13mm) of clearance, replace the brake lines. Proceed to step 6.
  - 4.2 If there is at least ½ inch (13mm) of clearance, proceed to step 5.

**IMPORTANT:** Do NOT attempt to bend or modify the brake lines if there is insufficient clearance.

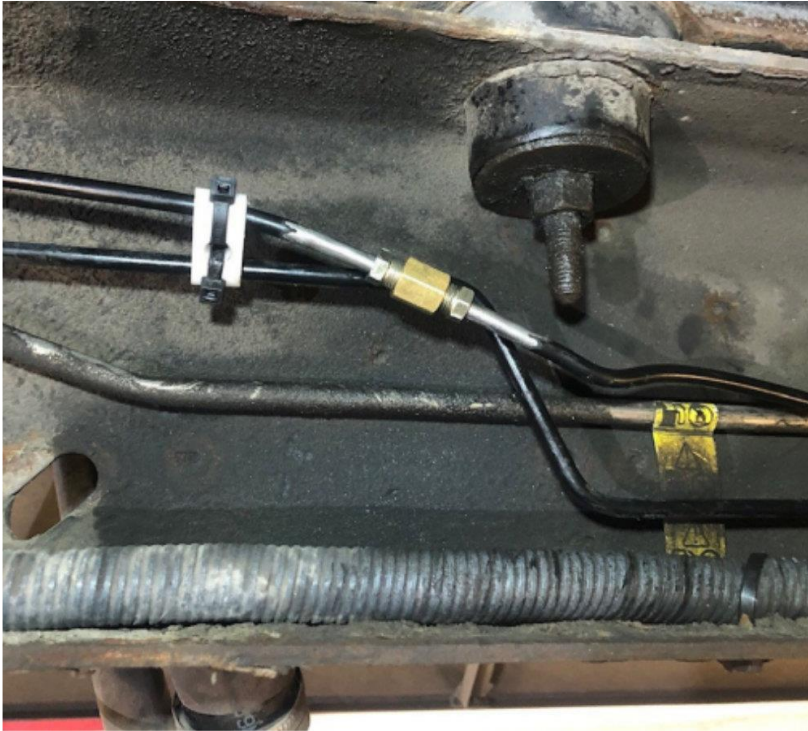
6737867

4.3 If the vehicle has been repaired prior to inspection, replace the brake lines. Proceed to step 6.

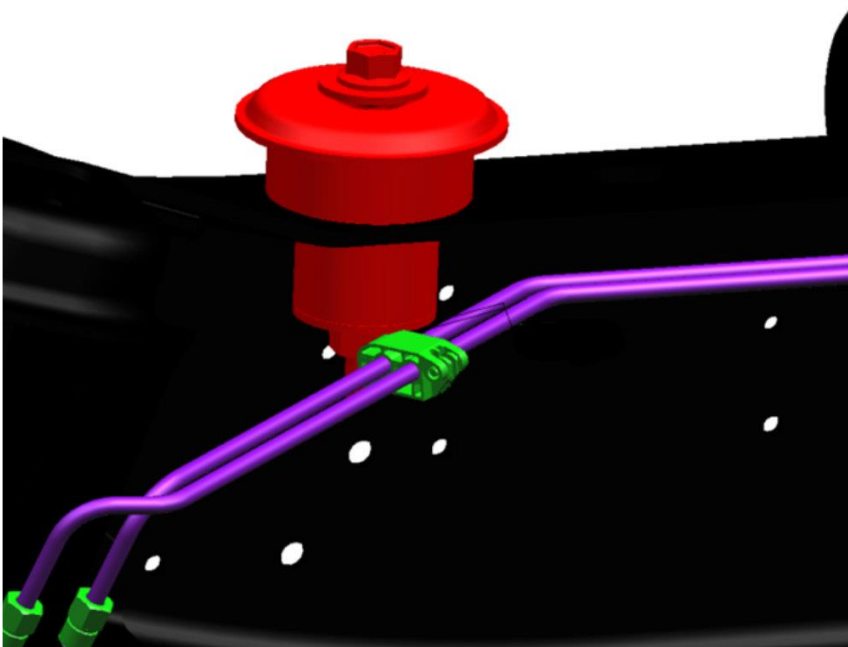
6737785

5. Inspect the brake lines near the rearward body mount (indicated by the color red in the first picture of the procedure and above) and ensure that there is at least  $\frac{1}{2}$  inch (13mm) of clearance between the body mount and the brake lines.
  - If there is NOT at least  $\frac{1}{2}$  inch (13mm) of clearance, replace the brake lines. Proceed to step 6.

**IMPORTANT:** Do NOT attempt to bend or modify the brake lines if there is insufficient clearance.

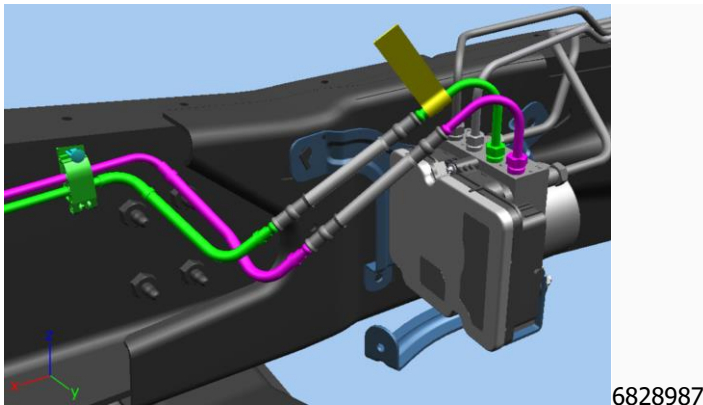
6.5 Install brake line clips into the frame rail.
