October 18, 2024

Version 3

Safety Recall: 2023–25 HR-V Steering Gearbox Repair

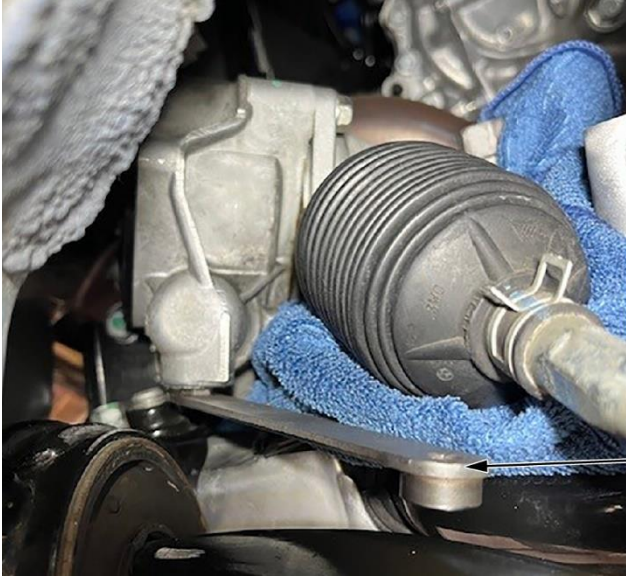
EPS PLUG
WRENCH

7. Use the EPS plug wrench to break loose the EPS end cover plug.
NOTE: The spring and spring seat may fall out during the end cap removal process.

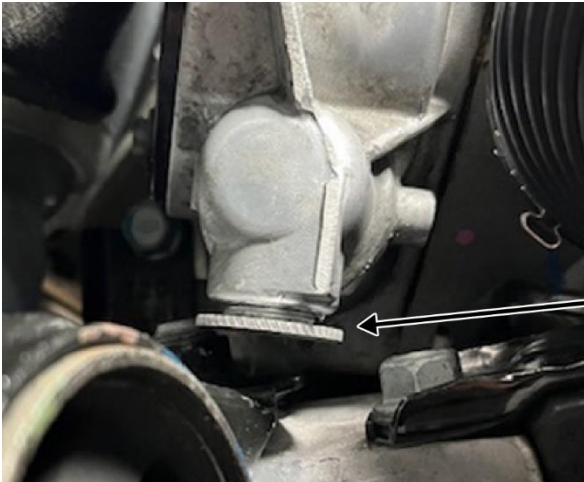
EPS PLUG
THUMB WHEEL

8. Then use the EPS plug thumb wheel to remove the EPS end cover plug.

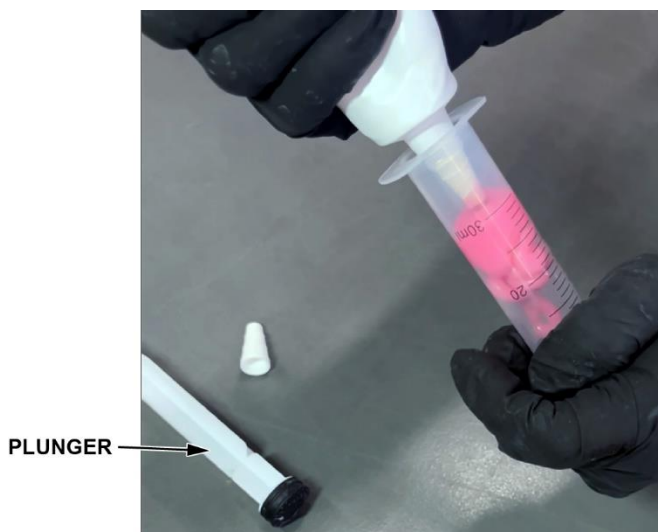
11. Open the tube of grease and squeeze the entire contents into the empty syringe, then insert the plunger.
NOTE: There should be a minimum of 15ml of grease in the syringe.

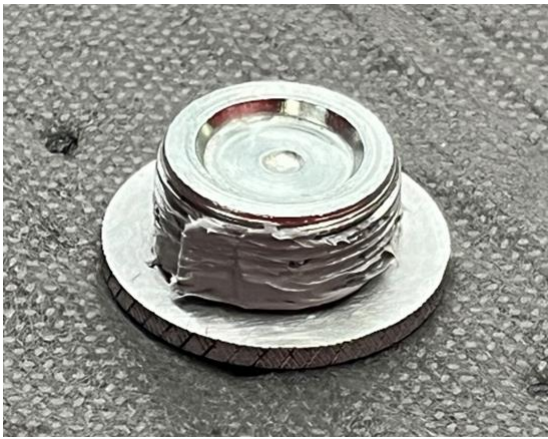
18. Apply a thin coat of Hondabond to the **NEW** EPS end cover plug threads and use the EPS plug thumb wheel to install.
