March 7, 2025

Version 6

Safety Recall: 2023–25 HR-V Steering Gearbox Repair

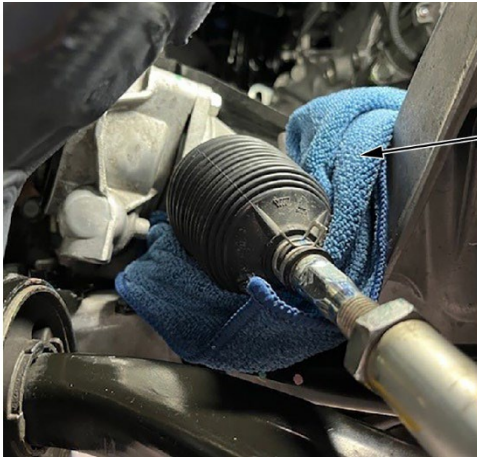
CLEAN RAG

6. Insert a clean rag between the steering gearbox and the subframe. This is to keep tools and/or parts from falling into this area.

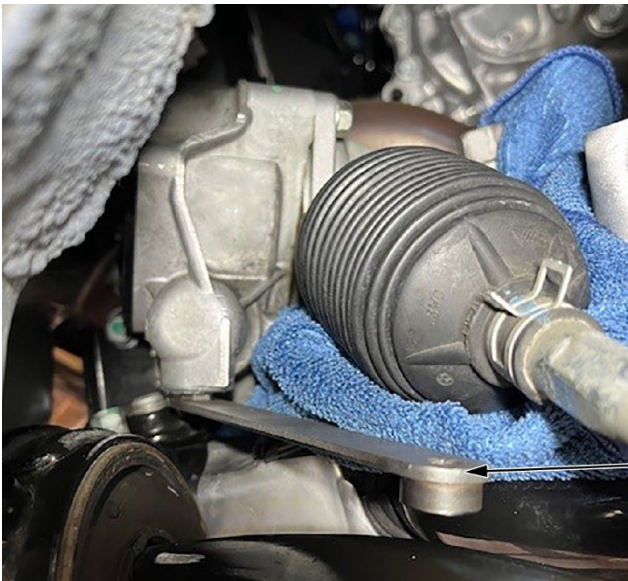
EPS PLUG
WRENCH

7. Use the EPS plug wrench to break loose the EPS end cover plug.
NOTE: The spring and spring seat may fall out during the end cap removal process.

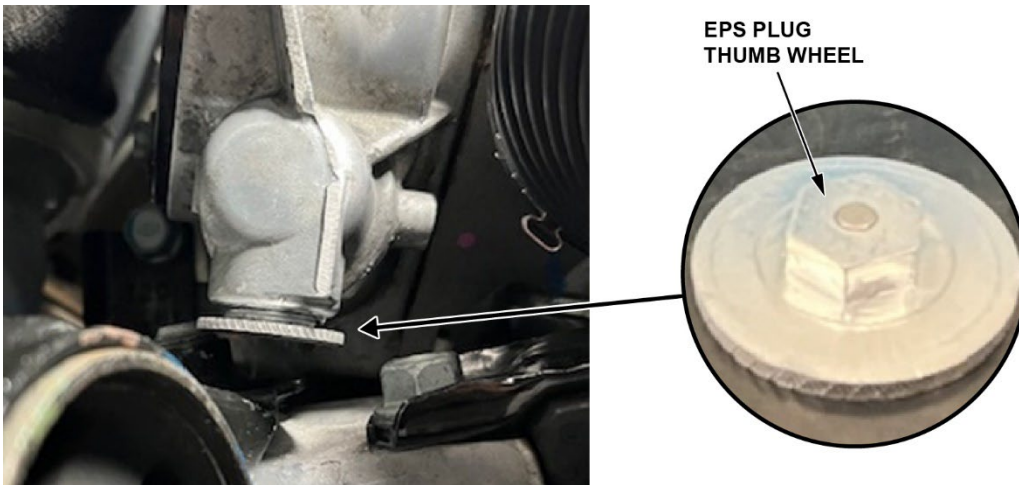
8. Then use the EPS plug thumb wheel to remove the EPS end cover plug.

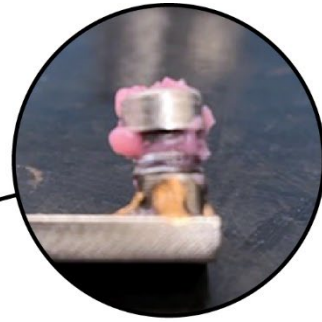
16. Using the spring/plug holder, install the **NEW** EPS spring and seat.

NOTE: Apply additional grease, saved in step 12, around the outside of the spring and spring seat to help hold them when inserted into the steering gearbox.

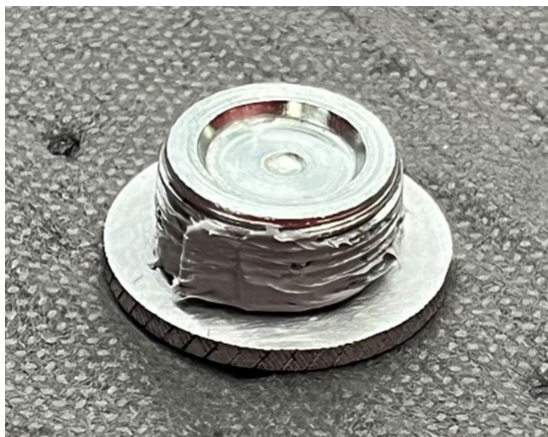
18. Apply a thin coat of Hondabond to the **NEW** EPS end cover plug threads and use the EPS plug thumb wheel to install.
