**October 25, 2024**

Version 5

**Safety Recall: 2022–25 Civic Steering Gearbox Repair**Supersedes 24-119 dated October 22, 2024, to revise the information highlighted in **yellow**.**AFFECTED VEHICLES**

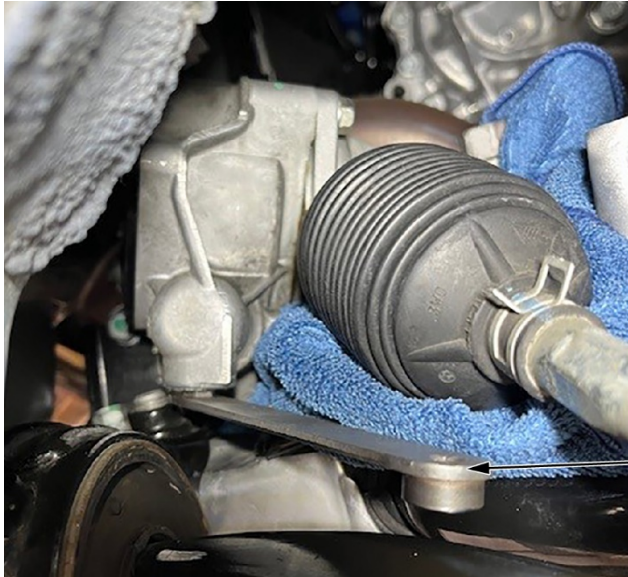
EPS PLUG  
WRENCH

8. Use the EPS plug wrench to break loose the EPS end cover plug.  
NOTE: The spring and spring seat may fall out during the end cap removal process.

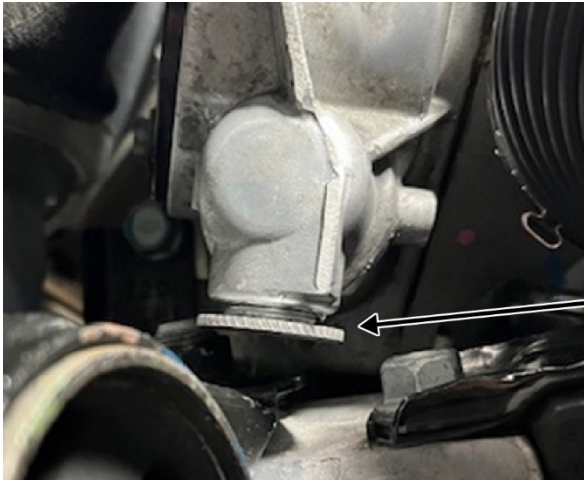
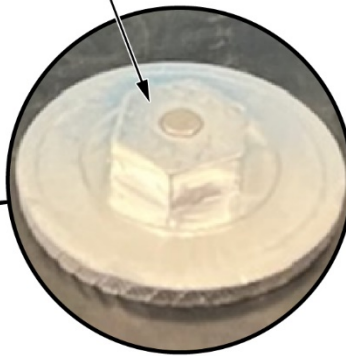
EPS PLUG  
THUMB WHEEL

9. Then use the EPS plug thumb wheel to remove the EPS end cover plug.

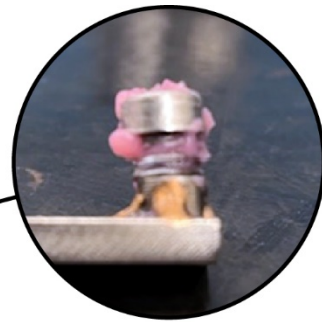
17. Using the spring/plug holder, install the **NEW** EPS spring and seat.

NOTE: Apply additional grease, saved in step 13, around the outside of the spring and spring seat to help hold them when inserted into the steering gearbox.

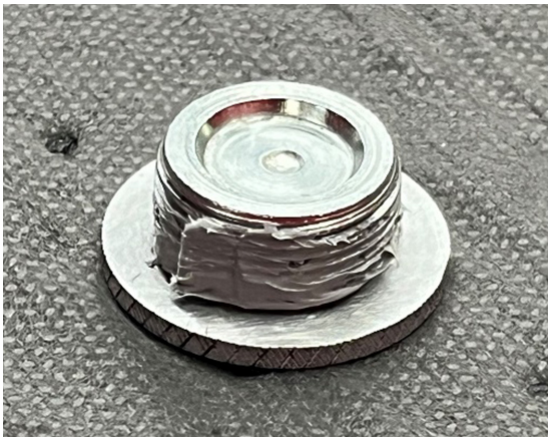
18. Apply a thin coat of Hondabond to the **NEW** EPS end cover plug threads and use the EPS plug thumb wheel to install.
