## Safety Recall: 2023–25 Integra Steering Gear Repair

Supersedes 24-054 dated October 18, 2024, to revise the information highlighted in **yellow**.

### BACKGROUND

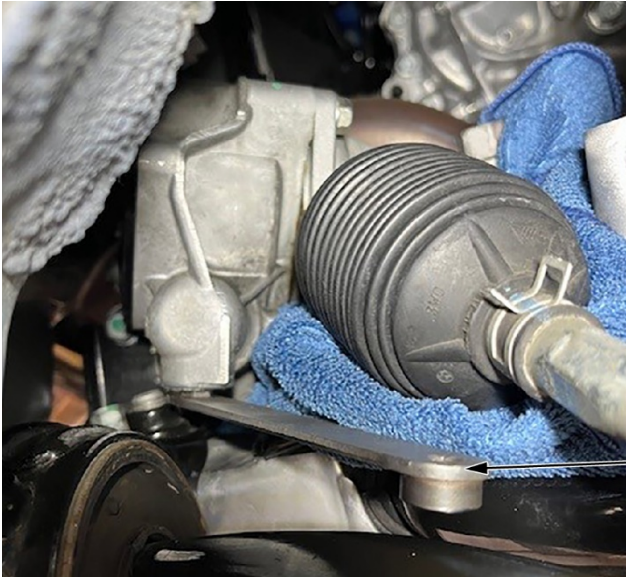
EPS PLUG  
WRENCH

8. Use the EPS plug wrench to break loose the EPS end cover plug.  
NOTE: The spring and spring seat may fall out during the end cap removal process.

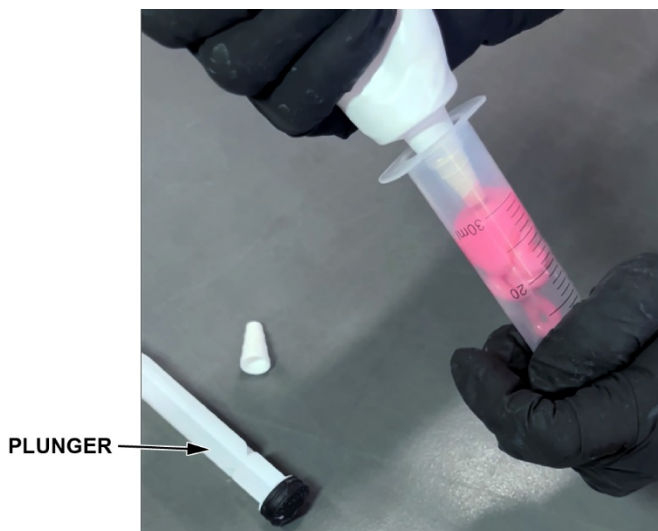
12. Open the tube of grease and squeeze the entire contents into the empty syringe, then insert the plunger.

NOTE: There should be a minimum of 15ml of grease in the syringe.

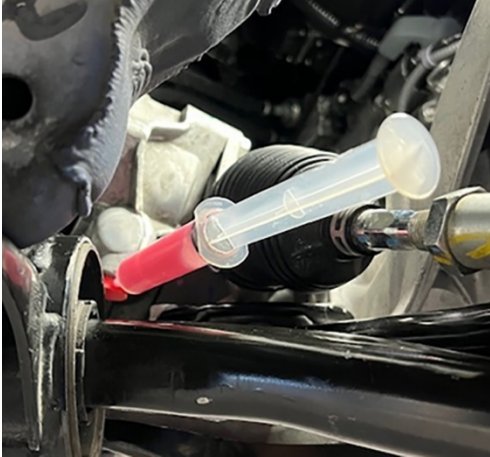
14. Insert the grease filled syringe into the grease plug and slowly inject the grease.

TIP: It may be necessary, apply pressure to the grease injection plug to keep it seated while injecting the grease.

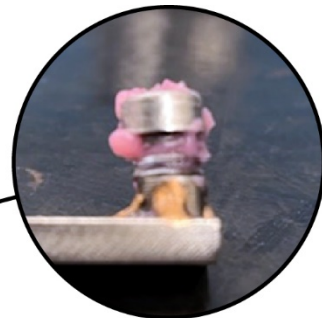
17. Using the spring/plug holder, install the **NEW** EPS spring and seat.

NOTE: Apply additional grease, saved in step 13, around the outside of the spring and spring seat to help hold them when inserted into the steering gearbox.

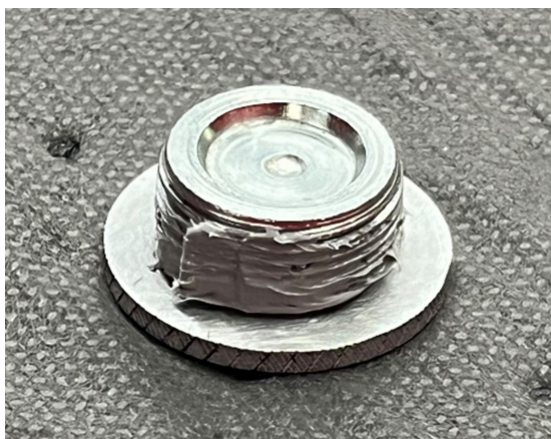
19. Apply a thin coat of Hondabond to the **NEW** EPS end cover plug threads and use the EPS plug thumb wheel to install.
