Safety Recall: 2022–25 Civic Steering Gearbox Repair

Supersedes 24-119 dated October 8, 2024, to revise the information.

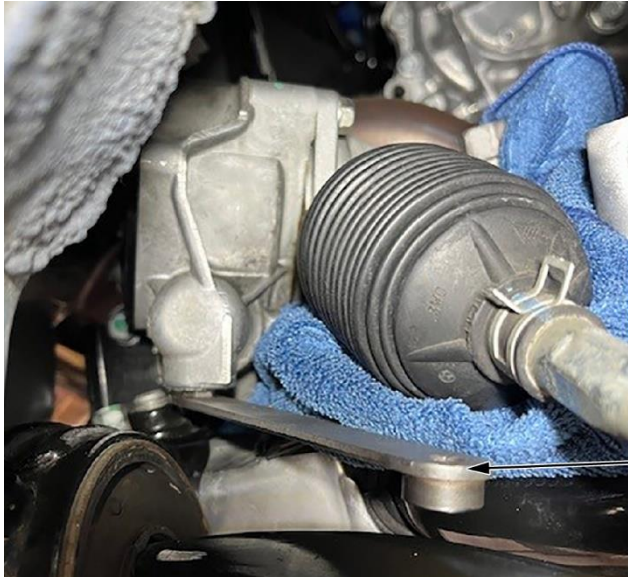
EPS PLUG
WRENCH

8. Use the EPS plug wrench to break loose the EPS end cover plug.
NOTE: The spring and spring seat may fall out during the end cap removal process.

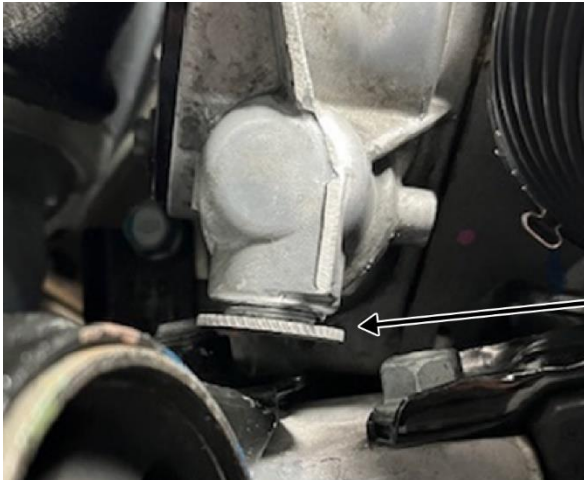
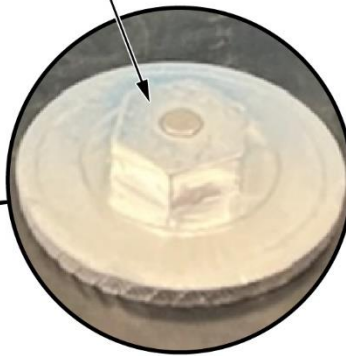
EPS PLUG
THUMB WHEEL

9. Then use the EPS plug thumb wheel to remove the EPS end cover plug.

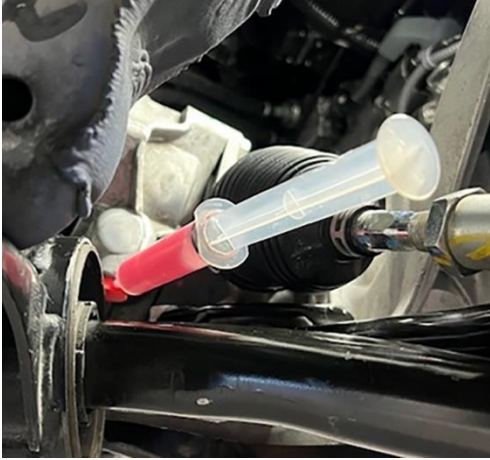
14. Insert the grease filled syringe into the grease plug and slowly inject the grease.

TIP: It may be necessary, apply pressure to the grease injection plug to keep it seated while injecting the grease.
