March 27, 2025

Version 7

Safety Recall: 2023–25 Integra Steering Gear Repair

AFFECTED VEHICLES

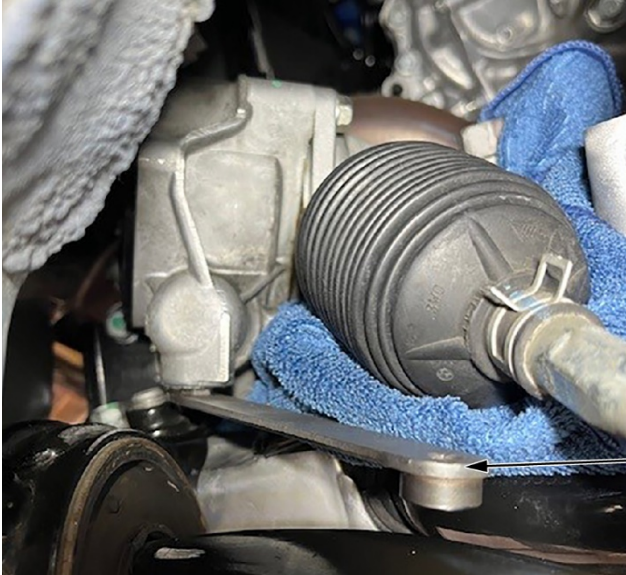
EPS PLUG
WRENCH

8. Use the EPS plug wrench to break loose the EPS end cover plug.
NOTE: The spring and spring seat may fall out during the end cap removal process.

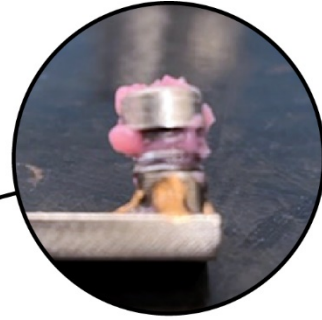
17. Using the spring/plug holder, install the **NEW** EPS spring and seat.

NOTE: Apply additional grease, saved in step 13, around the outside of the spring and spring seat to help hold them when inserted into the steering gearbox.

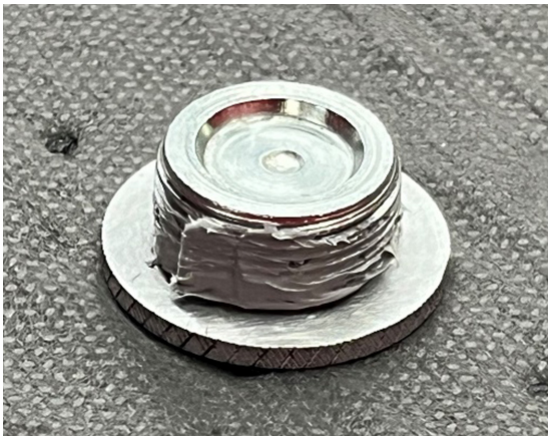
18. Apply a thin coat of Hondabond to the **NEW** EPS end cover plug threads and use the EPS plug thumb wheel to install.
