**October 18, 2024**

Version 3

## **Safety Recall: 2023–25 CR-V, 2023–25 CR-V Hybrid, 2025 CR-V e:FCEV Steering Gearbox Repair**

Supersedes 24-117 dated October 8, 2024, to revise the information.

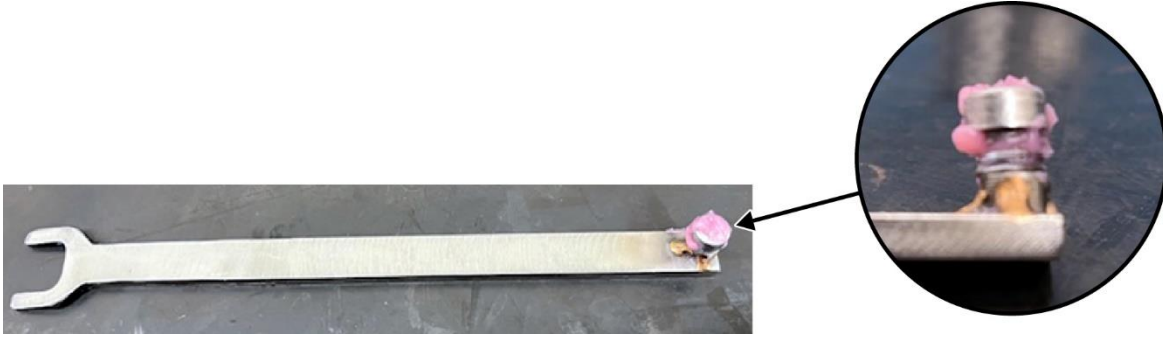
16. Using the spring/plug holder, install the **NEW** EPS spring and seat.

NOTE: Apply additional grease, saved in step 12, around the outside of the spring and spring seat to help hold them when inserted into the steering gearbox.

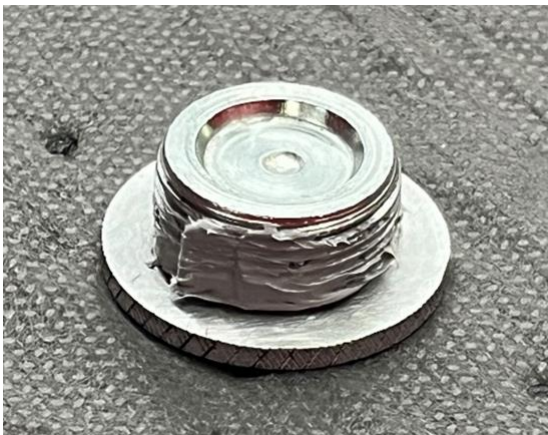
18. Apply a thin coat of Hondabond to the **NEW** EPS end cover plug threads and use the EPS plug thumb wheel to install.
