October 25, 2024

Version 4

Safety Recall: 2023–25 CR-V, 2023–25 CR-V Hybrid, 2025 CR-V e:FCEV Steering Gearbox Repair

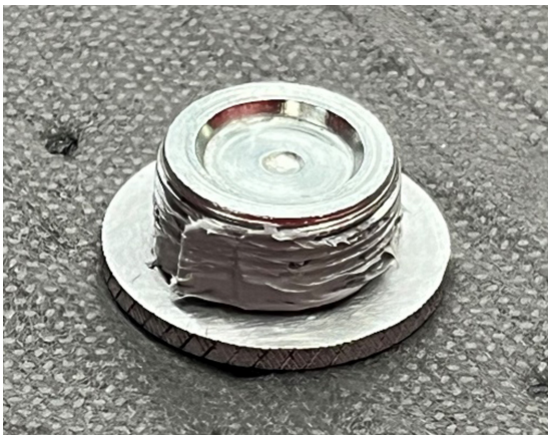
18. Apply a thin coat of Hondabond to the **NEW** EPS end cover plug threads and use the EPS plug thumb wheel to install.
