Safety Recall: 2023–25 HR-V Steering Gearbox Repair

Supersedes 24-118, dated March 7, 2025, to revise the information highlighted in **yellow**.

AFFECTED VEHICLES

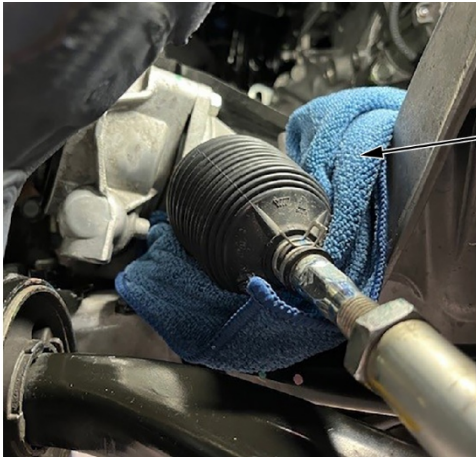
CLEAN RAG

6. Insert a clean rag between the steering gearbox and the subframe. This is to keep tools and/or parts from falling into this area.

20. Remove the rag from between the steering gearbox and subframe.

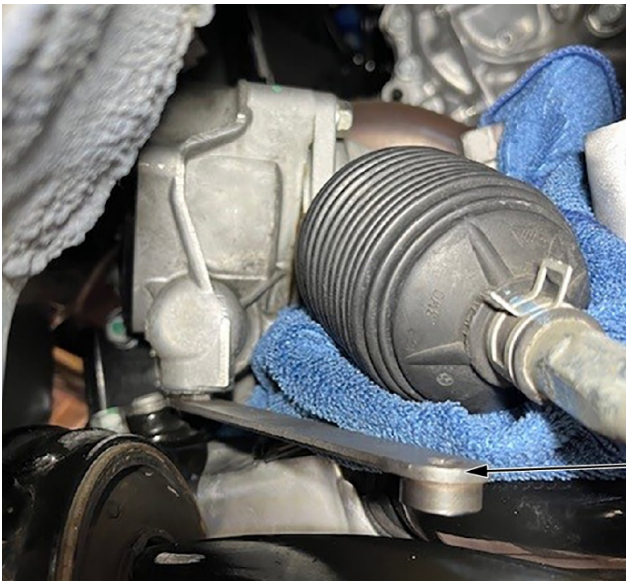
EPS PLUG
WRENCH

7. Use the EPS plug wrench to break loose the EPS end cover plug.
NOTE: The spring and spring seat may fall out during the end cap removal process.

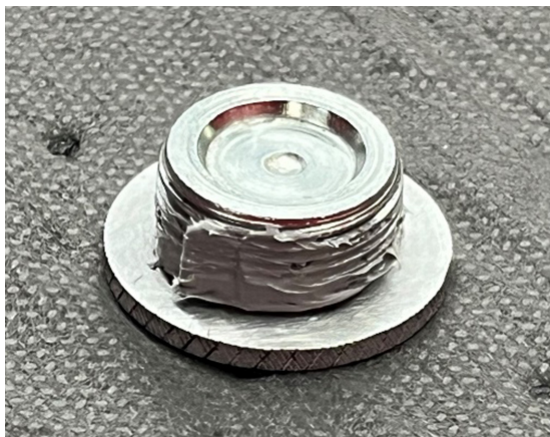
18. Apply a thin coat of Hondabond to the **NEW** EPS end cover plug threads and use the EPS plug thumb wheel to install.
