## Safety Recall: 2023–25 Integra Steering Gear Repair

Supersedes 24-054 dated October 8, 2024, to revise the information.

Year	Model	Trim Level	VIN Range
2023–25	Integra (Including Type S)	ALL	Check the iN VIN status for eligibility.

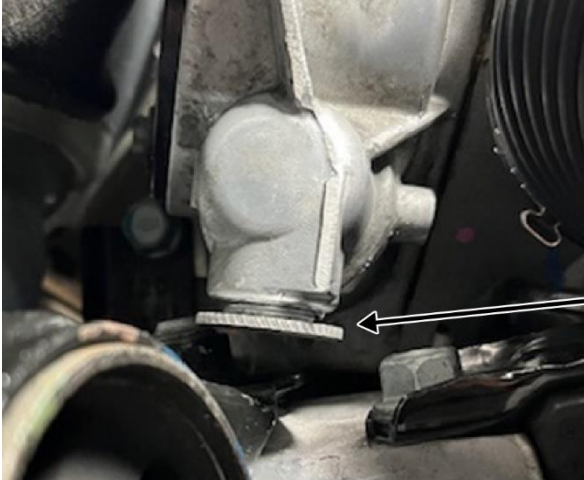
EPS PLUG  
THUMB WHEEL

9. Then use the EPS plug thumb wheel to remove the EPS end cover plug.

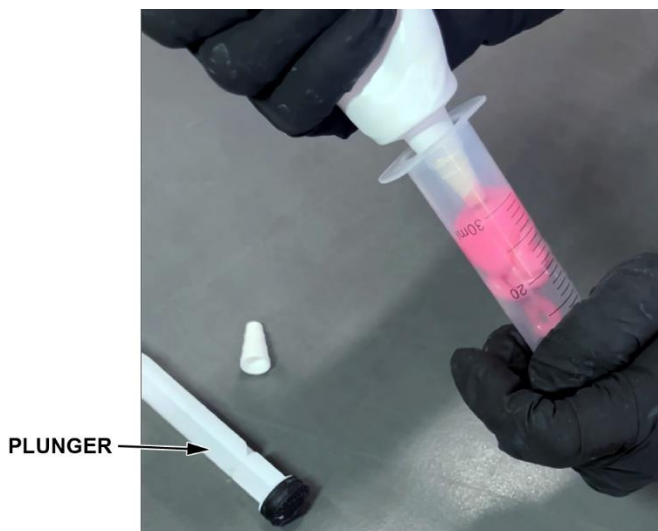
12. Open the tube of grease and squeeze the entire contents into the empty syringe, then insert the plunger.

NOTE: There should be a minimum of 15ml of grease in the syringe.

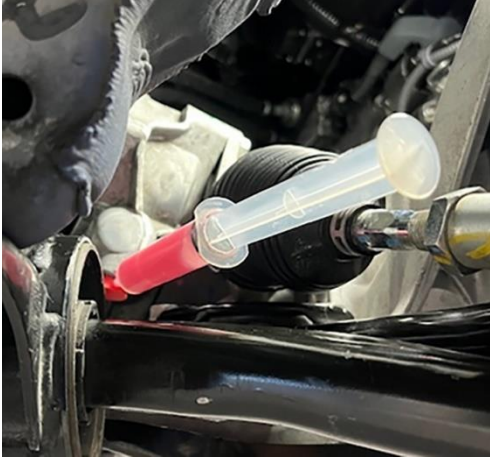
14. Insert the grease filled syringe into the grease plug and slowly inject the grease.

TIP: It may be necessary, apply pressure to the grease injection plug to keep it seated while injecting the grease.

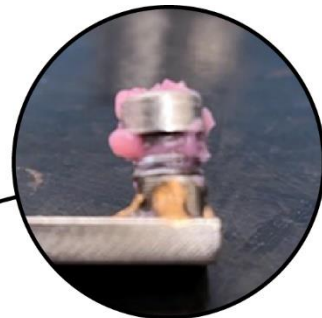
17. Using the spring/plug holder, install the **NEW** EPS spring and seat.

NOTE: Apply additional grease, saved in step 13, around the outside of the spring and spring seat to help hold them when inserted into the steering gearbox.

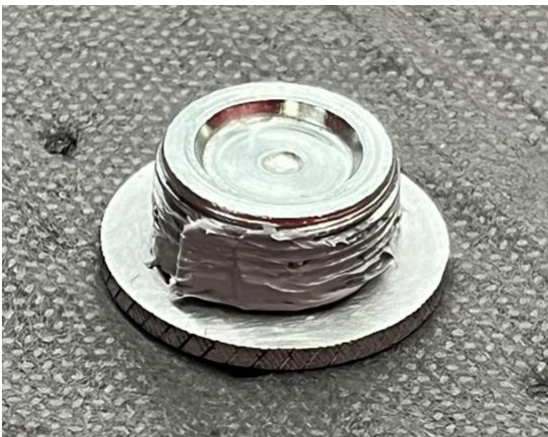
19. Apply a thin coat of Hondabond to the **NEW** EPS end cover plug threads and use the EPS plug thumb wheel to install.
