## Safety Recall: 2023–25 Integra Steering Gear Assembly

Supersedes 24-054 dated October 8, 2024, to revise the information highlighted in **yellow**.

Year	Model	Trim Level	VIN Range
2023–25	Integra (Including Type S)	ALL	Check the iN-VIN status for eligibility.

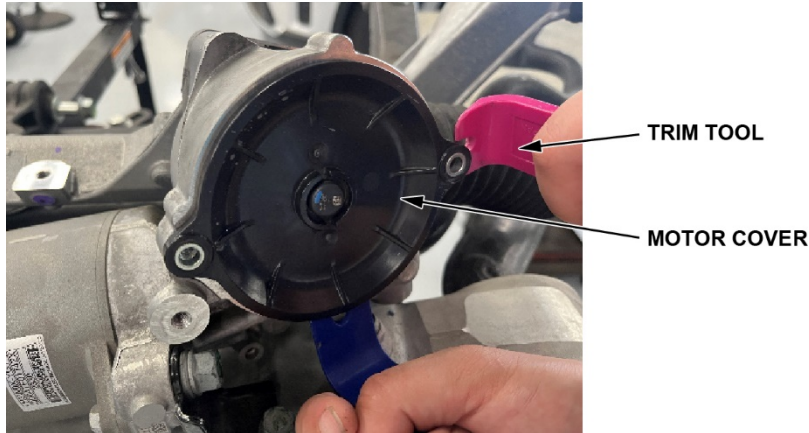
1. Remove the two bolts securing the black cover.
2. Using a plastic trim tool, gently pry the cover to separate it from the EPS gearbox. Slowly work the tool around the bottom edge of the cover to release the cover.

- **Do not** use a screwdriver or metal tool to pry the cover.
- The cover is sealed with an O-ring, which may provide some resistance.

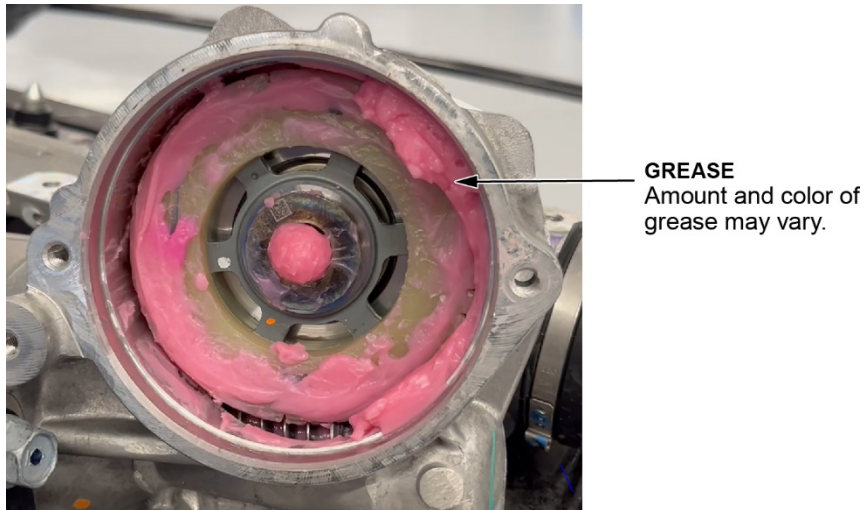
3. Remove the cover.

NOTE: The amount and color of the grease inside the housing may vary from vehicle to vehicle.

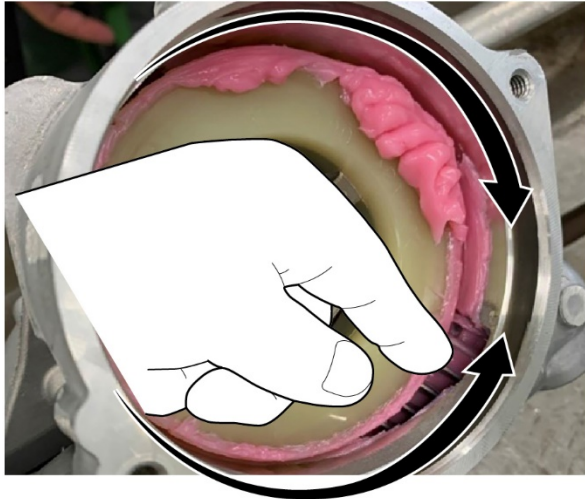
BEFORE

- **Do not** add any additional grease.
  - Save a small amount of grease to be used in Steps 8 and 9.
1. While wearing clean gloves, start at the top and run your finger along the nylon gear and aluminum housing while directing the excess grease to the metal worm gear at the lower area of the housing.
  2. Once the excess grease is moved to the lower area of the nylon gear, pack the grease into the worm gear location until the grease fills the gap where the worm gear mates with the nylon gear.

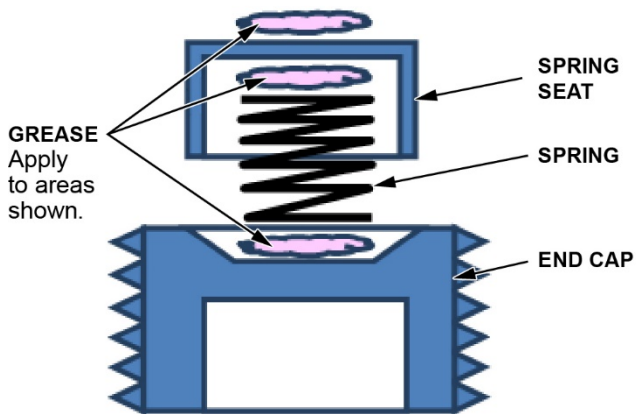
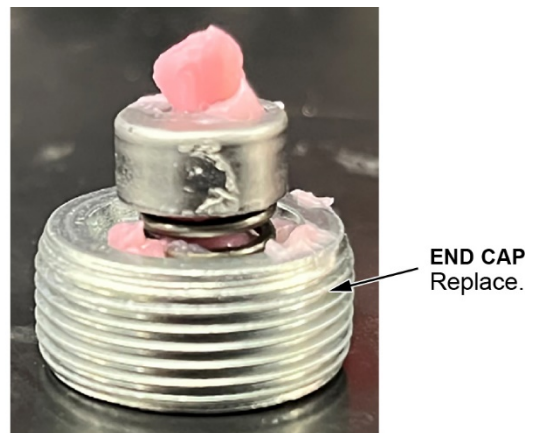
8. Using the extra grease from the previous step, apply grease between the new replacement end cap, spring, spring seat, and also on top of the spring seat. Protect the assembly from potential contamination by setting it aside in a safe place.

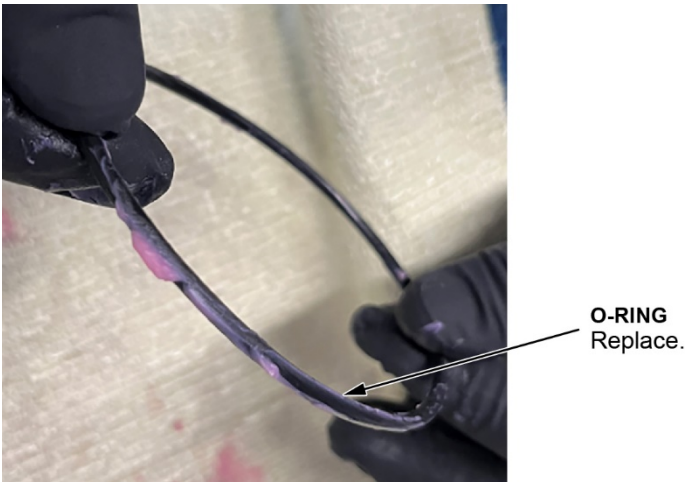
9. Apply grease to the new O-ring.

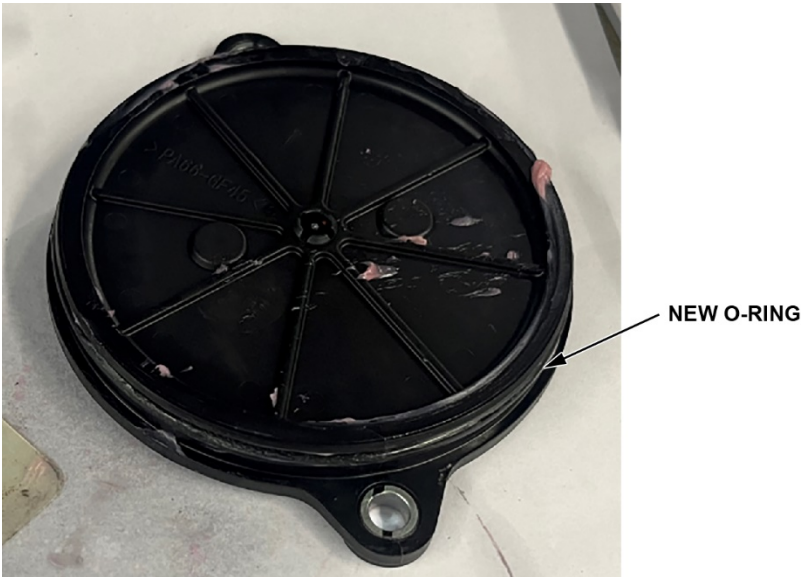
10. Install the new greased O-ring onto the cover.

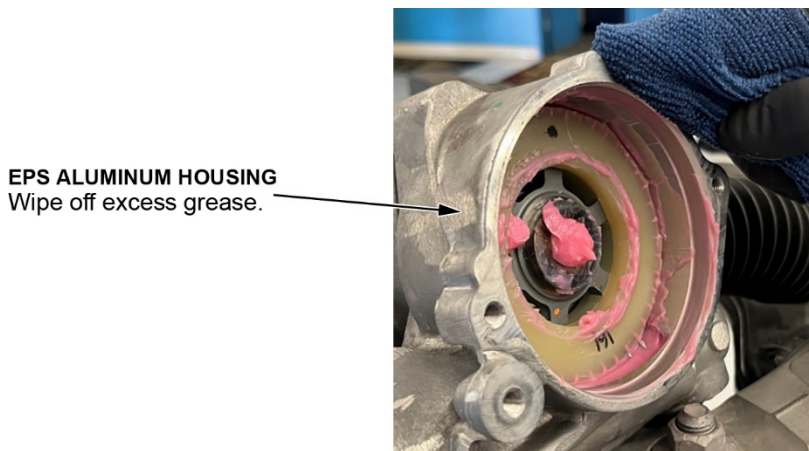
11. Wipe off any excess grease around the EPS aluminum housing.

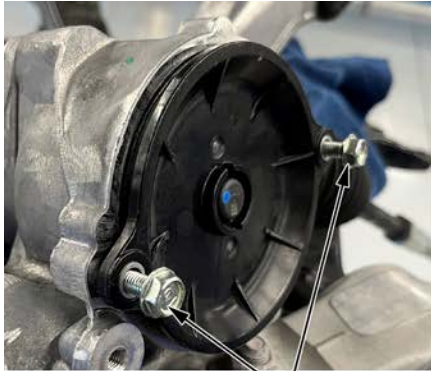
**BOLTS**  
Loosely install.

- Loosely install the bolts.
- Gently press the cover to set the cover onto the aluminum housing.
- Torque the two bolts to **8 N·m (6 lb-ft)**.

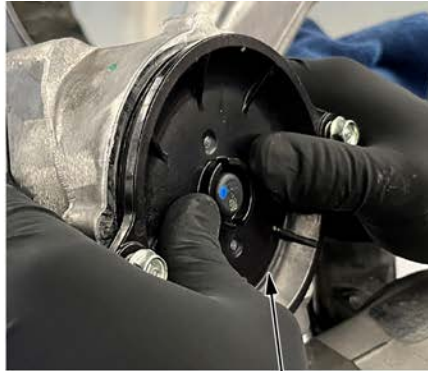
**COVER**  
Gently press.

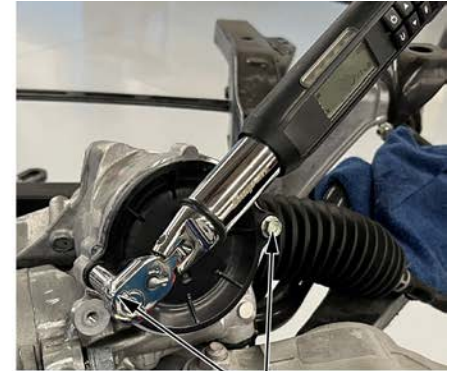
**TORQUE BOLTS**  
8 N·m (6 lb-ft)

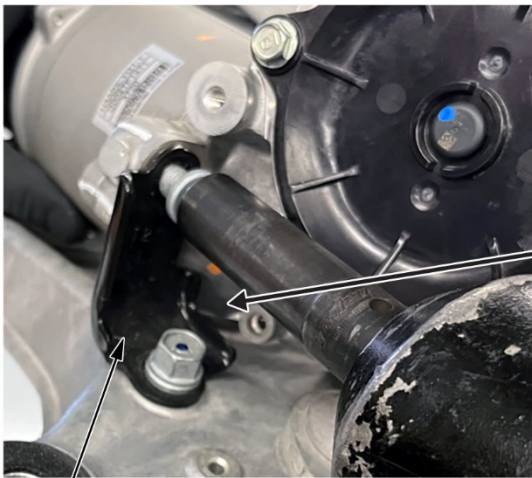
**EPS BRACKET**

13. Remove the EPS bracket.

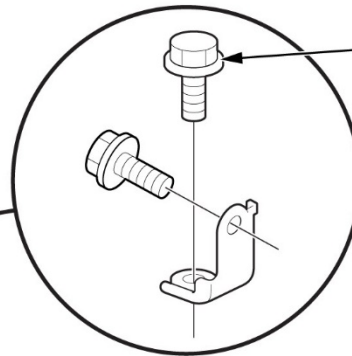
**BOLTS (2)**  
44 N·m (32 lb-ft)

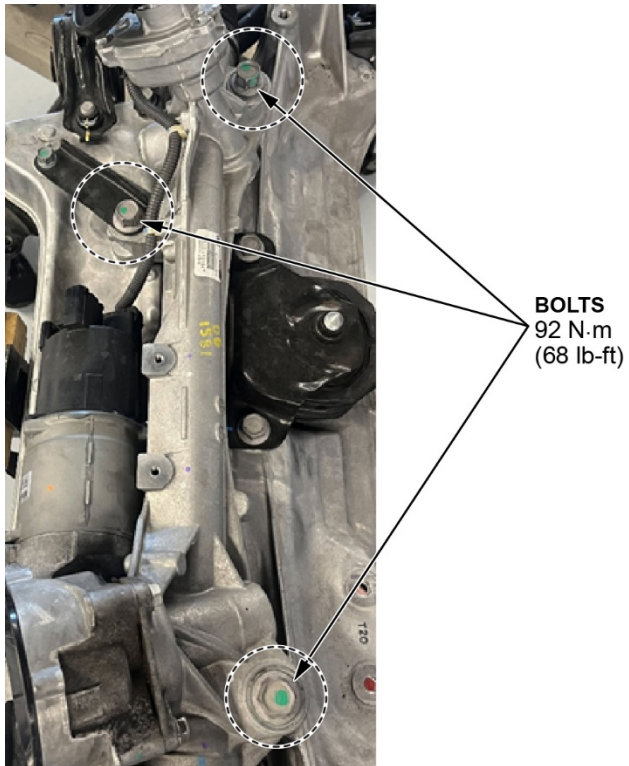
14. Remove the EPS gearbox from the subframe.

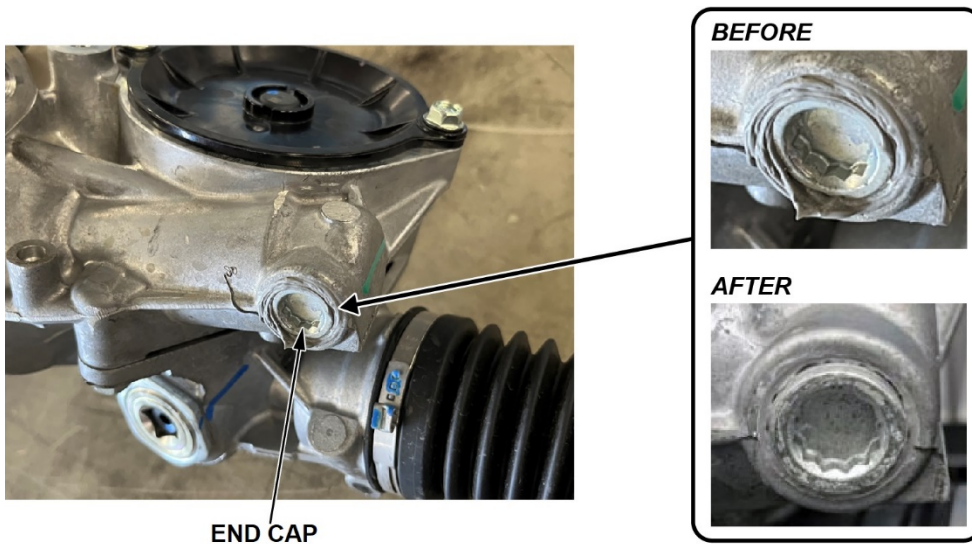
15. Using a wire brush, clean off the exposed sealant around the end cap. Then, use a rag (with brake cleaner) to wipe away any residual loose material.

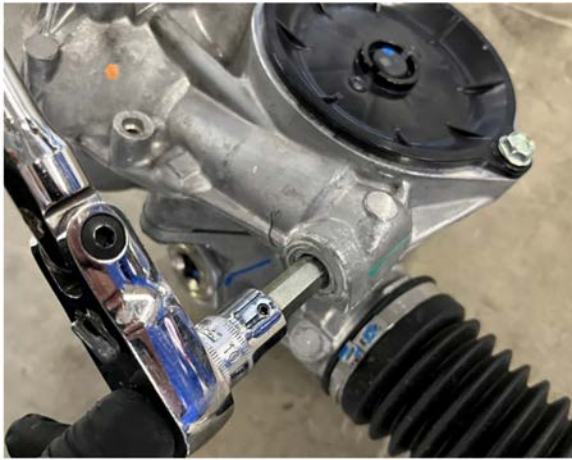
16. With a **10 mm** hex socket bit, remove the end cap on the EPS gearbox.

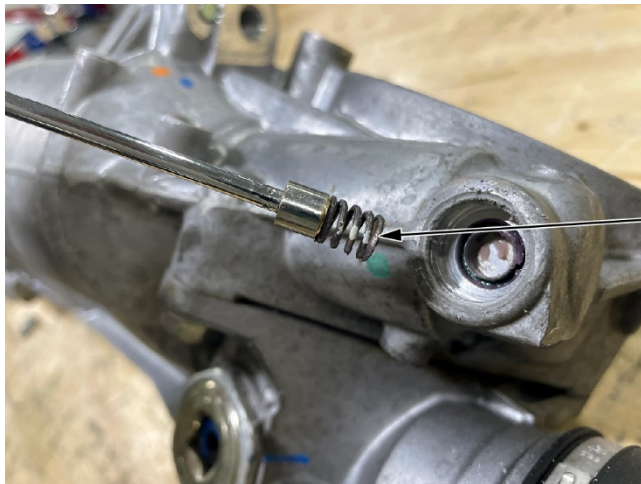
17. Using a magnet tool, remove the spring from the EPS gearbox and **immediately discard upon removal**.

SPRING  
Discard.

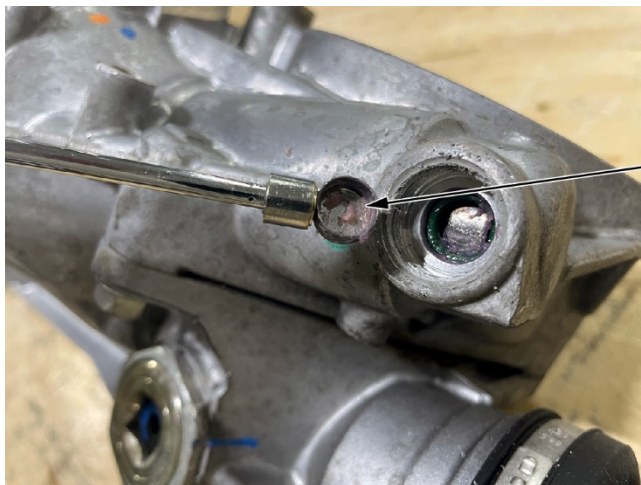
18. Using a magnet tool, remove the spring seat from the EPS gearbox and **immediately discard upon removal**.

SPRING SEAT  
Discard.

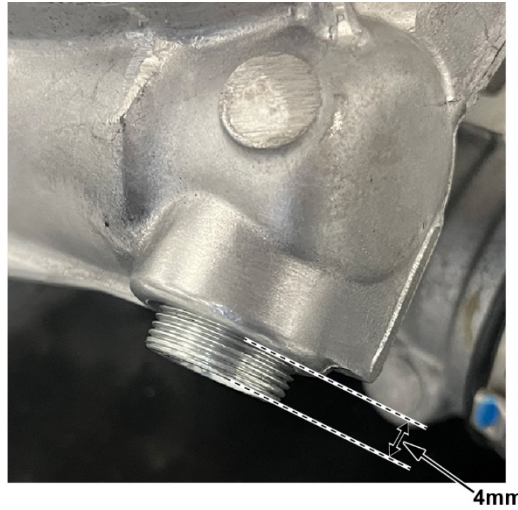
19. With the new spring seat, spring, and end cap held together by the grease, install the pieces together into the EPS gearbox, then tighten the end cover plug until **4 mm** of threads remain exposed.

NOTE: To keep the parts from falling off the hex socket bit while installing, rotate the EPS housing until the hole is facing downward, then install the spring seat, spring, and end cap up into the hole.

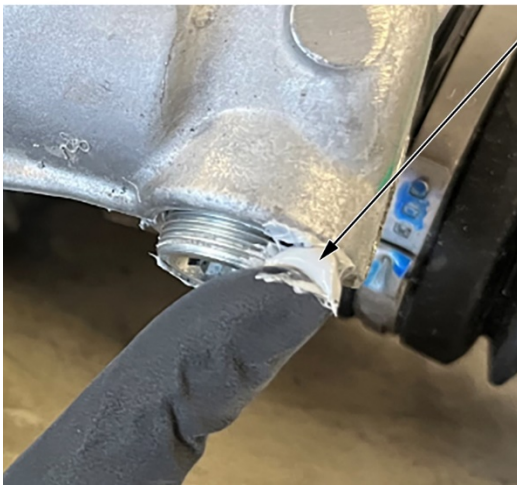
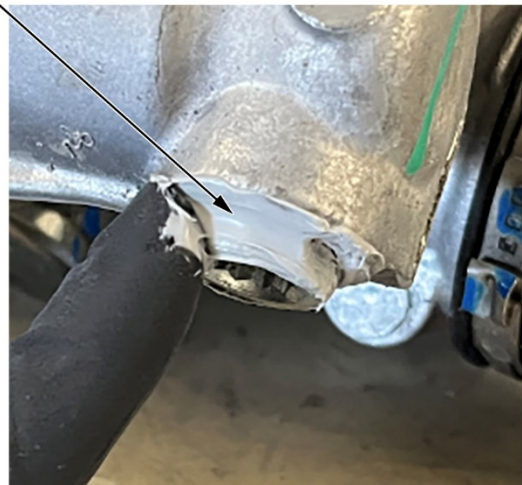
HONDABOND

20. Before torquing, apply Hondabond sealant to the exposed threads of the end cover plug.
