**October 25, 2024**

**Safety Recall: 2023–25 HR-V Steering Gearbox Repair**Supersedes 24-118 dated October 18, 2024, to revise the information highlighted in **yellow**.**AFFECTED VEHICLES**

Due to an improperly produced steering gearbox worm wheel, the wheel can swell during use, reducing the grease film thickness between the worm wheel and worm gear. In addition, the worm gear spring preload was set improperly high, increasing the sliding force between the components. As a result of the reduced grease film thickness and increased sliding force, friction between the worm wheel and worm gear increases.

Replace the end cap, spring, and spring seat in the EPS gearbox assembly and inject grease into the EPS gearbox.

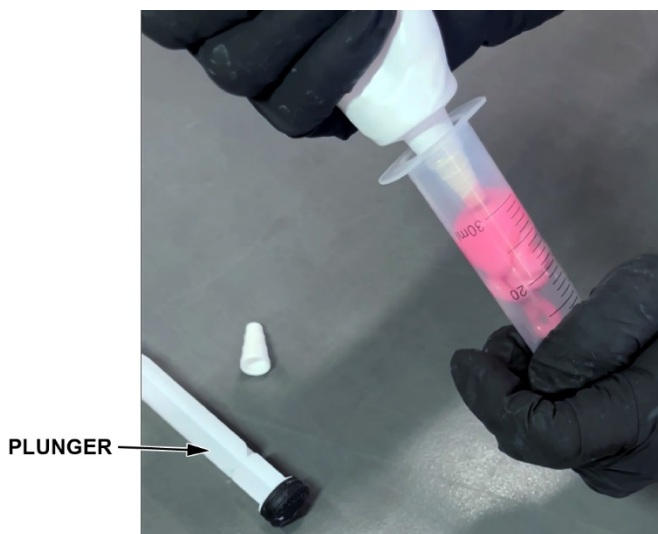
11. Open the tube of grease and squeeze the entire contents into the empty syringe, then insert the plunger.

NOTE: There should be a minimum of 15ml of grease in the syringe.

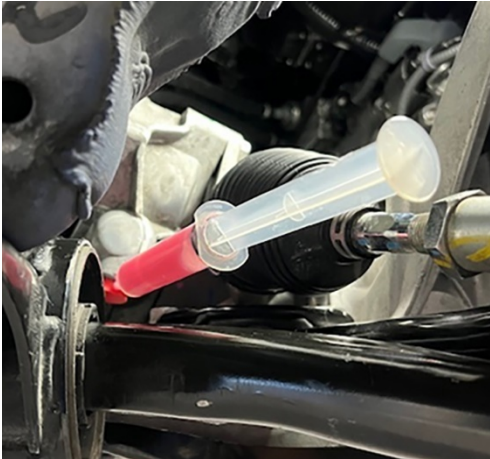
13. Insert the grease filled syringe into the grease plug and slowly inject the grease.

TIP: It may be necessary, apply pressure to the grease injection plug to keep it seated while injecting the grease.

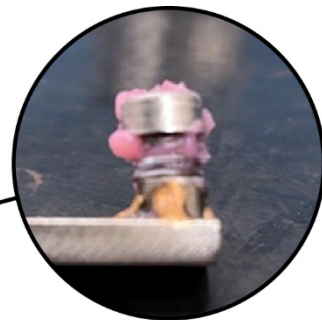
16. Using the spring/plug holder, install the **NEW** EPS spring and seat.

NOTE: Apply additional grease, saved in step 12, around the outside of the spring and spring seat to help hold them when inserted into the steering gearbox.

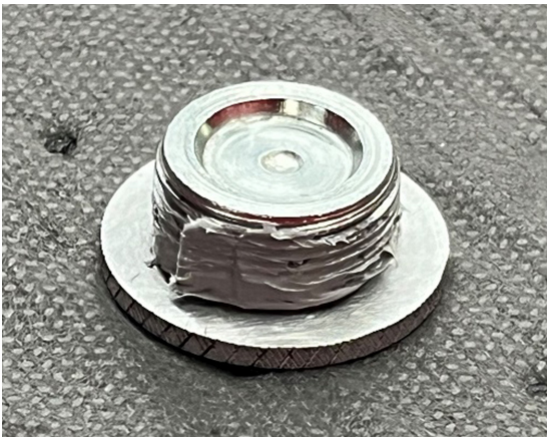
18. Apply a thin coat of Hondabond to the **NEW** EPS end cover plug threads and use the EPS plug thumb wheel to install.
