Service Bulletin

24-120

Safety Recall: 2023 CR-V Hybrid Lithium-ion Battery

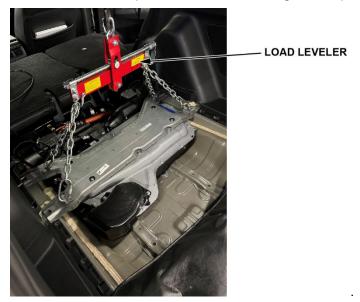
Using an engine hoist and load leveler, remove the IPU assembly from the vehicle taking care not to scratch or damage the interior and exterior of the vehicle.

NOTE: Make sure to protect the rear lower cargo with a protective mat.

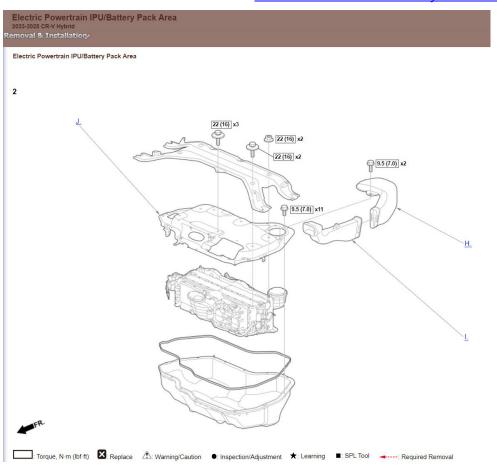
11. Remove the IPU Cover from the IPU case *Electric Powertrain IPU/Battery Pack Area*.

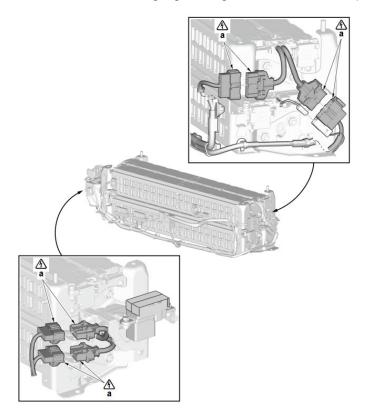
12. Disconnect the remaining high-voltage connectors and wrap them with insulating tape.

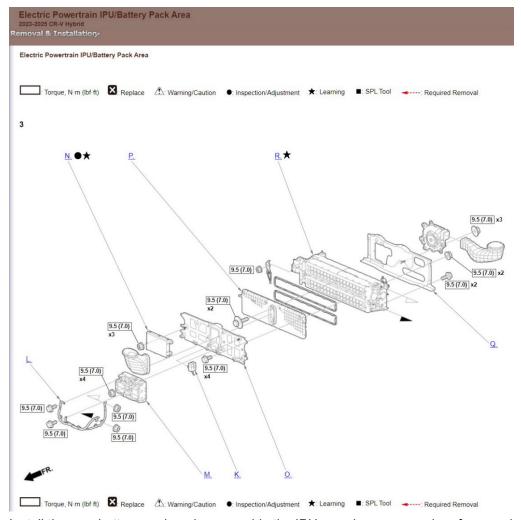
13. Remove the front (O) and rear (Q) battery pack plate, then remove the battery assembly (R).

- 14. Install the new battery pack and reassemble the IPU case in reverse order of removal.
- 15. Reinstall the IPU assembly into the vehicle.
- 16. Reconnect the 12-volt battery.
- 17. Connect i-HDS and perform the *Battery Condition Monitor Module Reset*. Select the following menu buttons on the HDS screen in sequence.
- 1. Electric Powertrain (System Selection Menu)
- 2. HV Battery/HV Battery ECU Replacement
- 3. HV Battery Replacement
- 18. Perform VSA Sensor Neutral Position Memorization.
