Vehicle Recall Verification

Repair Procedure

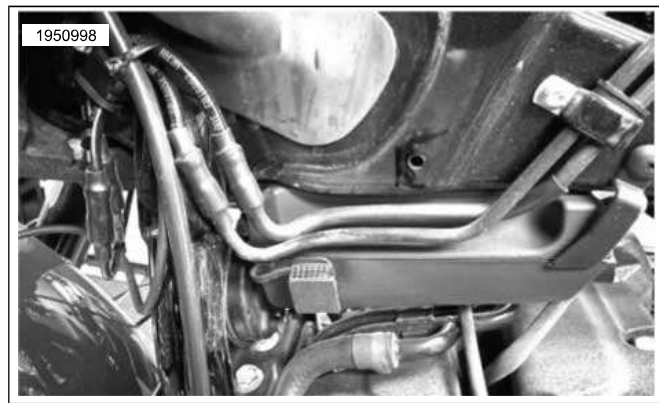
Figure 2. Inspection Area (Incorrect Brake Line Routing)

1. Clean brake line outer surface.
2. See Figure 2. Inspect brake lines for wear in the area shown.
 - a. See Figure 3. Inspect brake lines for proper orientation.
 - b. See Figure 4 and Figure 5. Verify brake lines are parallel to down tube in front and not across the front of the downtube.

3. If brake lines show signs of wear, replace brake lines according to the instructions in the applicable service manual.
4. If brake lines are bent incorrectly and routed outside of the left side downtube instead of over it, replace the brake lines according to the instructions in the applicable service manual.
5. If there are no signs of wear and brake lines are routed correctly, no replacement is needed.

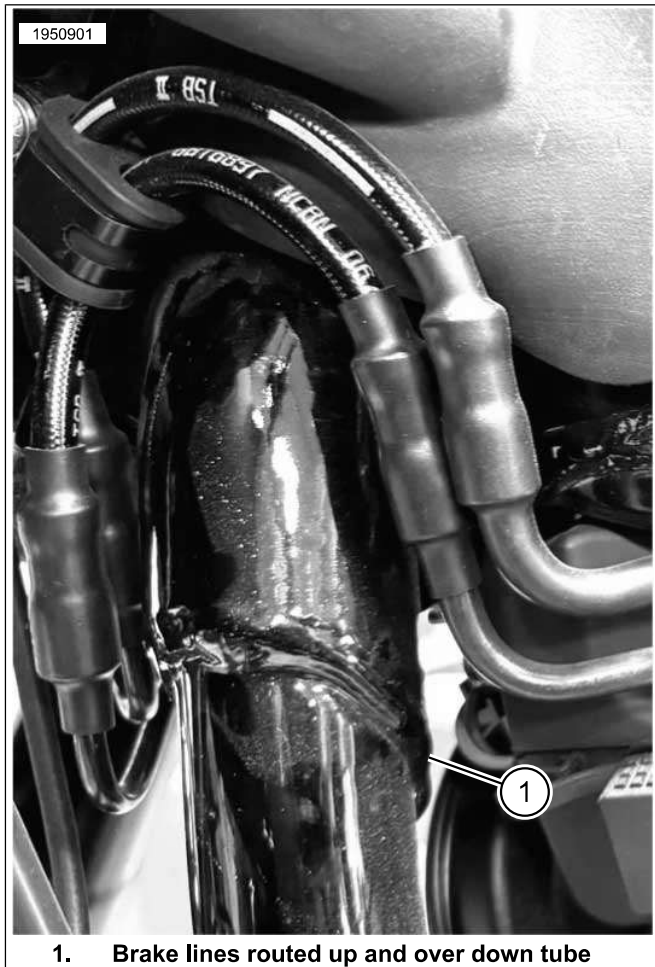
1. Brake lines routed up and over down tube
Figure 4. Correct Brake Line Routing
