Technical Service Bulletin

GROUP RECALL	NUMBER 24-01-098H
DATE DECEMBER 2024	MODEL(S) NEXO (FE)

SUBJECT: HYDROGEN TANK TPRD REPLACEMENT (RECALL 269)

This bulletin outlines the procedure to replace the existing TPRD on all 3 tanks with updated metal molten-type TPRD.

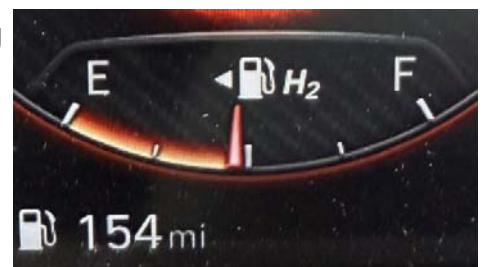
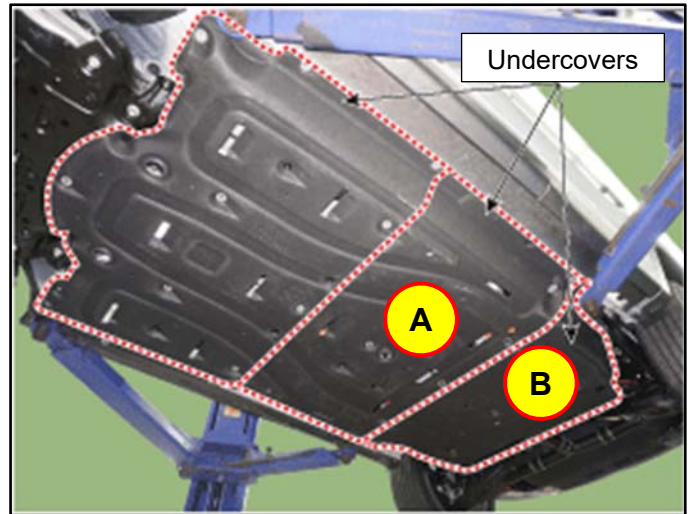
1. Raise vehicle on a hoist and remove the floor rear undercover (A), hydrogen tank front undercover (B), and rear hydrogen tank undercover (C).

Tightening Torque (Undercovers A & B):

lb-ft	5.3
lb-in	64
N.m	7.3

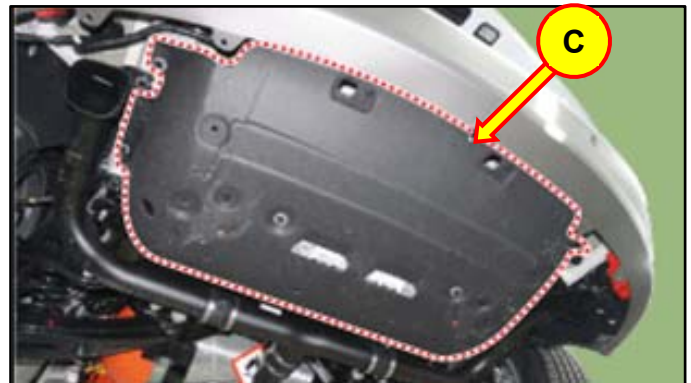
Tightening Torque (Undercover C):

lb-ft	6.4
lb-in	77
N.m	8.7

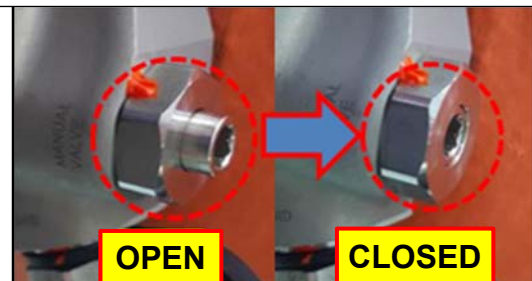
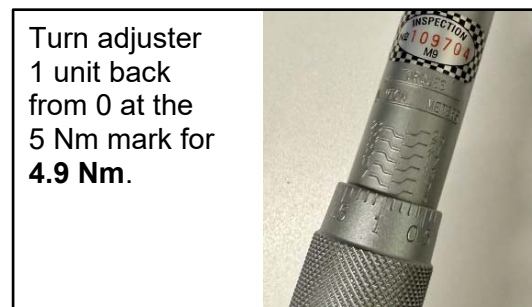
2. Close the manual valves on all 3 hydrogen tanks.
 - Using the torque wrench with the 6 mm hex/allen head socket, turn the manual valve **clockwise** until it stops at the set torque.

TIP: Turn manual valve until flush at set torque to close.

Tightening Torque (Manual Valve):

lb-ft	3.6
lb-in	43
N.m	4.9

Exceeding tightening torque specification when closing may damage the manual valve. **Do NOT over-torque.**

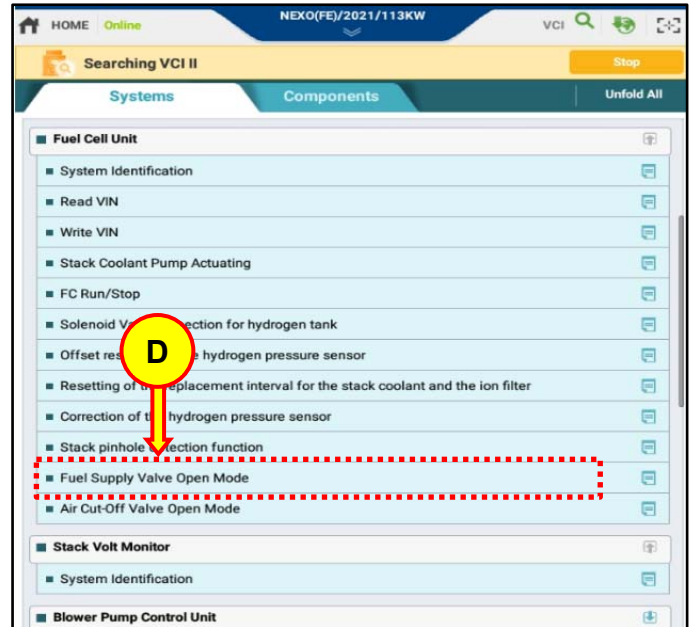
3. Refer to **TSB 23-FL-005H**, section **F. Releasing Residual Fuel Supply Pressure (GDS Procedure)**.

- Connect the GDS to Data Link Connector (DLC) with IGN ON (without pressing the brake pedal).
- Select the following: **Vehicle, Model Year, Engine, System > Vehicle S/W Management > Fuel Cell Unit > Fuel Supply Valve Open Mode (D)**.
- Perform the operation as directed by the GDS to release the residual fuel supply pressure.

If the **Fuel Supply Valve Open Mode** GDS procedure **CANNOT** be performed, then follow **TSB 23-FL-005H**, section **G. Releasing Residual Fuel Supply Pressure (Manual Procedure)** to release the residual pressure in the fuel supply line after relocating the vehicle **OUTSIDE** the shop in open air.

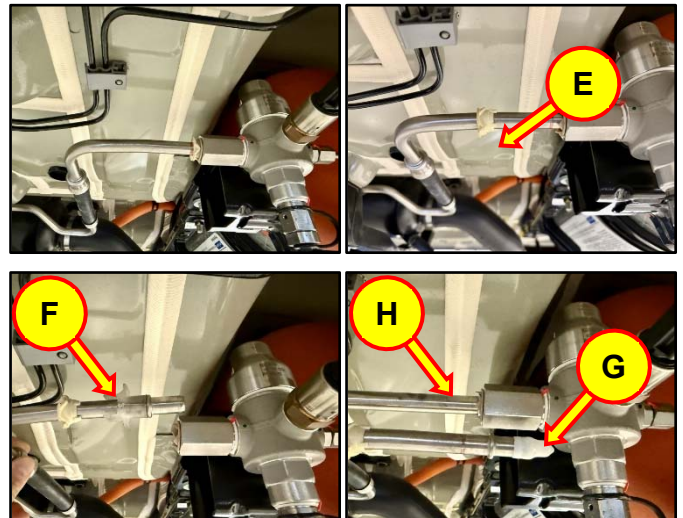
4. Refer to **TSB 23-FL-005H**, section **H. Installing the Vent Manifold Assembly**.

- Disengage the lock mechanism (E).
- Use the remover tool (F) to disconnect the hydrogen supply tube from the HPR (High Pressure Regulator).
- Seal the open end of the hydrogen supply tube with the tube cap (G) and then insert the vent manifold tube (H) to the HPR.

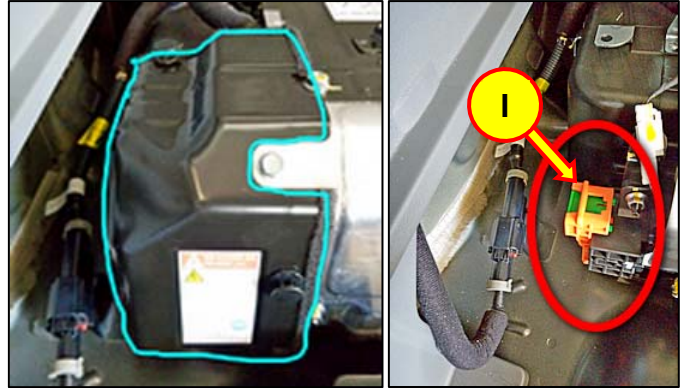
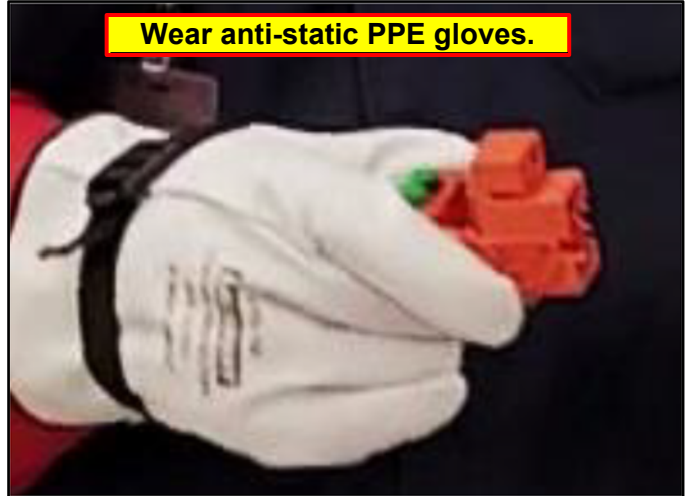
- Remove the cover shield to access the High Voltage Safety Plug (I).

Wear anti-static PPE gloves.

- Remove the HV Safety Plug as shown.

Store the removed safety plug (I) in a secure location outside and away from the vehicle.

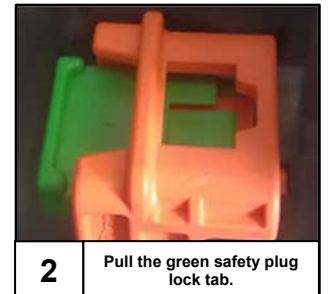
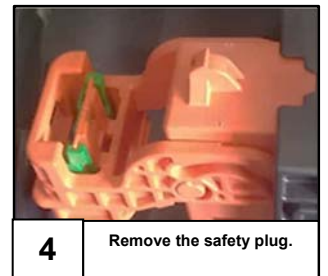
Pull the green safety plug lock tab.

Press down on the safety plug lever.

Remove the safety plug.

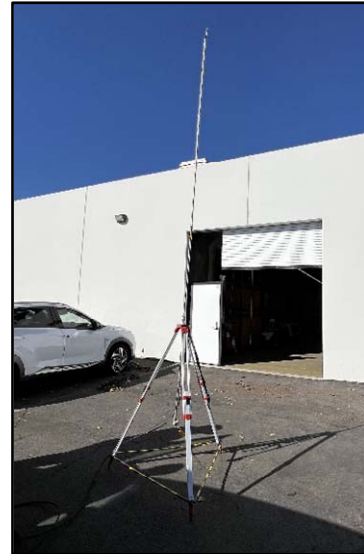
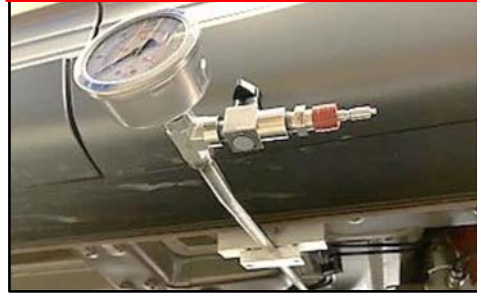
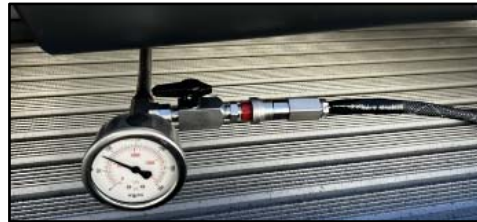
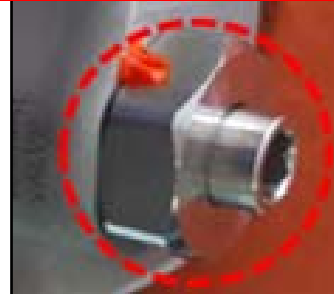
7. Refer to **TSB 23-FL-005H**, section **I. Venting the Hydrogen Tank** to fully vent all 3 hydrogen tanks **OUTSIDE** at the designated open air venting location.

- After connecting the venting SST, open the manual valves on all 3 hydrogen tanks.
- Using the torque wrench with the **6 mm** hex/allen head socket, turn the manual valves **counterclockwise** until it stops at the set torque.

Opening Torque (Manual Valve):

lb-ft	1.8
lb-in	22
N.m	2.4

Connect venting SST before opening manual valves

Reopen ALL 3 manual valves

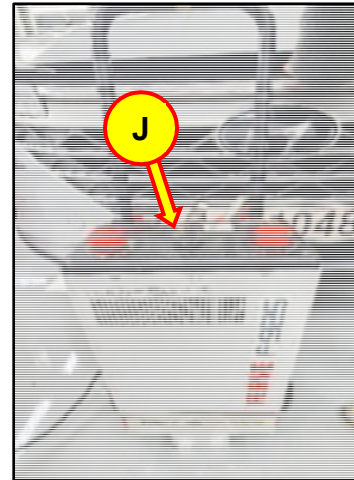
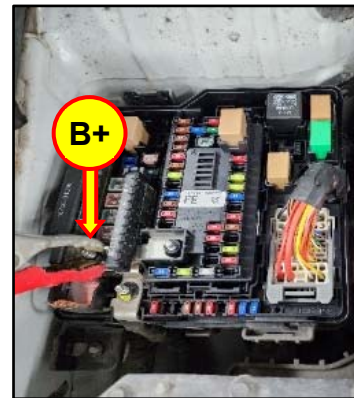
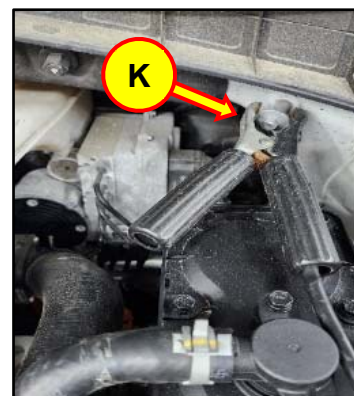
9. To provide stable 12V power during the tank venting process, connect a 12V battery booster or 12V battery charger (J) set to constant power to the front B+ and chassis ground point (K) under the hood.

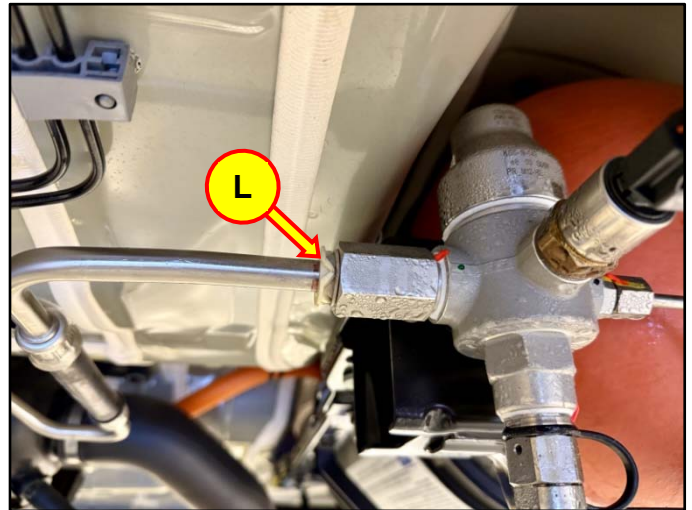
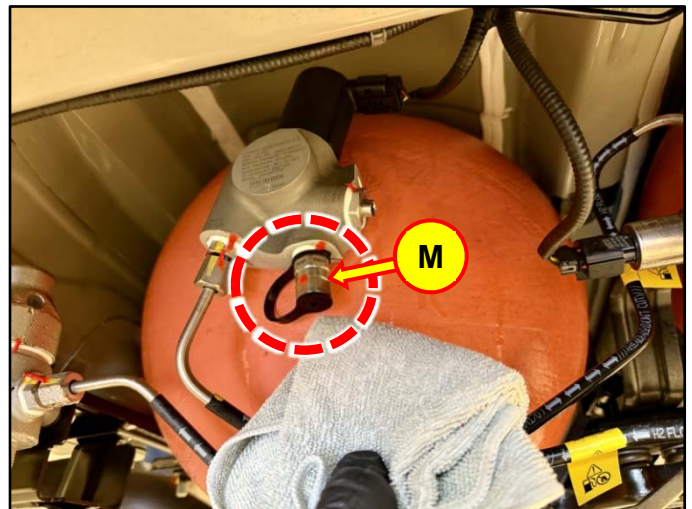
11. After all 3 hydrogen tanks have been fully vented, disconnect the venting SST from the HPR and **relocate the vehicle back inside the service bay**.
12. Raise vehicle on a hoist and reconnect the hydrogen supply tube into the HPR after removing the tube cap.
- A “click” sound can be heard after fully inserting the hydrogen supply tube to the HPR.
 - Reinstall the lock mechanism (L).
13. Using a clean lint-free cloth such as a microfiber towel (or equivalent), completely wipe all the condensation moisture from the TPRD (M) and surrounding valve area.

Repeat this step for all 3 hydrogen tanks.

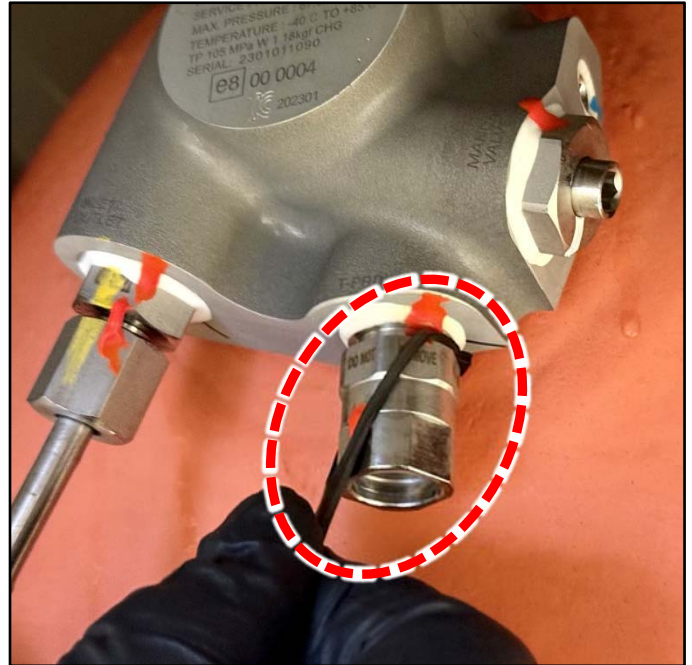
14. Pull and remove the existing TPRD cap.

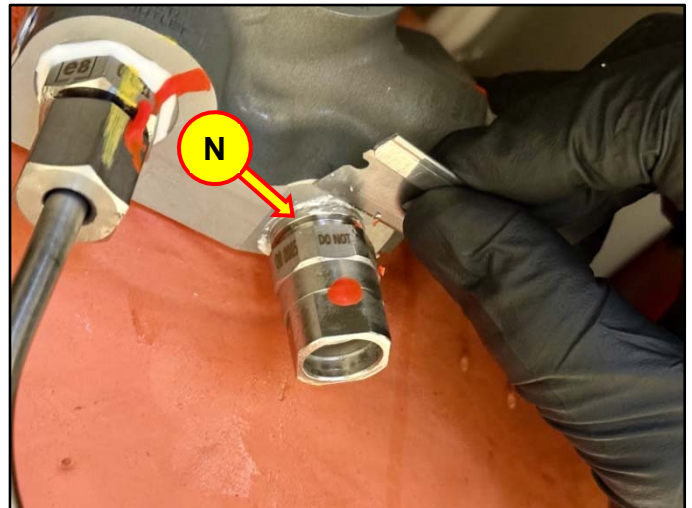
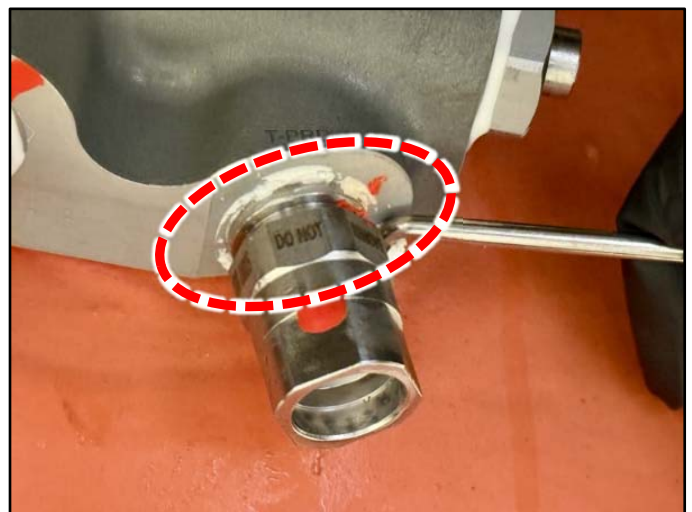
15. Using an angled pick and a flat blade, carefully remove all existing sealant from the threaded mounting areas (N) on each TPRD for all 3 tanks.

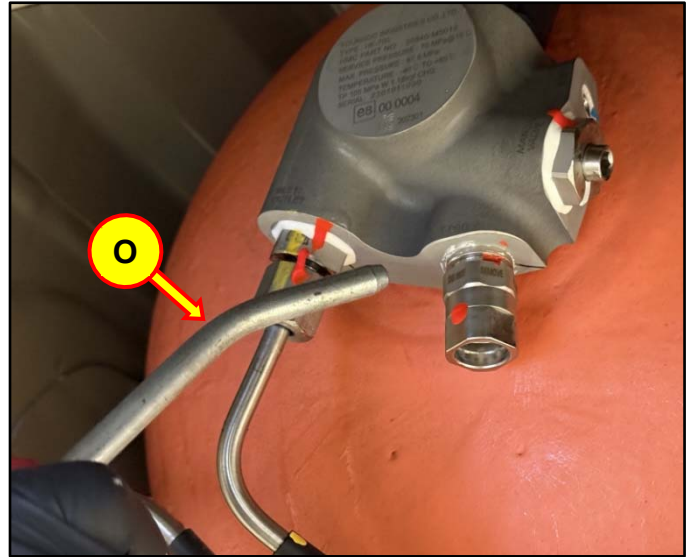
16. Use shop air and blow gun tip (O) to clear away all exterior debris for each TPRD of all 3 tanks.

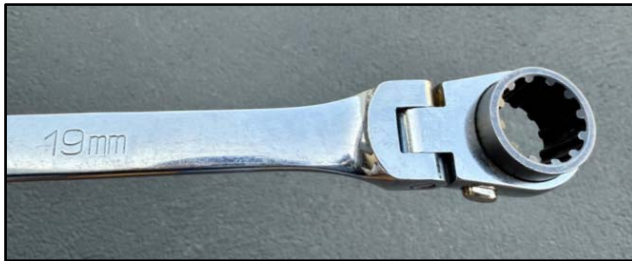
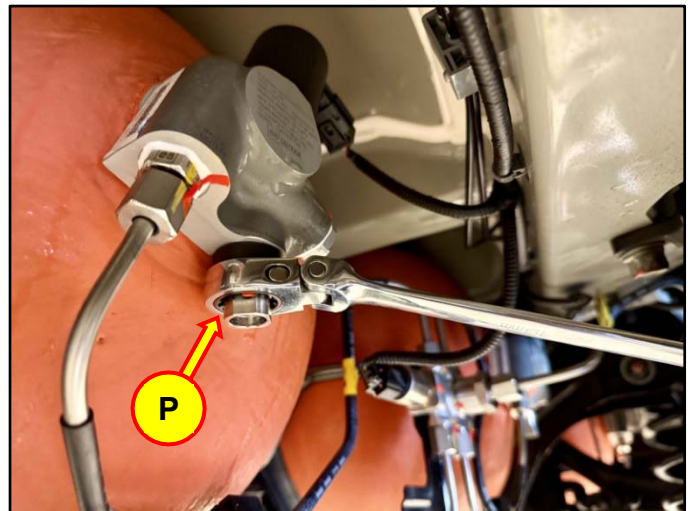
17. Using a 19 mm universal spline wrench (or equivalent), remove the TPRD (P) of the front tank.

Once the TPRD has been removed, **perform the next 3 steps within a limited time of 2 minutes to prevent contamination of the Fuel Cell tanks.**

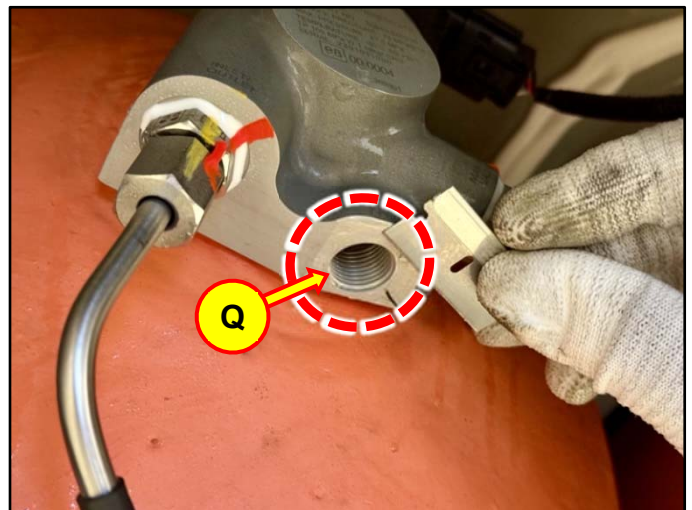
18. Using a flat blade, carefully remove any residual sealant near the threaded opening (Q) of the front tank valve body.

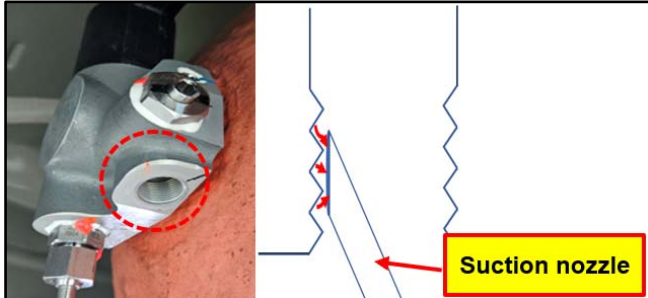
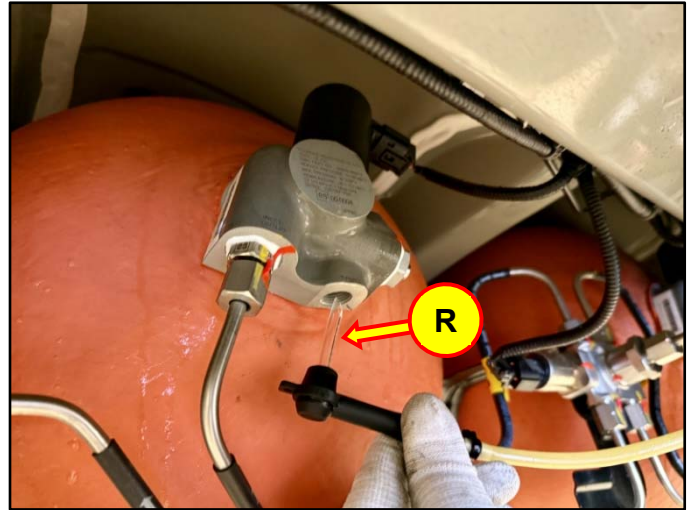
19. Remove any sealant residue from the inner threaded portion of the **front tank** valve body using the suction tool and the supplied suction nozzle (R).
- Insert the suction nozzle a maximum of 10mm into the inner threaded opening to remove any foreign debris.
 - Perform the suction as needed for a **maximum time of 30 seconds** to clear any debris.

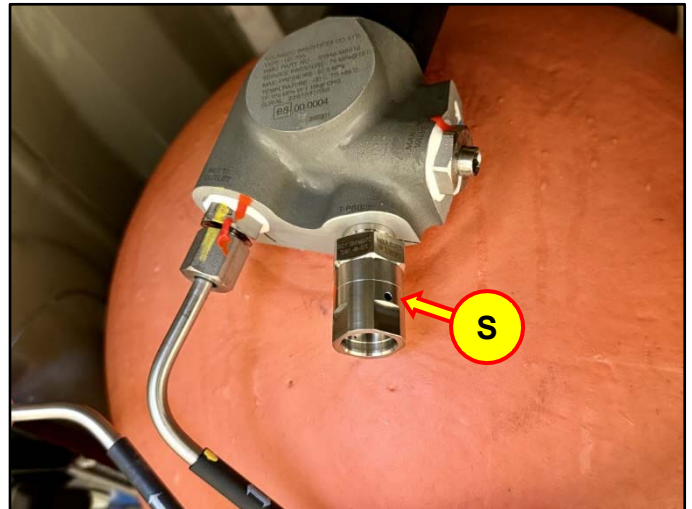
20. Hand thread a new TPRD (S) to the **front tank**.

- A **maximum** time of **2 minutes** should **NOT** be exceeded when the existing TPRD was removed at the end of step 17 up to this point.
- To avoid contamination, **do NOT** allow any hydrogen tanks to remain open to the atmosphere for an extended period.

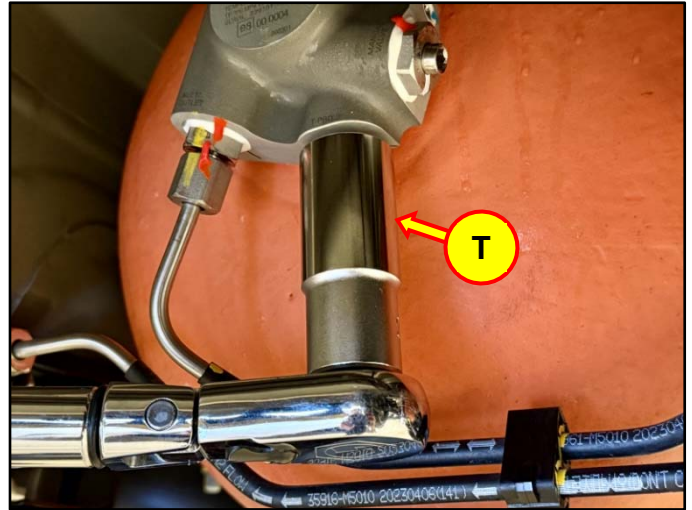
21. Using the supplied **23 mm** deep $\frac{1}{2}$ " drive socket (T), tighten the new TPRD to the specified torque.

Tightening Torque (TPRD):

lb-ft	56
N.m	77

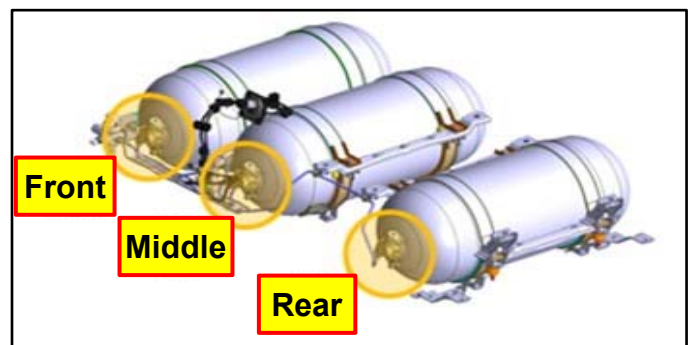
22. Repeat steps 17 through 21 for the **middle tank**.

Repeat steps 17 through 21 for the **rear tank**.

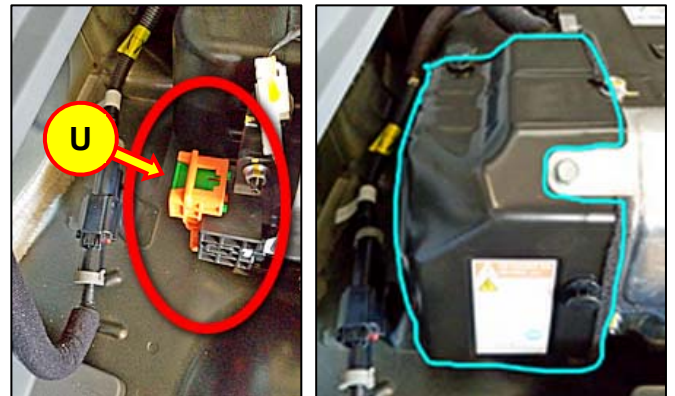
23. Reconnect the high voltage circuit.

- Reinstall the HV Safety Plug (U).
- Reinstall the cover shield.

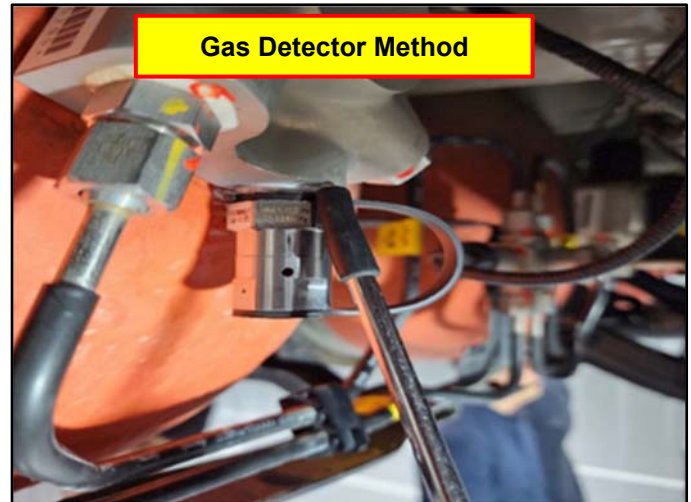
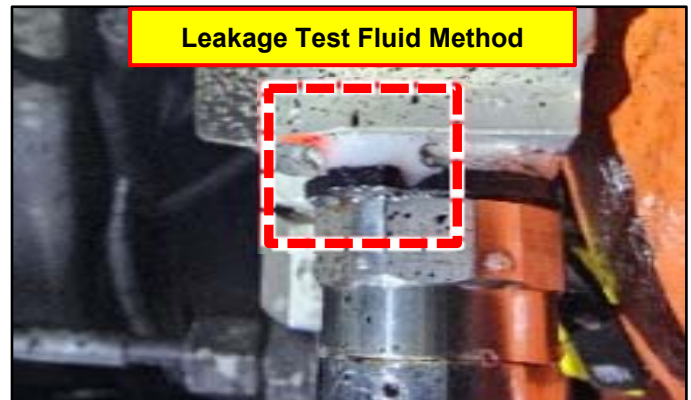
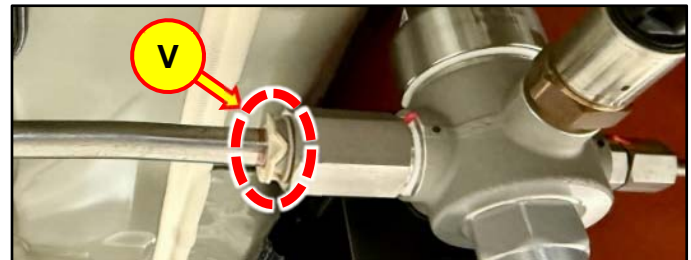
29. Completely wipe off the leakage test fluid and fully dry the exposed threaded area of the TPRD and valve body.

30. Apply Threebond 1211 sealant to the surrounding thread of the TPRD (W) and valve body of the tank.

This will help create a barrier from outside contamination.

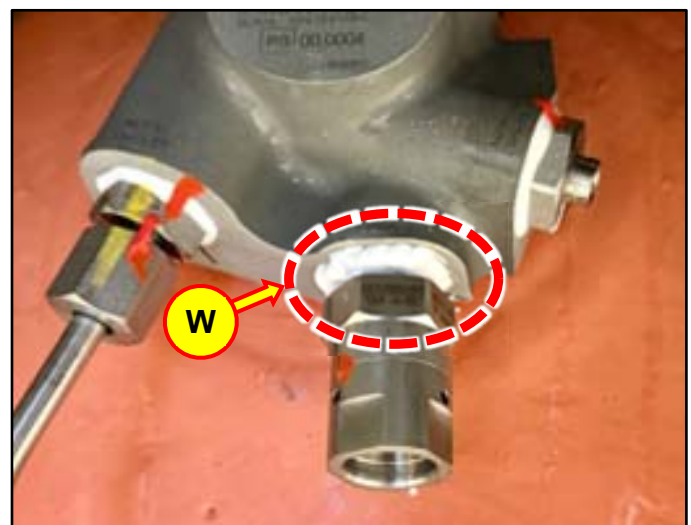
Repeat this step for each TPRD of all 3 tanks.

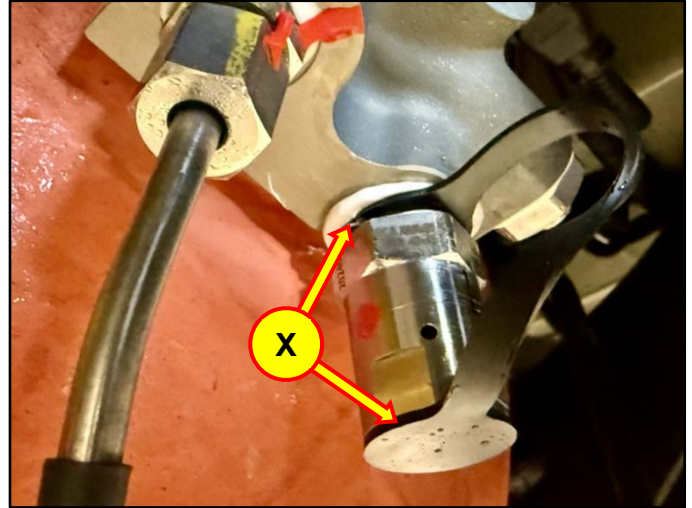
31. Install the TPRD cap (X).

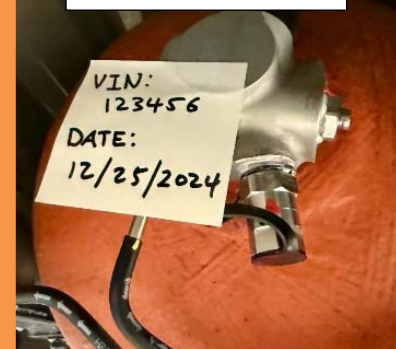
Sample STUI Photo 1

Using STUI, take a total of 3 photos of all 3 newly installed TPRD with the last 6 digits of VIN and date of repair on a piece of paper. Ensure the pictures are in focus and VIN with date of repair are legible. Upload the photos to STUI.
