SAFETY RECALL CAMPAIGN 3A04

2022 - 2024 Hayabusa Front Brake Master Cylinder Parts Replacement

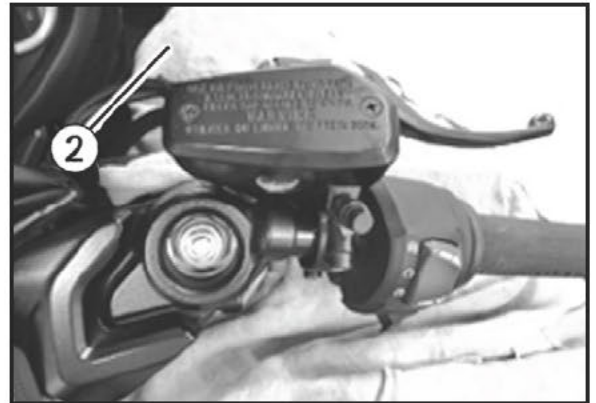
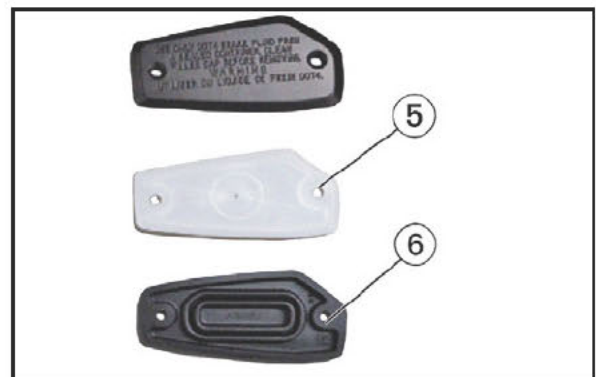
Remove the Front Brake Master Cylinder:

1. Turn the ignition switch OFF.
2. Record the position of the brake lever adjuster ①.
3. Position the motorcycle on a level surface and adjust the handlebars so the front brake master cylinder is level.
4. Place a clean absorbent cloth ② underneath the master cylinder as shown in the image at right. This helps prevent brake fluid from getting on other parts if it is spilled or splashed during the repair.
5. Remove the reservoir cap screws ③, the reservoir cap ④, and the plate ⑤, and diaphragm ⑥ from the front brake master cylinder.

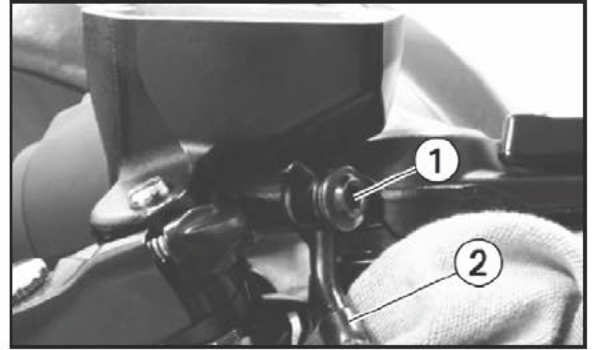
- Unscrew and remove the brake hose union bolt ① and disconnect the brake hose ② from the front brake master cylinder.

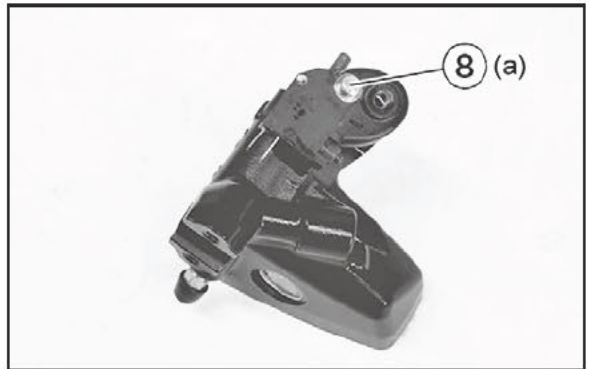
4. Tighten the front brake light switch screw ⑧ to the specified torque.

**Tightening torque - Brake light switch screw (a):**
0.90 lb-ft (1.2 N.m, 0.12 kgf-m)
