SAFETY RECALL CAMPAIGN 3A04

222 - 2024 Hayabusa Front Brake Master Cylinder Parts Replacement

- Affected Models:** 2022 ~ 2024 Hayabusa (GSX1300R_M2~M4) motorcycles
- Affected Departments:** Management, Service, Warranty, Sales, Parts, Accessories
- Attachments:** [Sales Bulletin 24-097](#) (Hayabusa Stop Sales) & Customer Notification Letter
- Reference:** [Hayabusa GSX1300R Service Manual](#) (99500-10L00-03E), & [Service Bulletin GS/GSX/GSX-R No. 259](#) (2022 Hayabusa Front Brake Master Cylinder Body Replacement Recall 2A99)

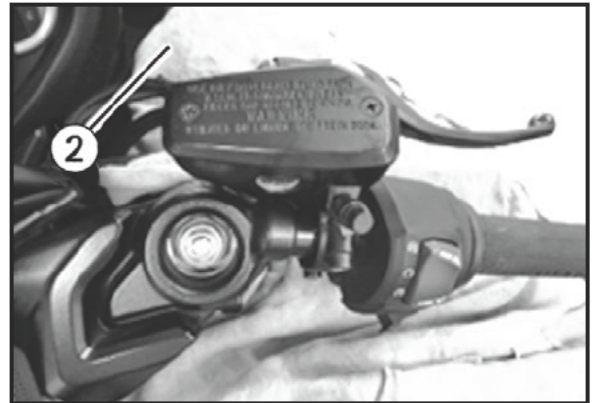
1. Turn the ignition switch OFF.
2. Record the position of the brake lever adjuster ①.
3. Position the motorcycle on a level surface and adjust the handlebars so the front brake master cylinder is level.
4. Place a clean absorbent cloth ② underneath the master cylinder as shown in the image at right. This helps prevent brake fluid from getting on other parts if it is spilled or splashed during the repair.
5. Remove the reservoir cap screws ③, the reservoir cap ④, and the plate ⑤, and diaphragm ⑥ from the front brake master cylinder.

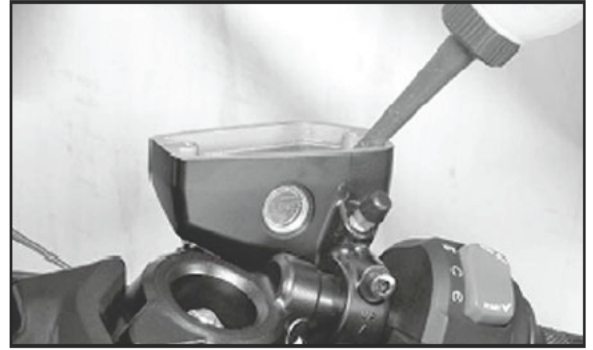
- Using a syringe or squeeze bottle, suck up as much of the brake fluid out of the reservoir as possible.

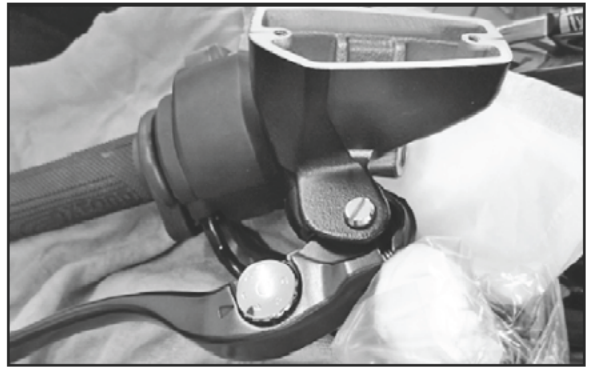
Cover the end of the disconnected brake hose with a plastic bag and tie it closed with a rubber band or twist tie to prevent brake fluid from spilling out from the brake hose.

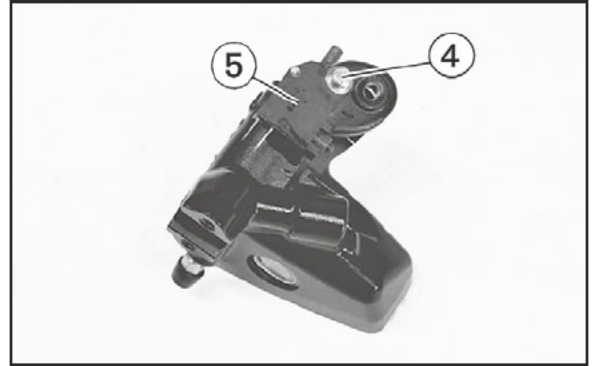
2. Remove the front brake light switch screw ④ and the front brake light switch ⑤ from the master cylinder body.

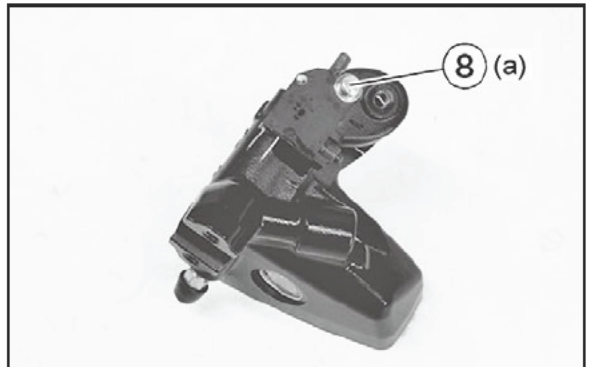
4. Tighten the front brake light switch screw ⑧ to the specified torque.

**Tightening torque - Brake light switch screw (a):**
0.90 lb-ft (1.2 N.m, 0.12 kgf-m)
