SAFETY RECALL CAMPAIGN 3A04

2022 - 2024 Hayabusa Front Brake Master Cylinder Parts Replacement

Affected Models:	2022 ~ 2024 Hayabusa (GSX1300R_M2~M4) motorcycles
Affected Departments:	Management, Service, Warranty, Sales, Parts, Accessories
Attachments:	Sales Bulletin 24-097 (Hayabusa Stop Sales) & Customer Notification Letter
Reference:	Hayabusa GSX1300R Service Manual (99500-10L00-03E), & Service Bulletin GS/GSX/GSX-R No. 259 (2022 Hayabusa Front Brake Master Cylinder Body Replacement Recall 2A99)

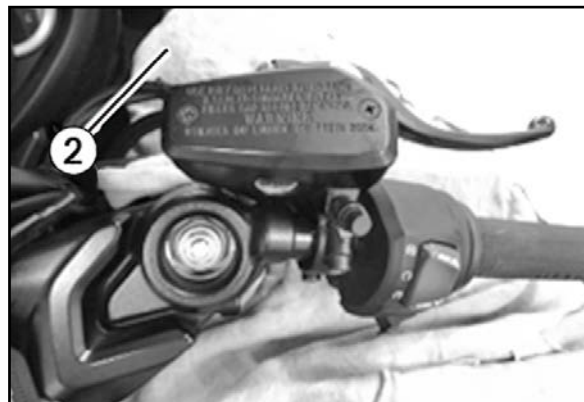
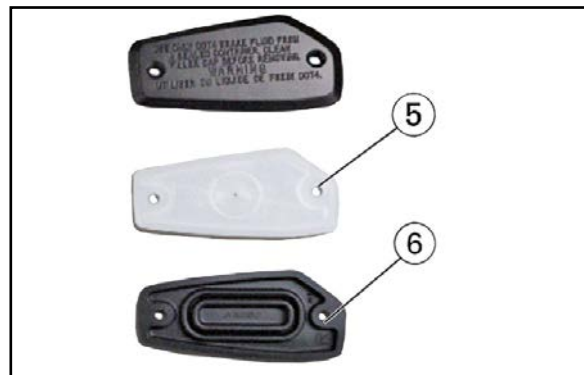
Remove the Front Brake Master Cylinder:

1. Turn the ignition switch OFF.
2. Record the position of the brake lever adjuster ①.
3. Position the motorcycle on a level surface and adjust the handlebars so the front brake master cylinder is level.
4. Place a clean absorbent cloth ② underneath the master cylinder as shown in the image at right. This helps prevent brake fluid from getting on other parts if it is spilled or splashed during the repair.
5. Remove the reservoir cap screws ③, the reservoir cap ④, and the plate ⑤, and diaphragm ⑥ from the front brake master cylinder.

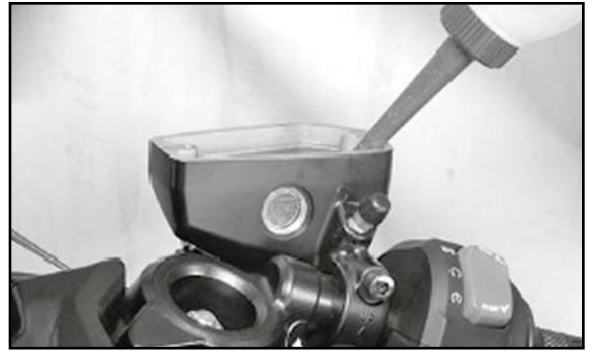
6. Using a syringe or squeeze bottle, suck up as much of the brake fluid out of the reservoir as possible.

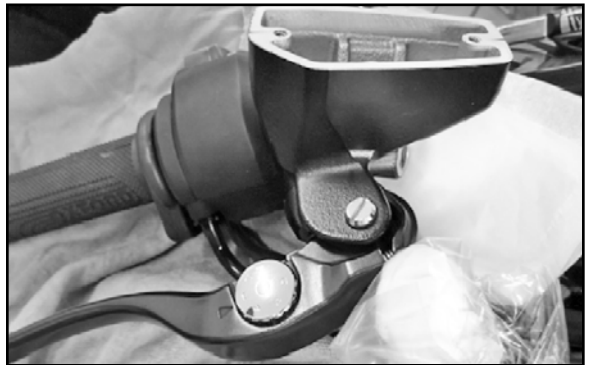
Cover the end of the disconnected brake hose with a plastic bag and tie it closed with a rubber band or twist tie to prevent brake fluid from spilling out from the brake hose.

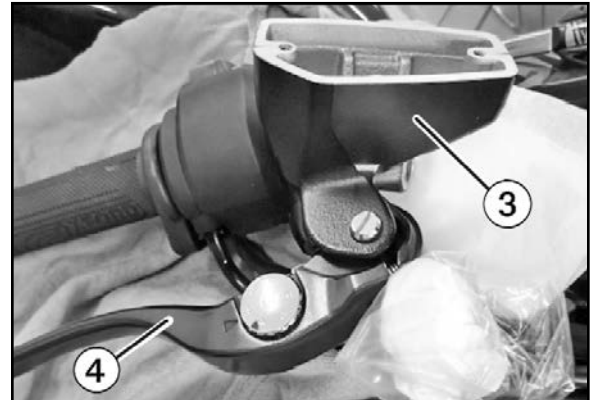
10. Remove the front brake master cylinder ③ and the front brake lever ④ as an assembly..

When removing and handling the front brake master cylinder, take care to not spill the brake fluid still in the reservoir.

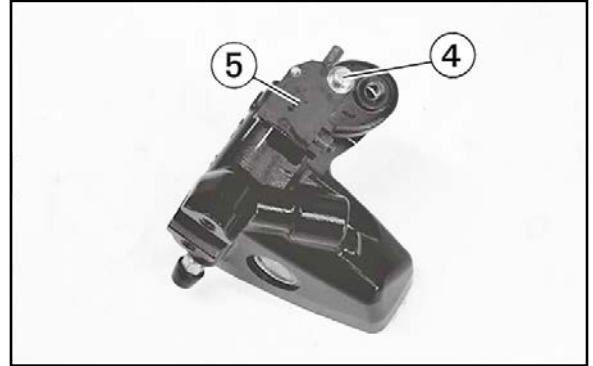
2. Remove the front brake light switch screw ④ and the front brake light switch ⑤ from the master cylinder body.

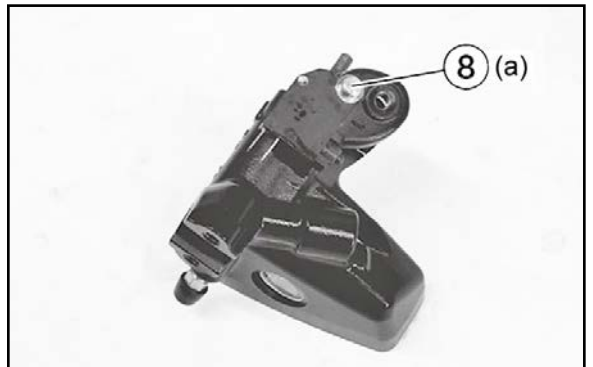
4. Tighten the front brake light switch screw ⑧ to the specified torque.

**Tightening torque - Brake light switch screw (a):**
0.90 lb-ft (1.2 N.m, 0.12 kgf-m)

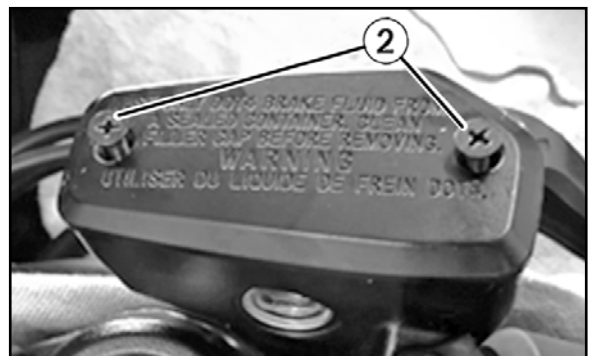
3. Install the reservoir cap and lightly hand thread the reservoir cap screws ② in to hold the cap in place.

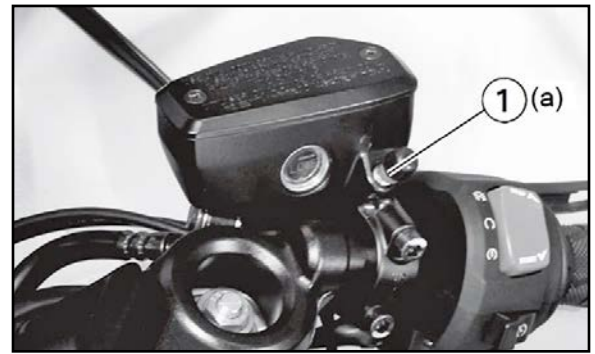
Front brake master cylinder air bleeder valve (a):
4.45 lb-ft (6.0 N.m, 0.61 kgf-m)
