SAFETY RECALL CAMPAIGN 3A04

2022 - 2024 Hayabusa Front Brake Master Cylinder Parts Replacement

Suzuki Motor Corporation is initiating a safety recall campaign to replace parts in the front brake master cylinder.

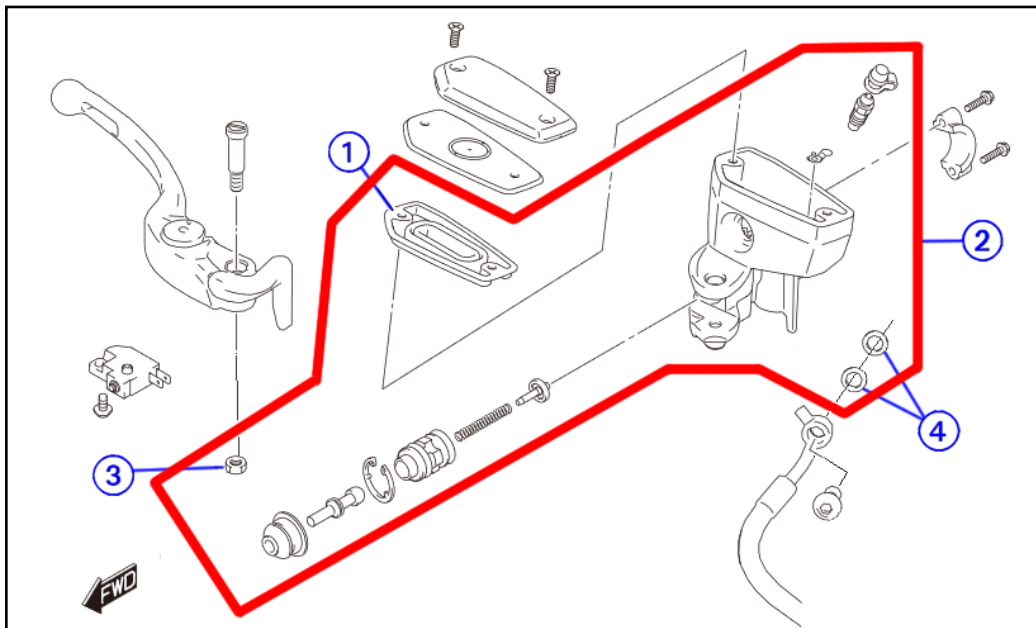
Recall service parts:

Part Name	Part Number	Quantity	Includes
PARTS SET, FR MASTER CYLINDER	59600-10870-RX0	1	DIAPHRAGM, R (59667-23H10-RX0) x 1 ①
			CYLINDER SET, FRONT MASTER (59601-10LA0-RX0) x 1 ②
			NUT (08319-2106A) x 1 ③
			WASHER (09161-10009) x 2 ④

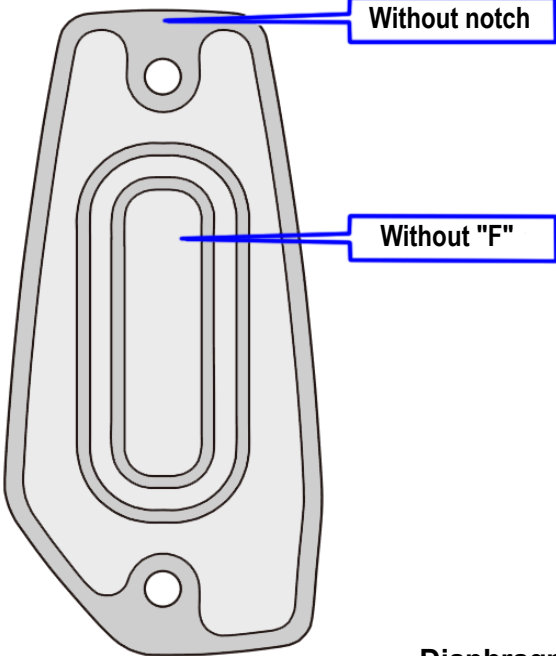
Existing (original) Parts	New (countermeasure) Parts
<ul style="list-style-type: none">• 59667-23H00

<p style="text-align: right;">Diaphragm</p>	<ul style="list-style-type: none">• 59667-23H10-RX0

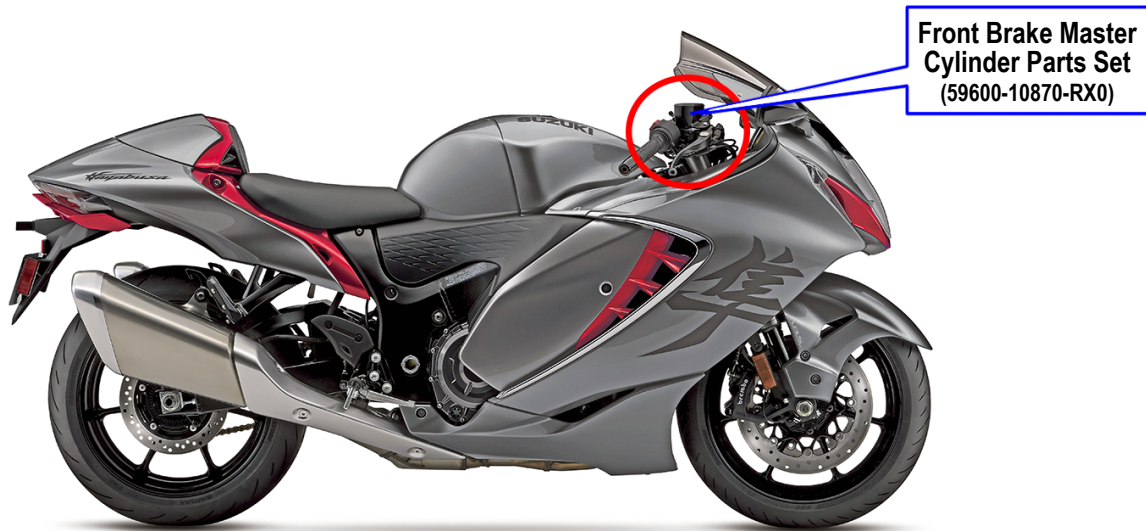
- Follow the repair procedure listed on the following pages to replace the front brake master cylinder parts set and the diaphragm of the front brake master cylinder assembly. You will also replenish the brake fluid and bleed any air from the brake system.

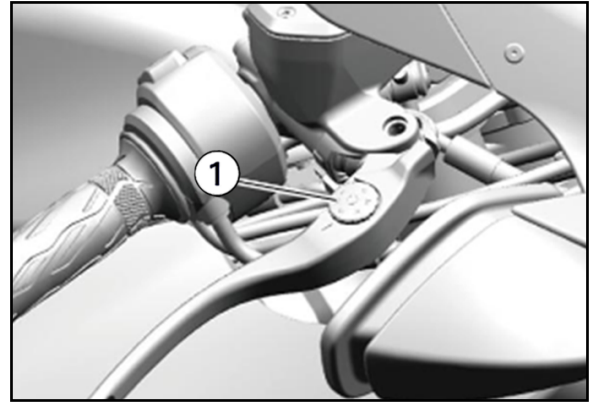
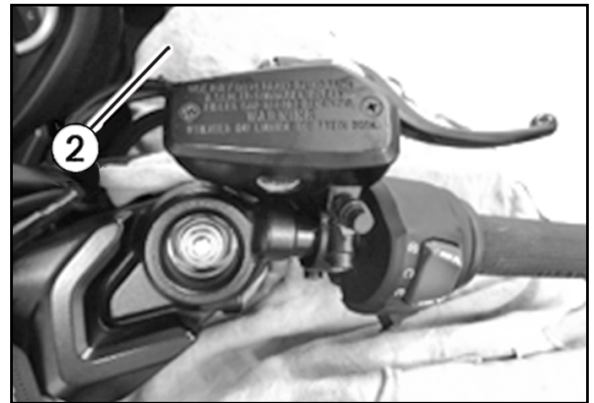
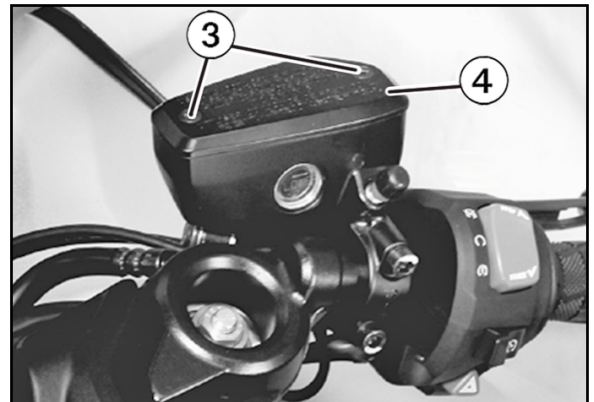
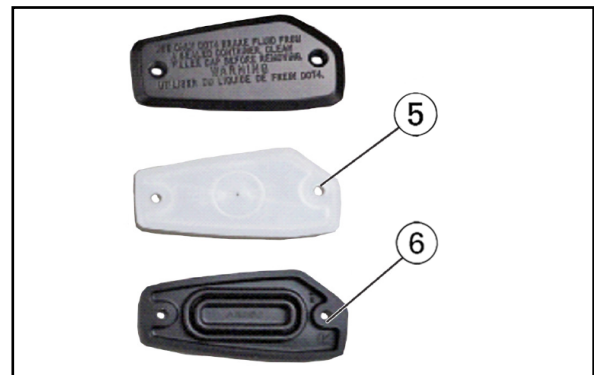
Remove the Front Brake Master Cylinder:

1. Turn the ignition switch OFF.
2. Record the position of the brake lever adjuster ①.
3. Position the motorcycle on a level surface and adjust the handlebars so the front brake master cylinder is level.
4. Place a clean absorbent cloth ② underneath the master cylinder as shown in the image at right. This helps prevent brake fluid from getting on other parts if it is spilled or splashed during the repair.
5. Remove the reservoir cap screws ③, the reservoir cap ④, and the plate ⑤, and diaphragm ⑥ from the front brake master cylinder.

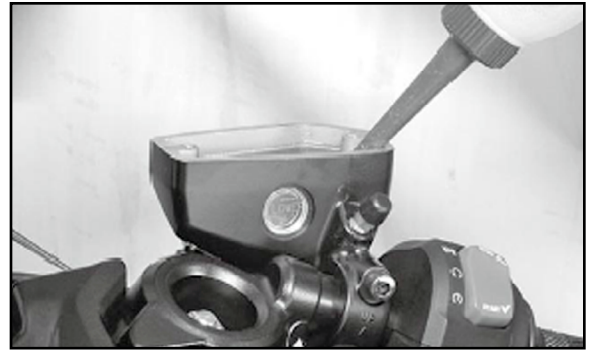
- Using a syringe or squeeze bottle, suck up as much of the brake fluid out of the reservoir as possible.

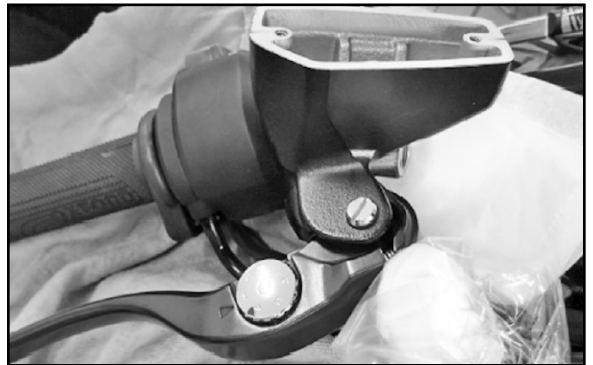
Cover the end of the disconnected brake hose with a plastic bag and tie it closed with a rubber band or twist tie to prevent brake fluid from spilling out from the brake hose.

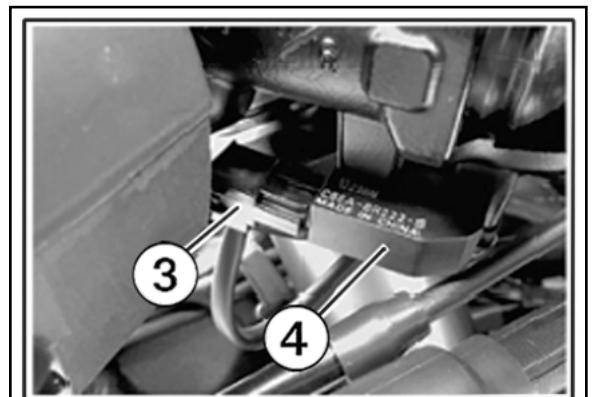
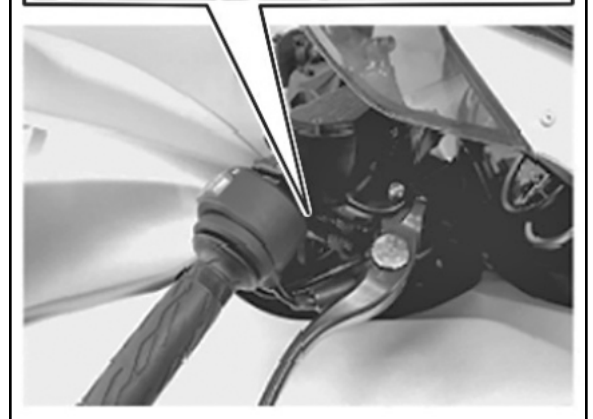
- Disconnect the front brake light switch lead wire coupler ③ from the front brake light switch ④.

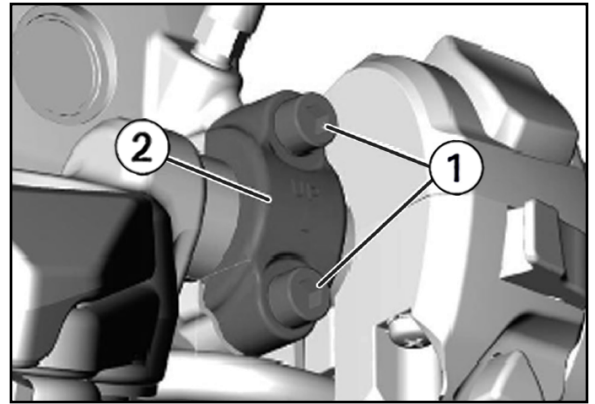
9. Remove the master cylinder holder bolts ①, and then remove the master cylinder holder (clamp) ②.

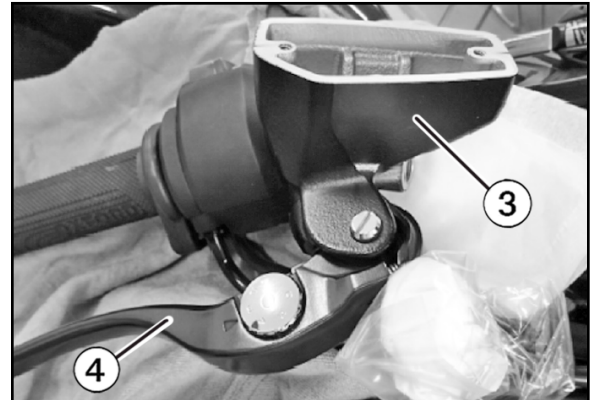
10. Remove the front brake master cylinder ③ and the front brake lever ④ as an assembly..

When removing and handling the front brake master cylinder, take care to not spill the brake fluid still in the reservoir.

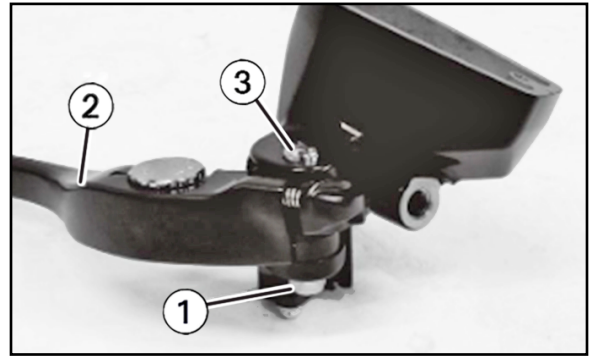
1. Remove the brake lever pivot lock nut ①, bolt, ②, and brake lever ③.

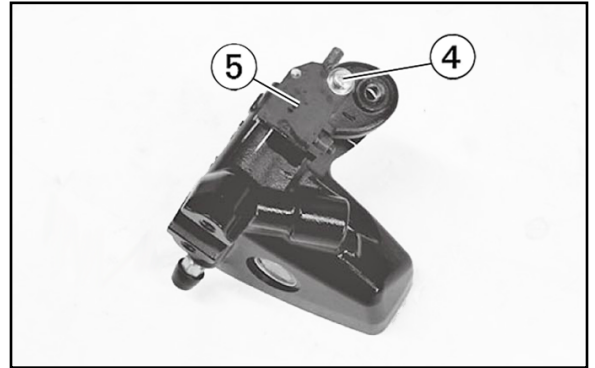
2. Remove the front brake light switch screw ④ and the front brake light switch ⑤ from the master cylinder body.

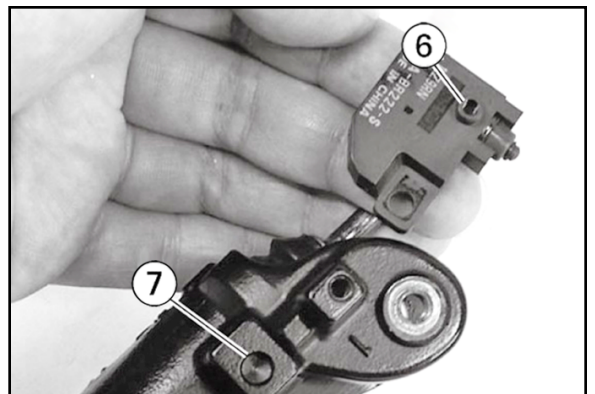
3. Align the protrusion ⑥ of front brake light switch with the hole ⑦ of the new front brake master cylinder, and then install the front brake light switch.

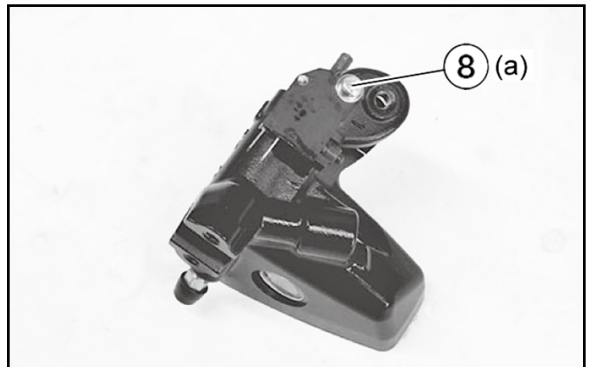
4. Tighten the front brake light switch screw ⑧ to the specified torque.

**Tightening torque - Brake light switch screw (a):**
0.90 lb-ft (1.2 N.m, 0.12 kgf-m)

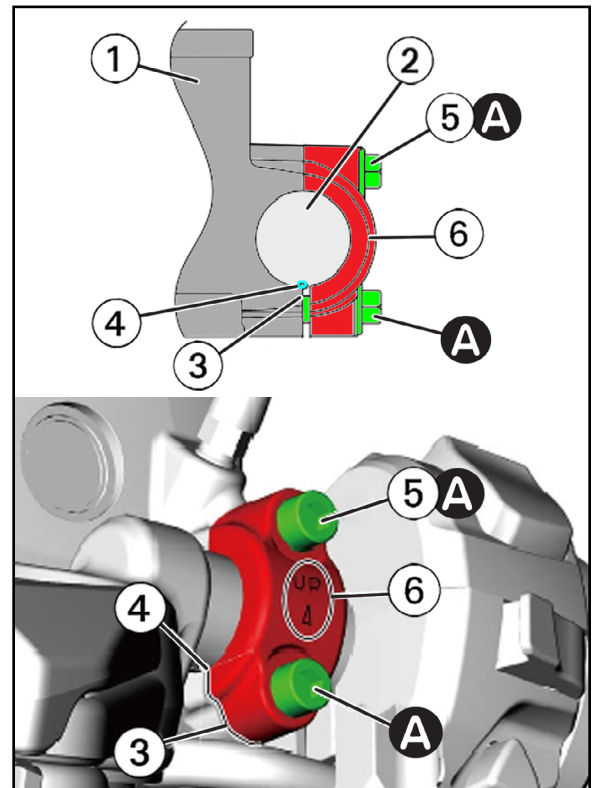
Installation of the Front Brake Master Cylinder:

1. Install the new front brake master cylinder ① and front brake lever as an assembly onto the handlebar ②, paying attention to the following points:
 - Align the edge ③ of the master cylinder body with the punch mark ④ on the handlebar ②.
 - Tighten the upper front brake master cylinder holder bolt ⑤ to the specified torque first, and then tighten the lower bolt to the specified torque.

Tightening torque - Brake hose union bolt (a):
17 lb-ft (23 N.m, 2.3 kgf-m)

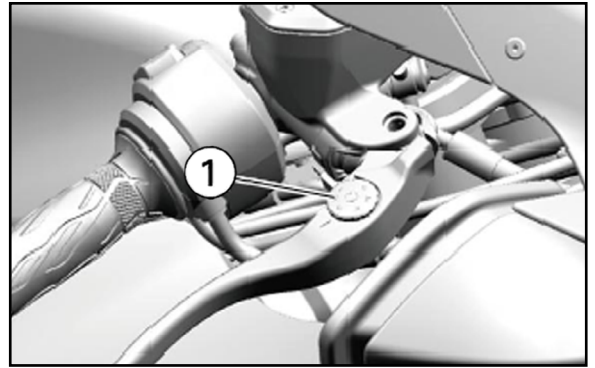
Brake Fluid Replacement & Air Bleeding of the Front Brake:

1. Verify that the brake lever adjuster ① is set in the #3 position.

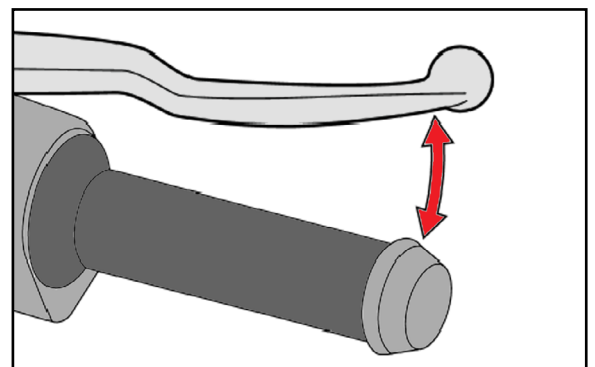
5. Squeeze the brake lever several times and, while holding the lever as close to the hand grip as possible, loosen the front brake master cylinder air bleeder valve ④ to drain the brake fluid and air into the receptacle.
6. Tighten the master cylinder air bleeder valve ④ and slowly release the brake lever.
7. Repeat steps 5 and 6 until the brake fluid is flowing out of the tube with no air bubbles present.

While bleeding the brake system, replenish the reservoir with brake fluid as necessary to keep the fluid at the proper level "a".

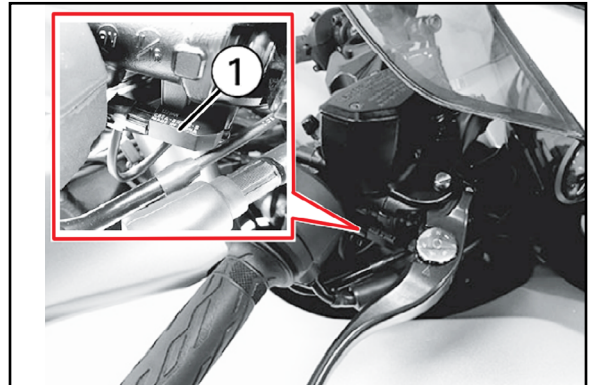
4. Verify that the brake light illuminates when you operate the front brake lever (when the ignition is switched ON). If the brake lamp does not function correctly, make sure the front brake light switch ① and its electrical coupler and properly connected. If they are, check the taillight's connection under the passenger seat.

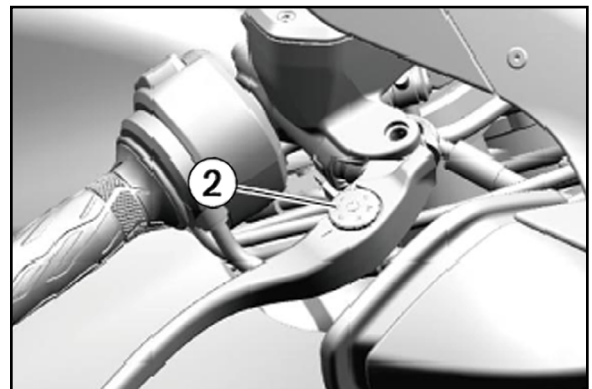
5. Reset the brake lever adjuster ② to the same position that was recorded during the recall service ([page 10, step 1](#)).
6. Test ride the motorcycle on a dry, paved road and operate the front brake to make sure is braking performance is proper. During the test ride, watch for any abnormal operation and listen for any unusual sounds and resolve them before returning the motorcycle to the customer.
7. Clean the motorcycle with special attention to areas where the recall service was performed. When delivering the motorcycle to the customer, explain the recall service and thank them for their patience.
