RECALL 24V771 / 2024-610 REMEDY INSTRUCTIONS

FOREST RIVER	Make(s): MANY, SEE BELOW Model(s): MANY, SEE BELOW Model Year(s): MANY, SEE BELOW	Repair Code: RC-048-09-00-004724 Allotted Time: 1.00 HRS – PER A/C Inspection Code: RC-048-05-00-004725 Allotted Time: .25 HRS – PER A/C
	Concern: The GE “Soft Start” add-on component to the air conditioner may cause a fire.	Photo(s) Required: YES – SEE GE DOC. Prior Authorization Required: YES Part(s) Kit Number: 24E-071X Part(s) Return: N/A – FIELD DESTROY

Service Bulletin

PL59-25

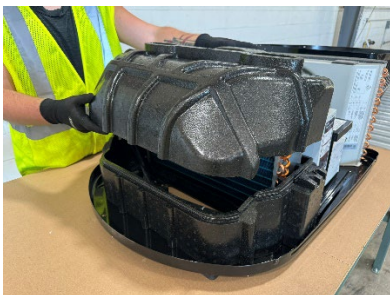
3. Lift upper foam to separate.

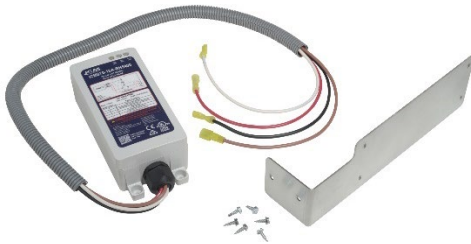
8. Remove & discard prior soft start parts.

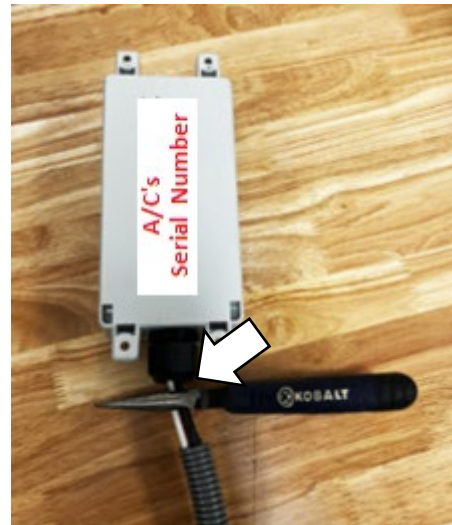
9. To document the destruction of the recalled soft start:

- a. Cut off the wire harness as close as possible to the soft start housing, as shown.
- b. Write the serial number from the air conditioner onto the soft start housing.
- c. Take picture of soft start with the cut cord and A/C's serial number

- d. Send picture documenting removal and destruction of recalled unit to RecreationalLiving-warranty@geappliances.com

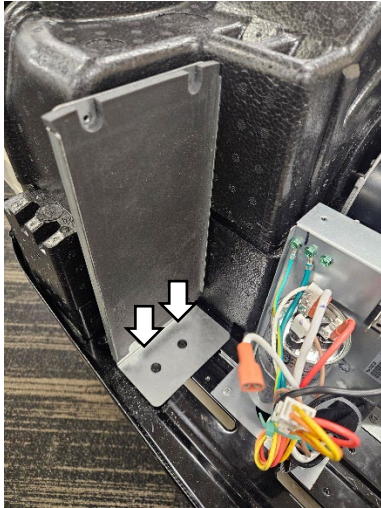
1. Using $\frac{5}{16}$ " driver, install new soft start bracket and foam assembly to the base pan using two of the provided screws.

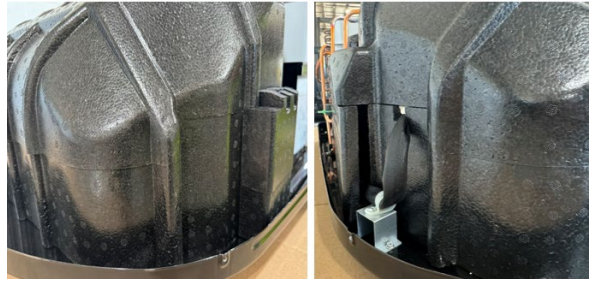
6. Reassemble foam. Inspect all sides for proper alignment

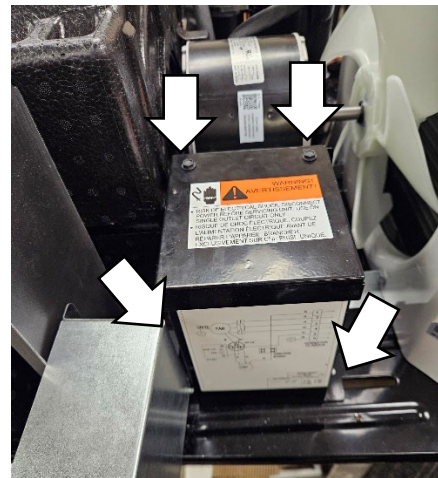
7. Reassemble electrical enclosure using four retained Phillips head screws.

IMPORTANT: Make sure not to pinch any wires during reassembly.

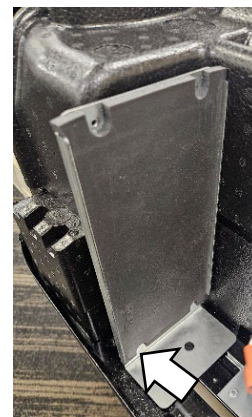
8. Partially drive lower soft start retention screw.

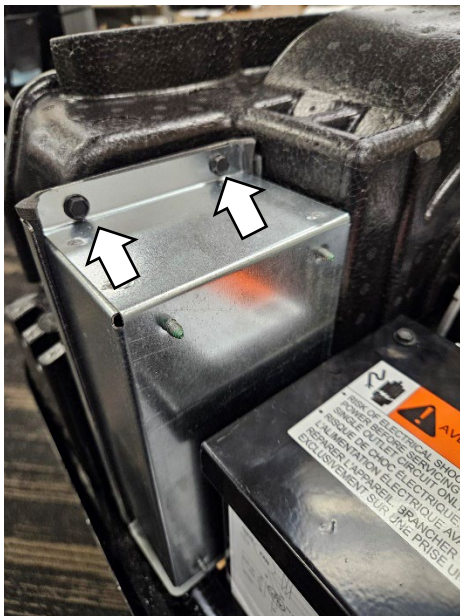
10. Install two provided screws to top of soft start enclosure and fully tighten, then fully tighten bottom screw from prior step.
