SIB 65 30 24

RECALL 24V-772: PASSENGER AIR BAG

This Service Information Bulletin (Revision 2) replaces SI B65 30 24 **dated October 2024**.

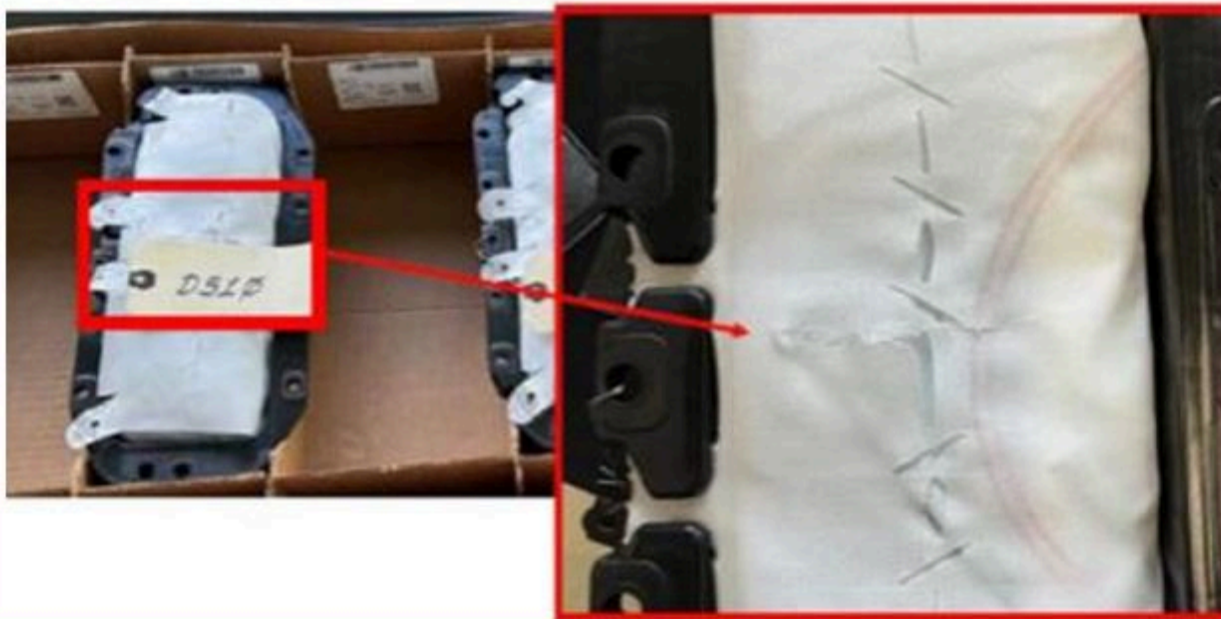
During supplier handling, the front passenger air bag may have become damaged.

Damage to the air bag due to opening the packaging with an unsuitable tool

The front passenger's side air bag will be replaced.

Replace the front passenger air bag. Follow repair instructions **REP 72 12 000** “Removing and installing/replacing the airbag module on the passenger's side”. A copy of these repair instructions is attached to this bulletin.

Caution: Only open the packaging with a suitable (blunt) tool, so that the air bag material of the front passenger air bag is not damaged.

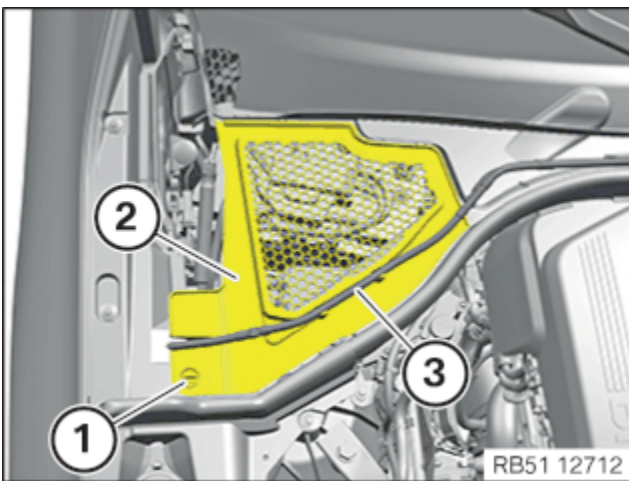
Remove the cover of the rear right engine compartment

- Unclip the line (3).
- Loosen the lock (1).
- Remove the cover (2).

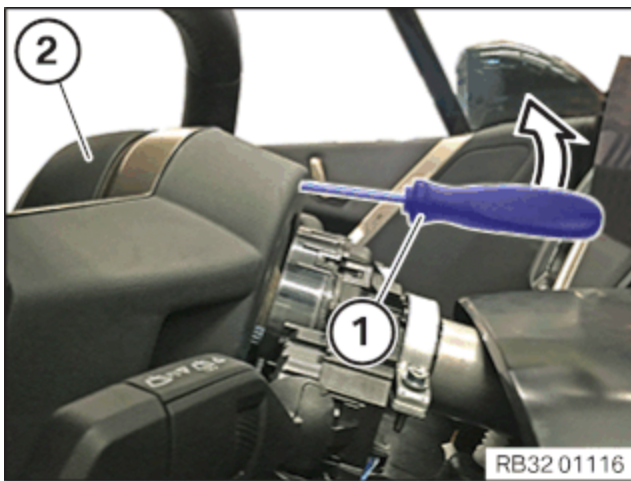
- Insert Torx screwdriver T25 (1) on the rear side of the steering wheel into opening (2) about 35 mm deep upwards at an angle.

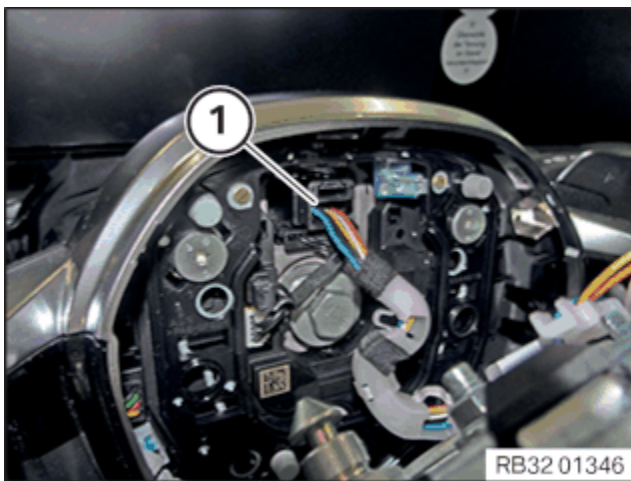
- Using the upward lever movement of Torx screwdriver (1), unlock and remove airbag unit (2).

- Disconnect plug connection (1) and remove the airbag unit.

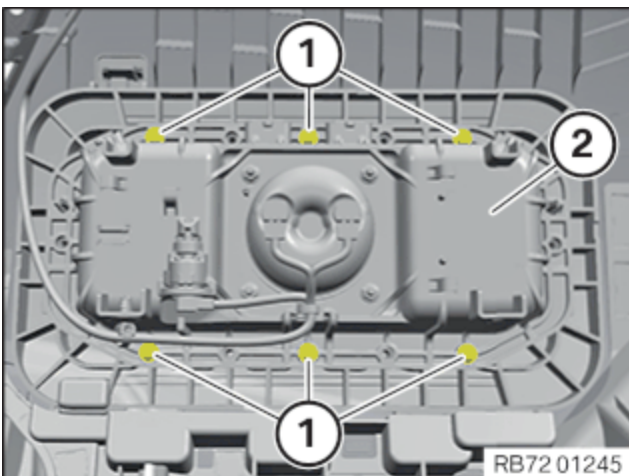
- **Case 1:** *Front passenger airbag is attached with 6 screws.*
- Loosen screws (1).
- Carefully remove front passenger airbag (2).

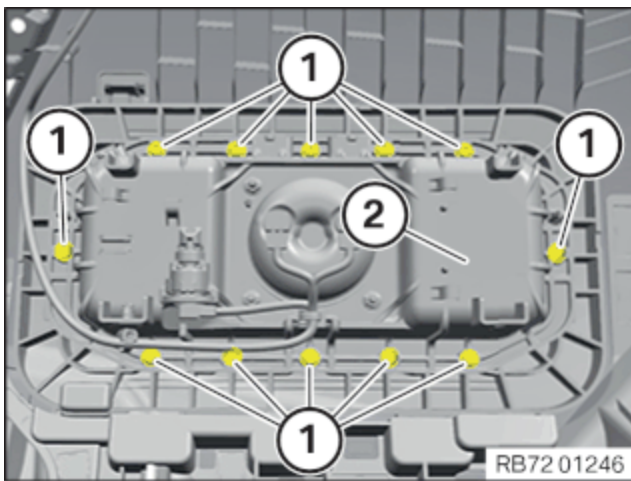
- **Case 2:** *Front passenger airbag is attached with 12 screws.*
- Loosen screws (1).
- Carefully remove front passenger airbag (2).

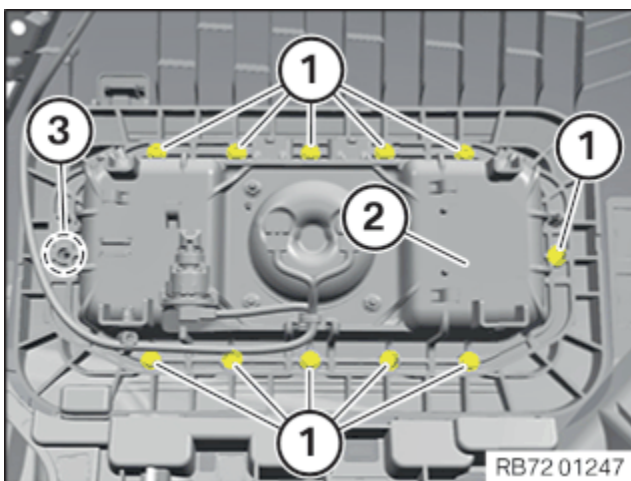
- **Case 3:** *Front passenger airbag is attached with 11 screws.*

- Loosen screws (1).
- Remove front passenger airbag (2).

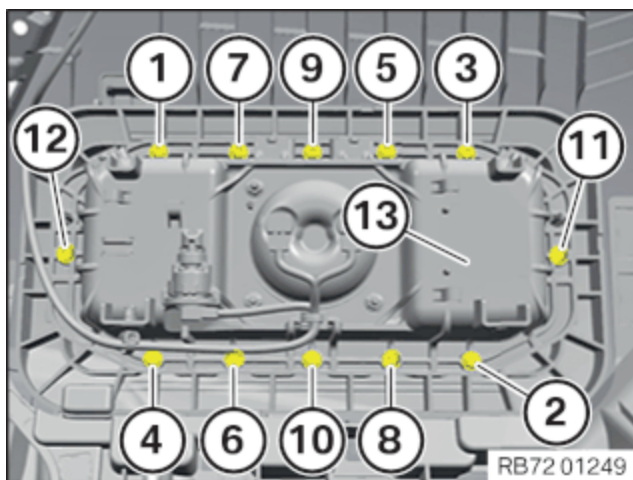
- **Case 1:** Assembly of the front passenger airbag in a new instrument panel or removed instrument panel

Removed front passenger airbag was attached with 6 screws.

- The tightening torque must be applied on at least 11 screws.
- The one screw for which the tightening torque cannot be reached must be removed.
- If the tightening torque is not reached for more than one screw, the instrument panel must be renewed.

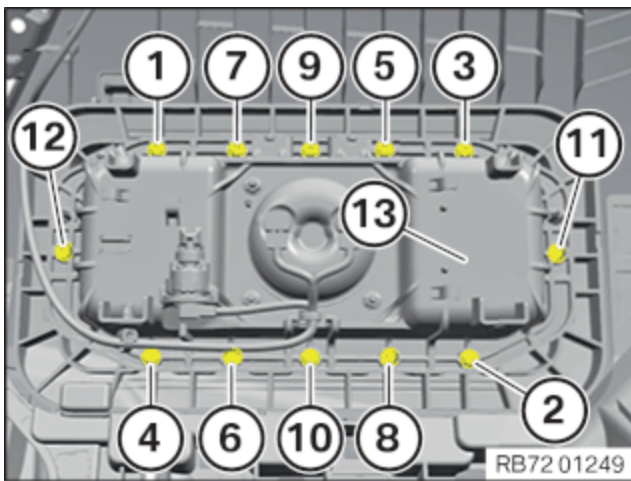
- **Case 2:** *Assembly of the front passenger airbag in a new instrument panel or removed instrument panel*

Removed front passenger airbag was attached with 12 screws.

- The tightening torque must be applied on at least 11 screws.
- The one screw for which the tightening torque cannot be reached must be removed.
- If the tightening torque is not reached for more than one screw, the instrument panel must be renewed.

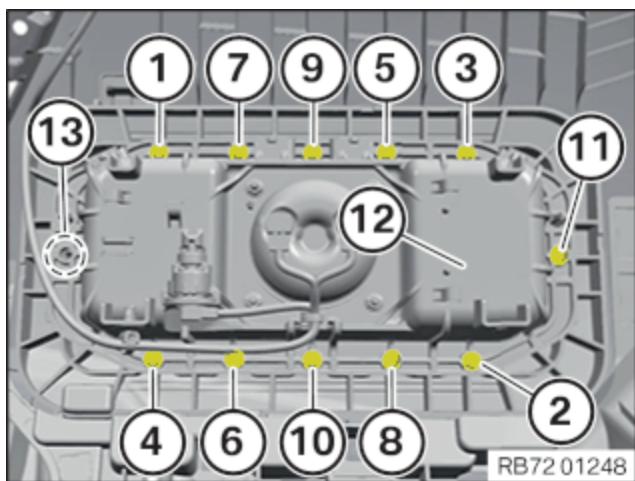
- **Case 3:** Assembly of the front passenger airbag in a new instrument panel or removed instrument panel

The removed front passenger airbag was fastened with 11 screws.

- Check if all the screw heads (1) rest without any gaps using, for example, a thin paper strip (2) as shown.
