RIMAC NEVERA

12V Line check and reposition.

12 V line Check,  
 Visual check of the 12V line connected to the main 12V fuse box. Line C19.  
 Visual check with an Endoscope or Phone.

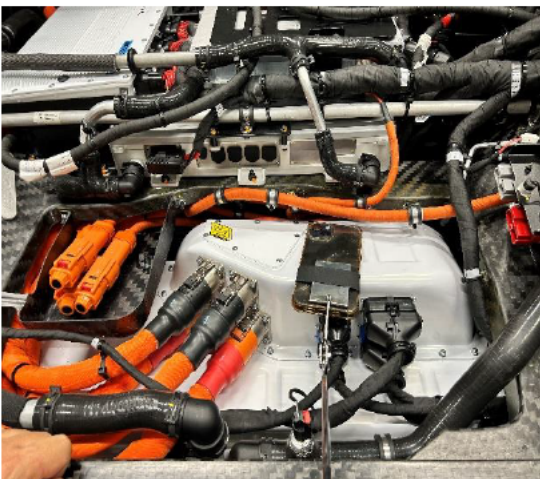
**1 Mobile phone**

Endoscope camera (2) best option or Mobile phone equipped with camera (1)

1. Please refer to the Service manual for all operations
2. Remove the rear clam to reach the open state of the car.
3. Using a Mobile phone with a selfie stick the line can be checked inserting the phone under the Nvidia drive, while recording the whole process.
4. If the line is in OK position, take a picture and send it to Rimac A&S to confirm. Remove the Endoscope and reset the 12V battery. The car is completed, clean up and return to the customer
5. If the line is not OK. Refer to section 3
