**Recall Service Bulletin
RSB24-230-001**

APPLIES TO: This service bulletin applies to certain model year 2024-2025 Metro Star and FC-94, and 2025 Gladiator and KME Panther model emergency response chassis cabs built between August 2024 and October 2024.

CONDITION: Cab Tilt Cylinder may be lacking an internal mechanical stop and may overextend.

CORRECTION: Inspect and replace non-conforming cylinders

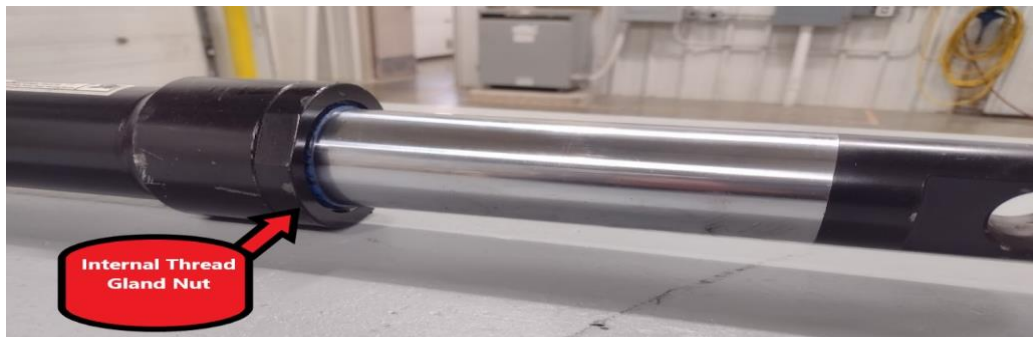
Non-conforming Cab Tilt Cylinder

- The cylinder gland nut has external threads and threads internally into the barrel.

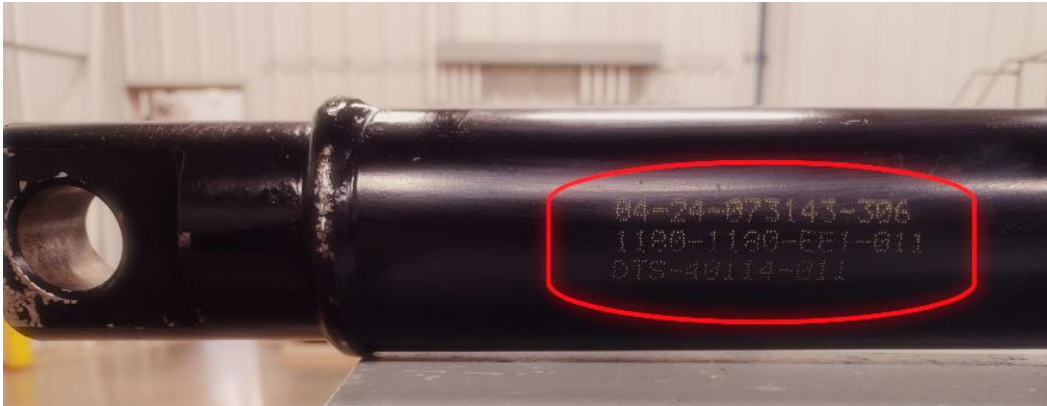
- Part Number and Serial Number are laser dot etched into the barrel.

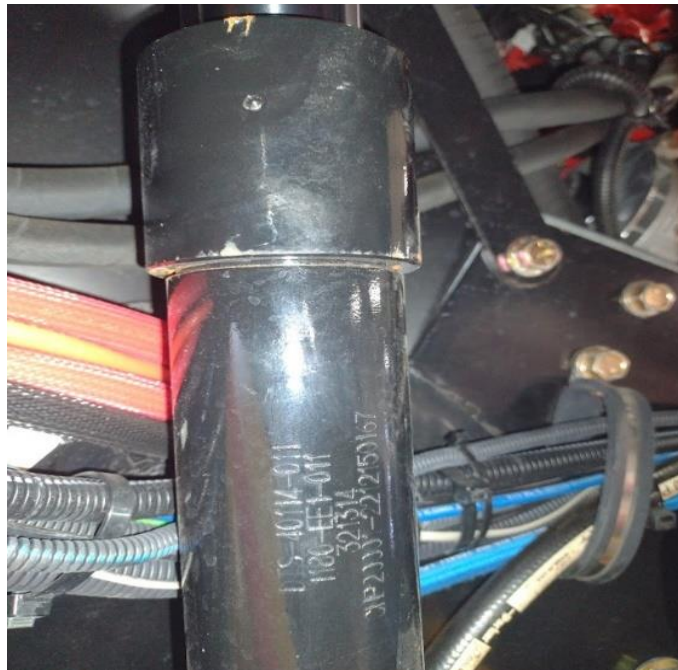
Conforming Cab Tilt Cylinder

- Cylinder gland nut threads externally over the cylinder barrel.
- Part number and serial number are engraved in the cylinder barrel.

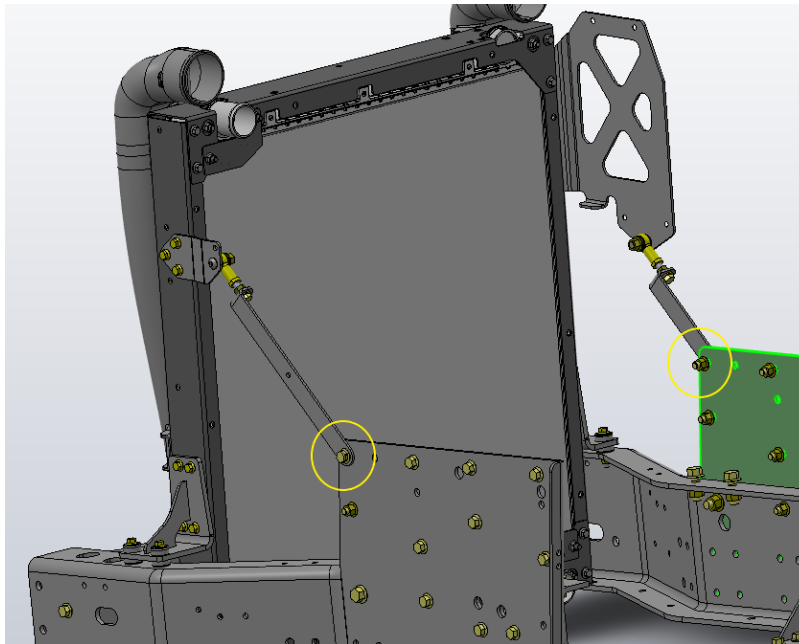
Figure 4.1

- 1) Ensure park brake is set.
- 2) With Master switch on, ignition off, raise cab only to the point that the yellow safety bar engages on the cylinder rod.
- 3) Remove radiator stay rod lower bolts and move stay rods out of the way. *See Figure 4.1*

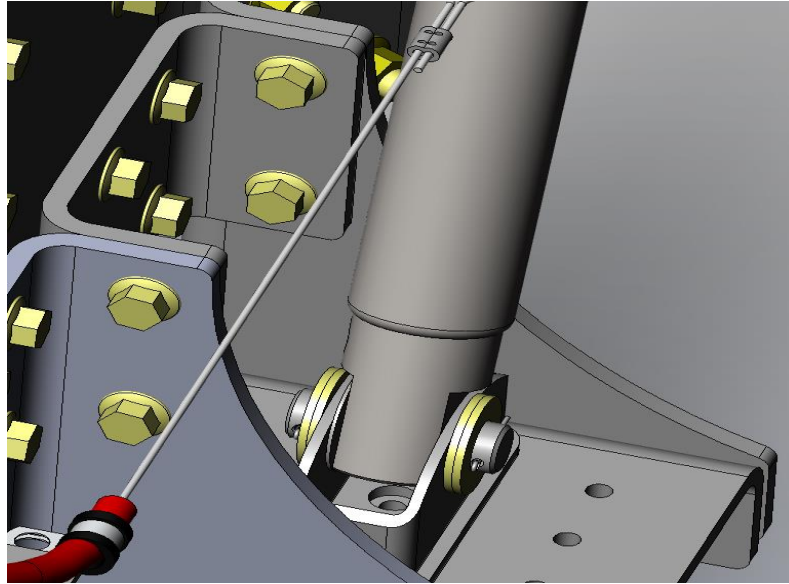
Figure 5.1

- 4) Lower cab and ensure it is down completely, and the light is off in the cab tilt pendent.
- 5) With drain pan in place, disconnect hydraulic hoses from the bottom of the cab tilt cylinders. *(A cap can be made to plug the line to prevent fluid draining from the hose.)*
- 6) Remove lower cab tilt cylinder pins by first removing the cotter-pins and the flat washers. *See Figure 5.1*

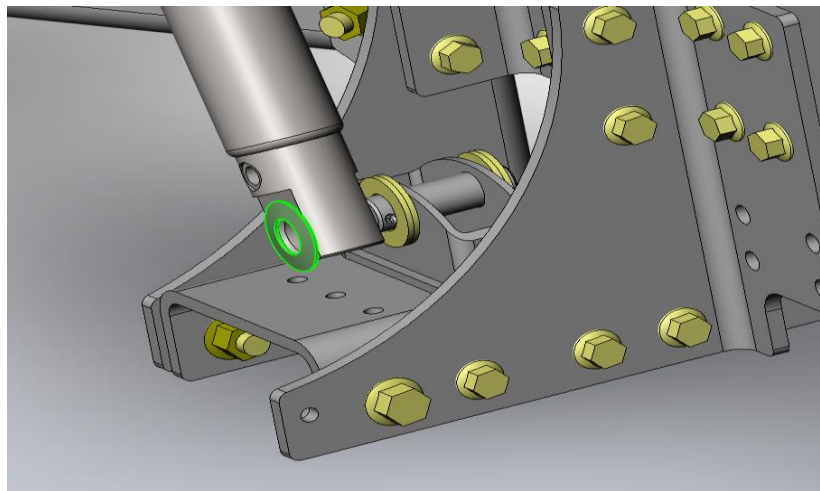
- 7) Remove the lower pins and note the number of washers (flat and belleville) that are located between mount and cylinder base. They will need to be reinstalled with the new cylinders.
See Figure 5.2

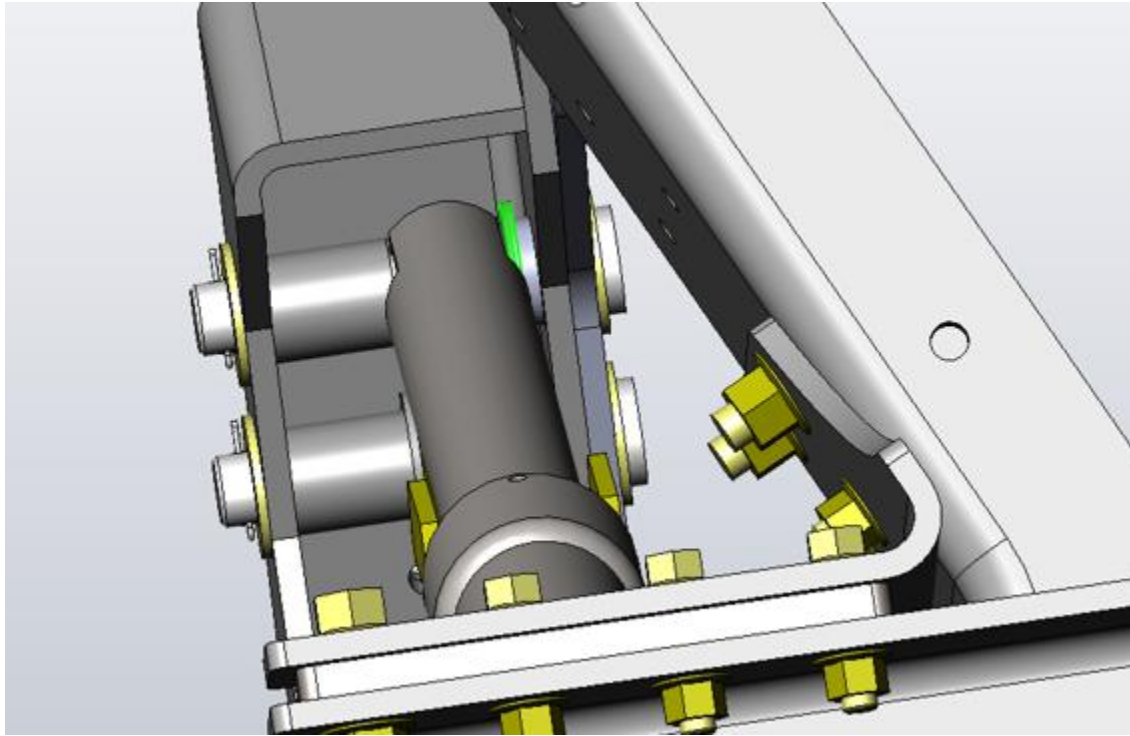
Figure 6.1

- 8) Remove the upper cylinder pin cotter-pins and outer washers. *See Figure 6.1*

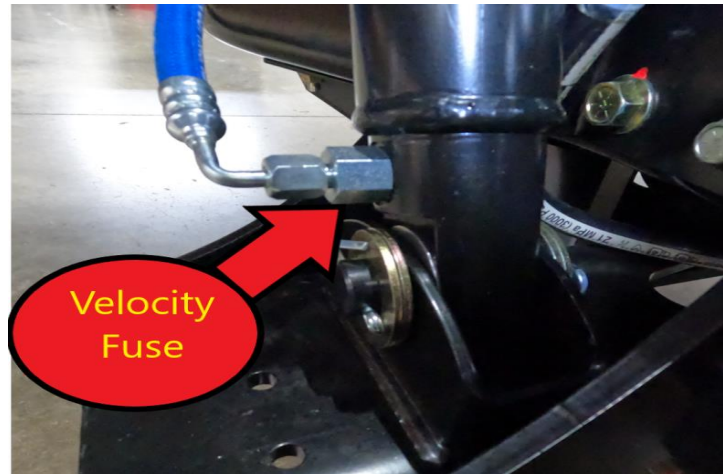
Figure 7.1

12) Install the velocity fuse fitting into the new cylinder. *See Figure 7.1*

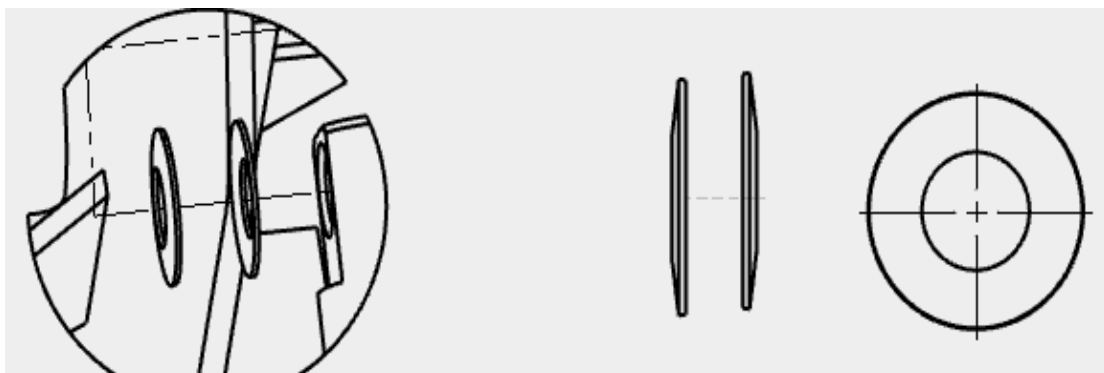
Figure 7.2

- 13) Install the new cylinder into the mounts.
- 14) Insert Belleville and flat washers between the cylinder base and the mount to prevent cylinder mount clunking.
- 15) Install lower and upper cab tilt cylinder pins, washers, and cotter pins. Ensure cotter pin split ends are separated from each other and wrap around the cylinder pin to ensure retainment.
 - a. Upper pin requires two belleville washers installed cupped towards each other as shown in figure 7.2. Shim any additional gap with standard washers that were removed when original cylinder was removed.

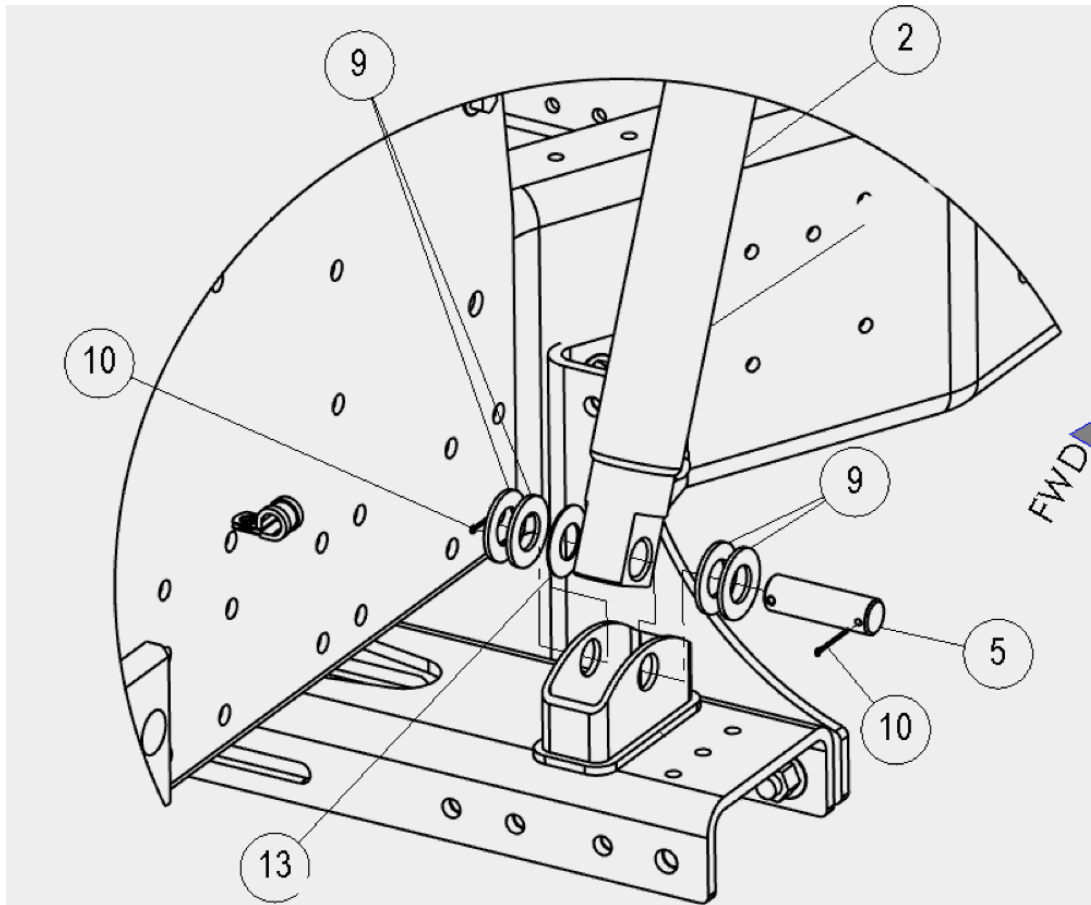
- b. Install lower and upper cab tilt cylinder pins, washers, and cotter pins and split cotter pin ends to ensure retainment. The lower cylinder mount requires one Belleville washer and then regular washers as necessary to shim the gap and prevent cylinder clunking. See Figure 8.1

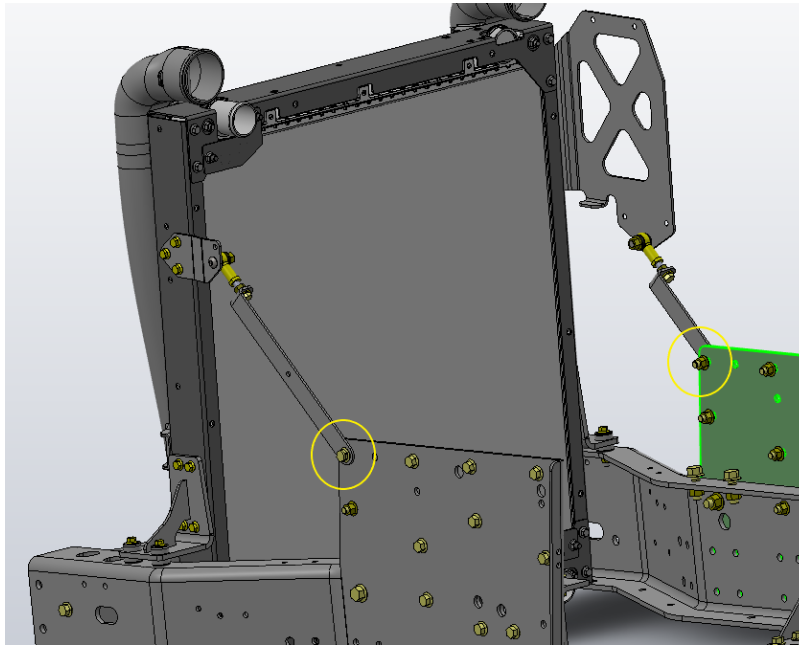
Figure 9.1

- 18) Raise cab until safety lock bar is in place.
- 19) Add Dexron 3 ATF to the cab tilt pump reservoir as needed.
- 20) Reconnect radiator stay rod lower bolts and torque the bolt side to 93 ft. lbs. *See Figure 9.1*
