## IMPORTANT SAFETY RECALL

**NHTSA Safety Recall 24V-824**

**SUBJECT: Campaign # 191 – Entrance Door Window May Detach**

# Lippert Metallarte Entrance Door

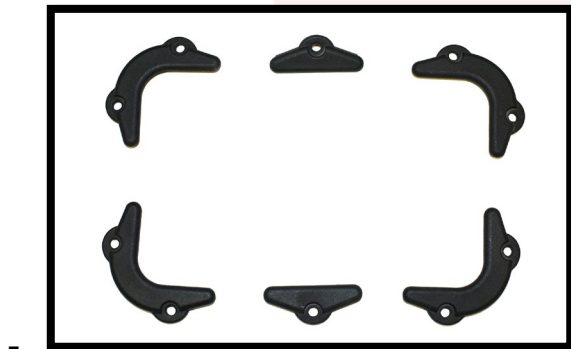
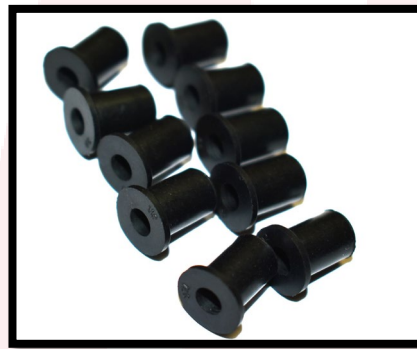
## Part/s Required

1. 6 Clips (2 Linear & 4 Angled)
2. 10 Threaded Inserts
3. 10 Painted Screws

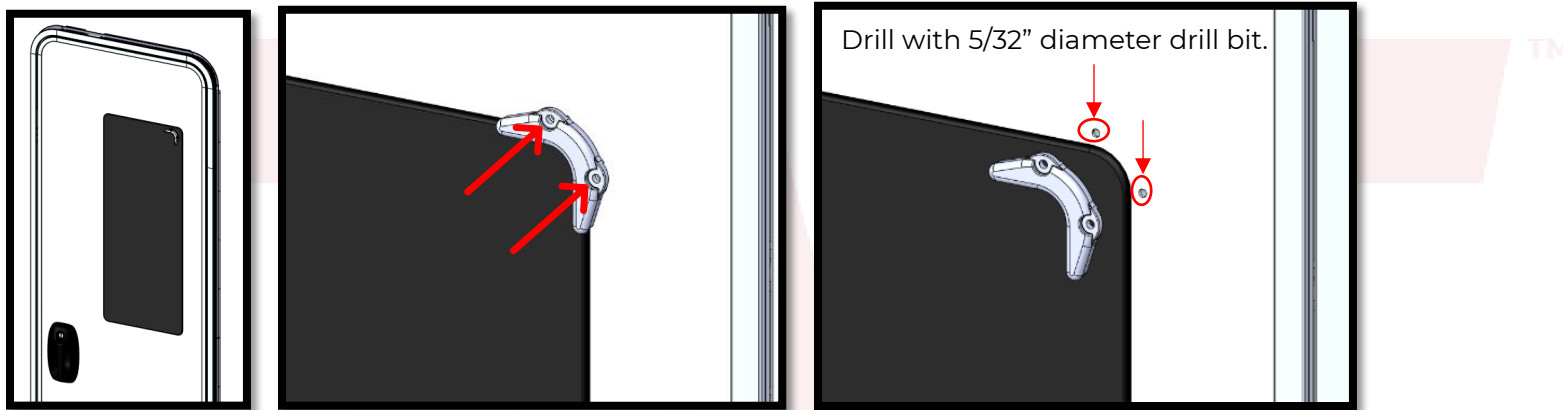
1. Place the corner piece against the window and drill pre-holes with a 5/32" (4 mm) diameter drill bit. The depth of the hole should not exceed 0.50 inch (13 mm). (See Page 4 for More Information)

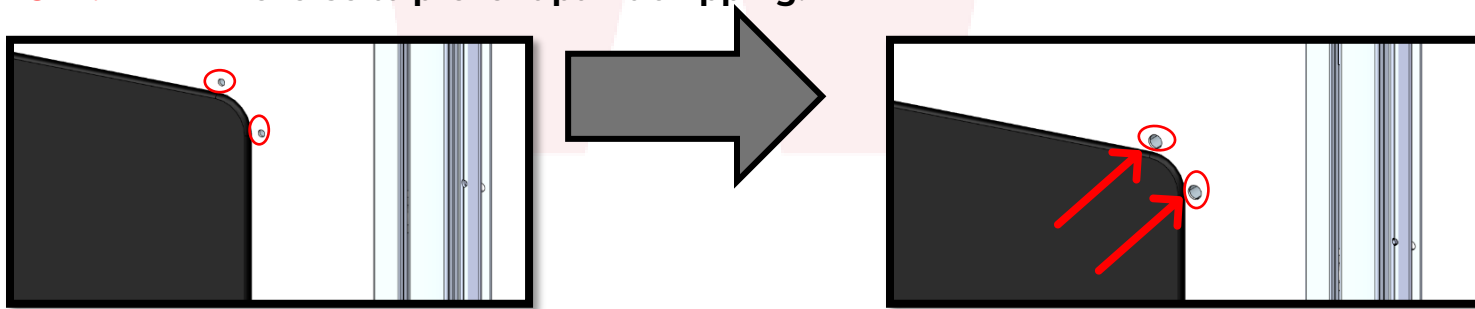
2. Increase the diameter from 5/32 to 5/16", drilling with 5/16" (8 mm) drill bit. The depth of the hole should not exceed 0.50 inch (13mm).

**NOTE: Drill in Reverse to prevent paint chipping.**

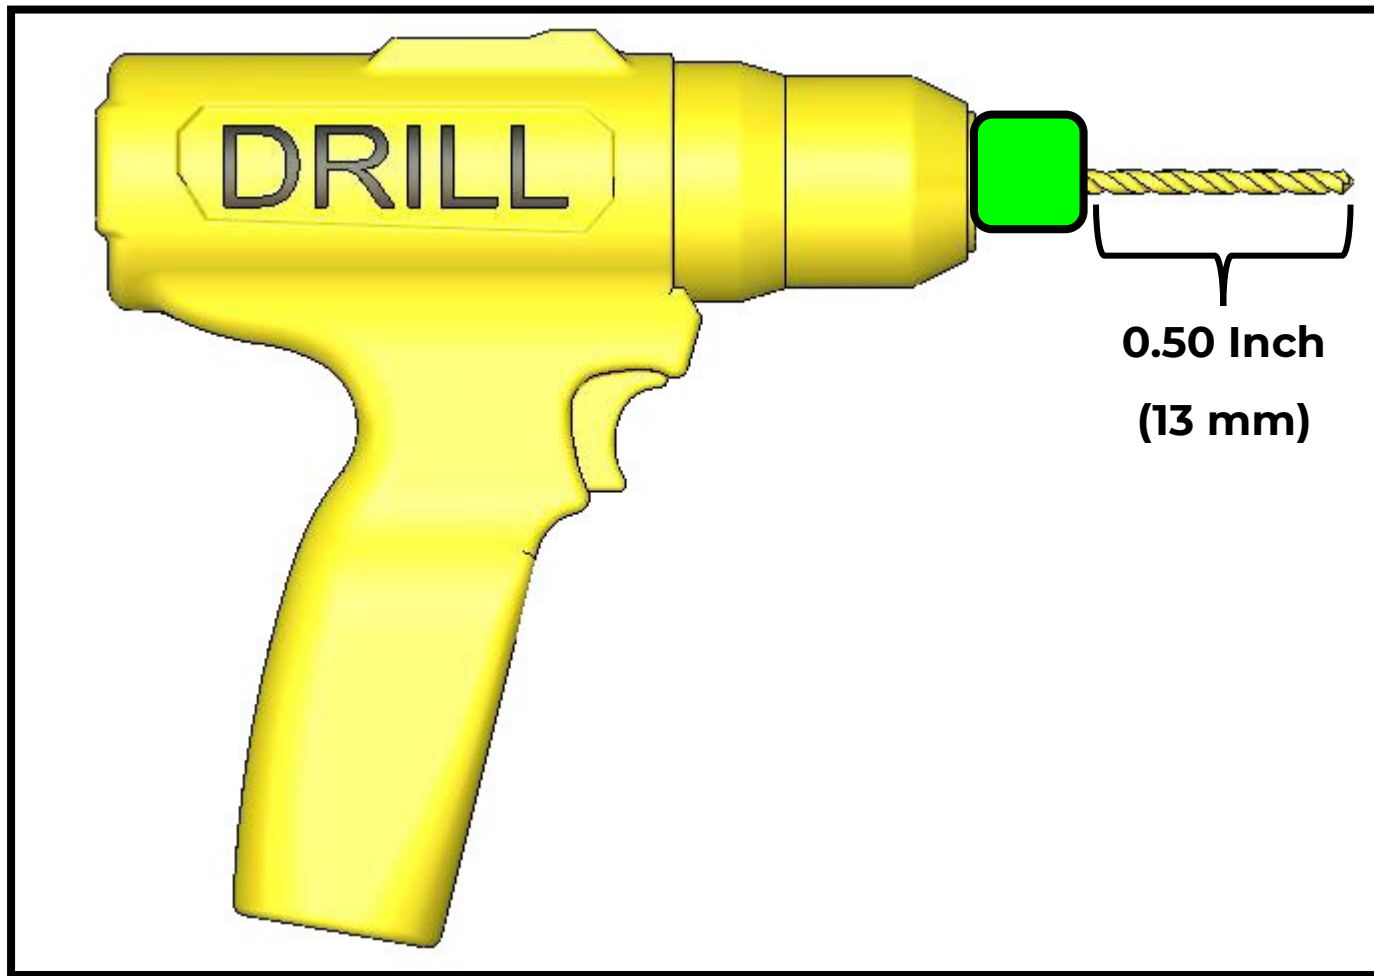
**ATTENTION:** Wrap some tape at 0.50 inch (13 mm) on the drill bits. This will guide you to make the hole the correct depth. (See the Figure Below: Green colored box for Tape Location Reference)

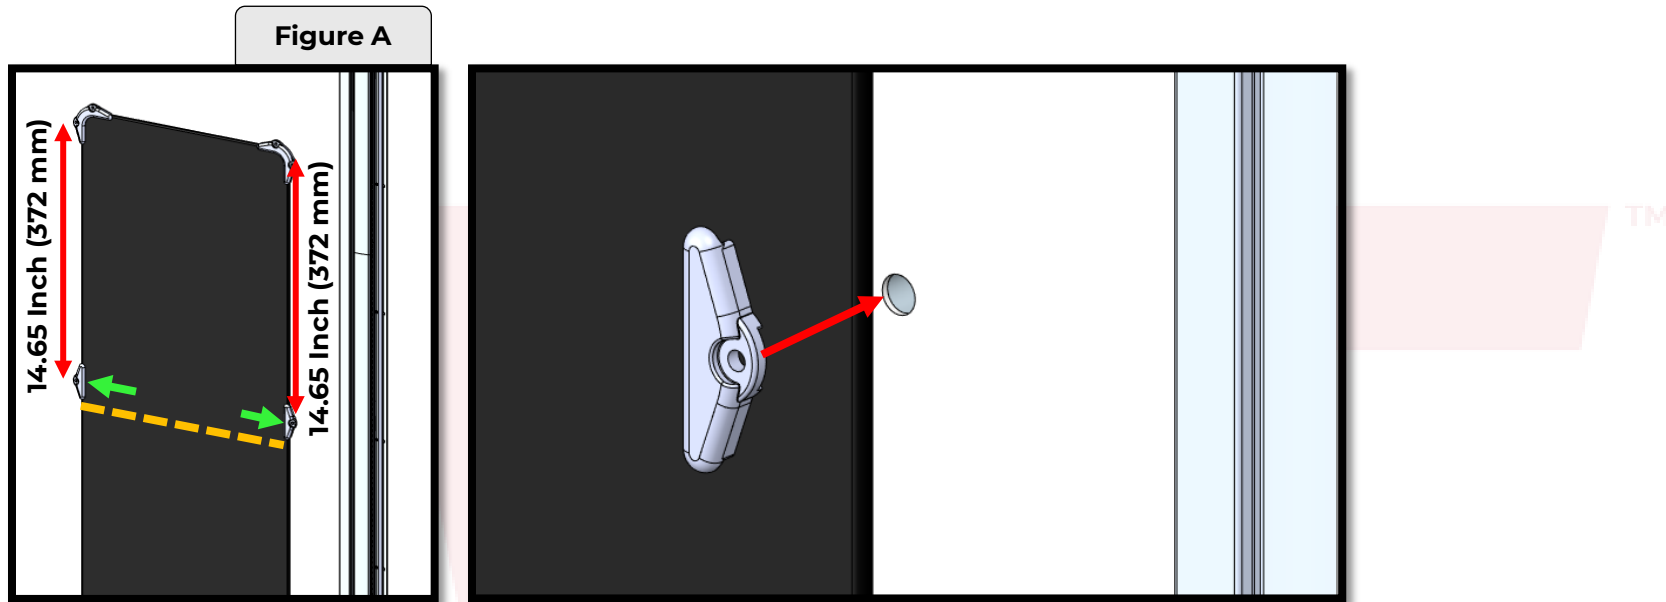
Objective: Repeat the procedure in Step 1 for the two linear clips. Position the two linear clips along the window's centerline (See Figure A -Green arrows), pre-drill 5/32", enlarge the hole to 5/16".

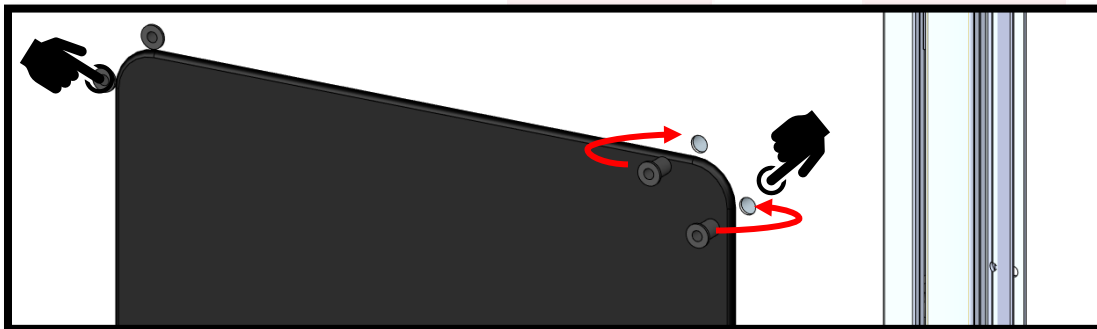
Objective: Push the threaded inserts into the holes.

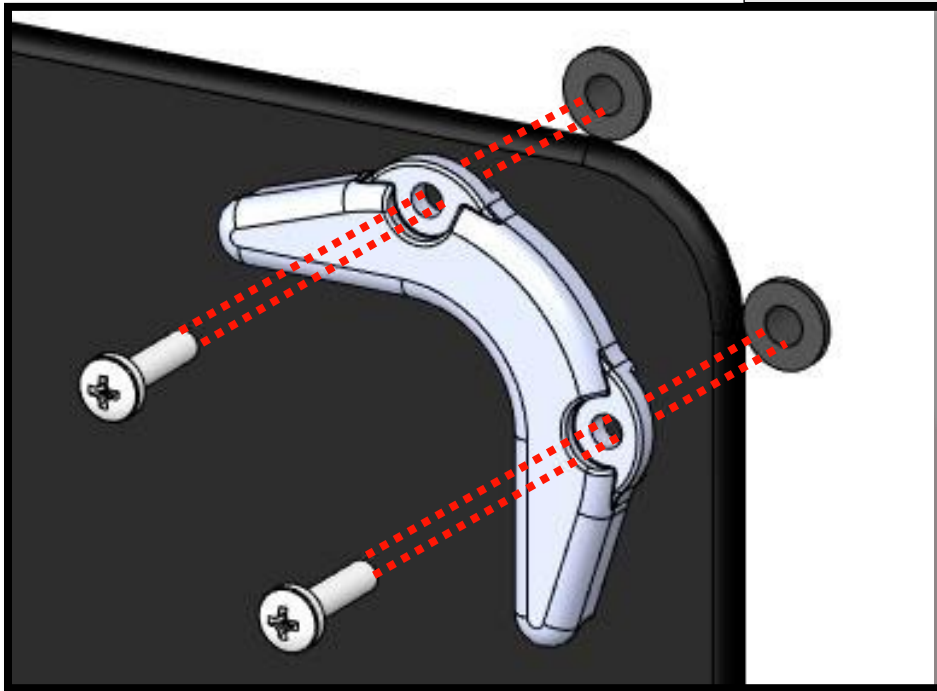
Figure A

1. Place the clips over the threaded inserts and tighten the screws with a torque screwdriver. (See Figure A)

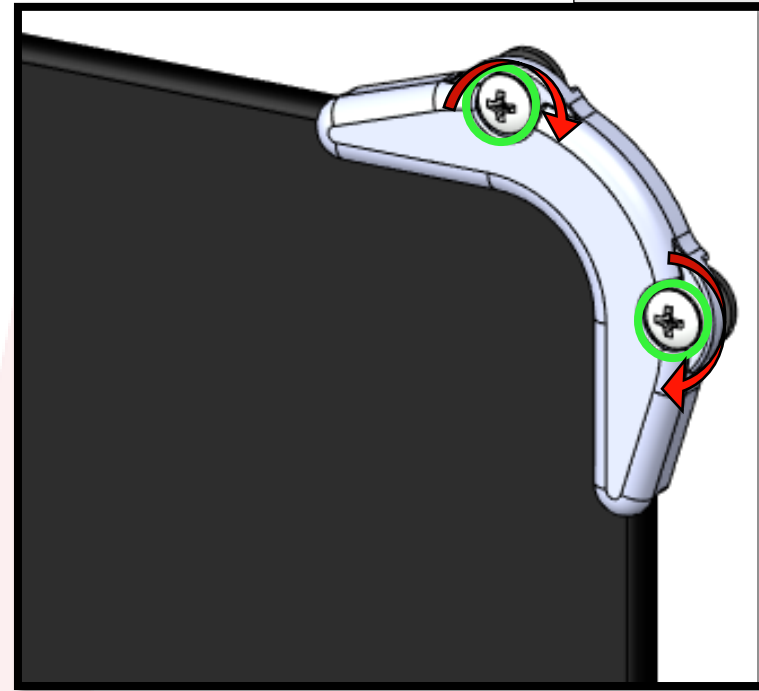
Figure B

**CAUTION:** Observe the tightening torque of 4.4 inches/lbs. (0.5 Nm.) (See Figure B)
