Service Bulletin

NCW50 #1
December 2024

SAFETY RECALL

2016 - 2025 NCW50 Metropolitan Transmission Case

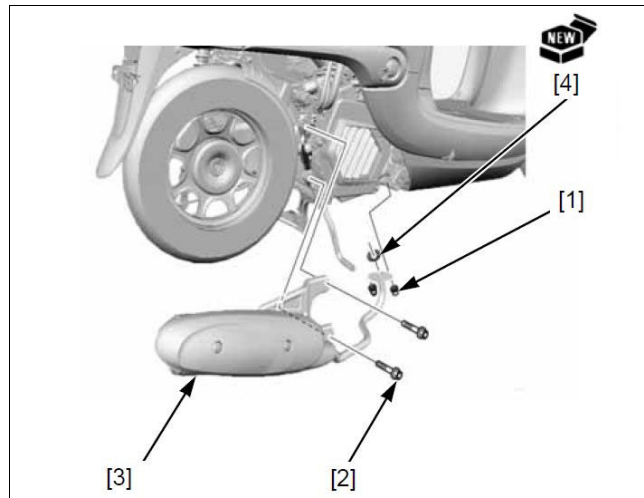
Remove the two joint nuts [1], two bracket bolts [2] and muffler [3].

Remove the exhaust pipe gasket [4] from the exhaust pipe flange and replace it with a new one.

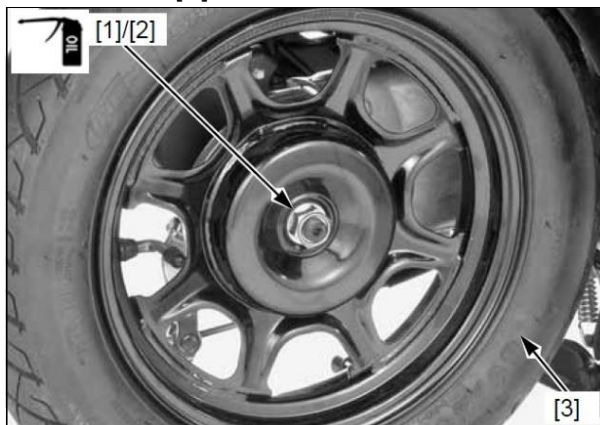
Lower the rear wheel to the ground and set the rear brake, then loosen the axle nut [1]. Remove the rear axle nut, washer [2] and rear wheel [3].

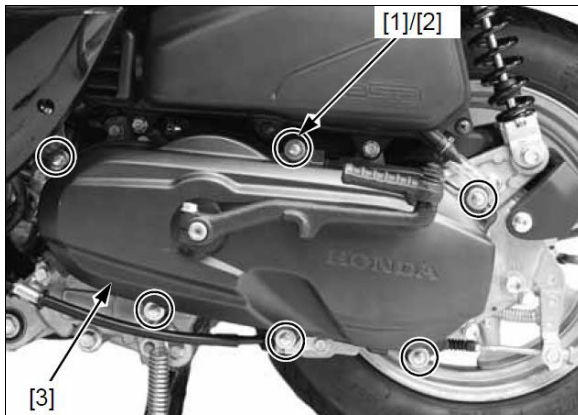
Remove the six left crankcase cover special bolts [1], mount rubbers [2], and left crankcase cover [3].

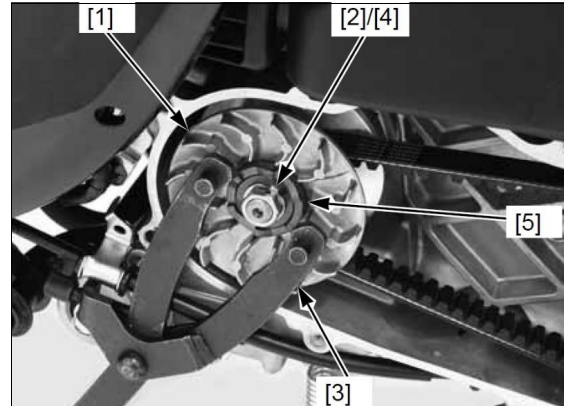
Hold the drive pulley face [1] with special tool and loosen the drive pulley face nut [2].

[3] Clutch center holder 07725-0030000

- Drive pulley face nut
- Washer [4]
- Ratchet plate [5]
- Drive pulley face [1]

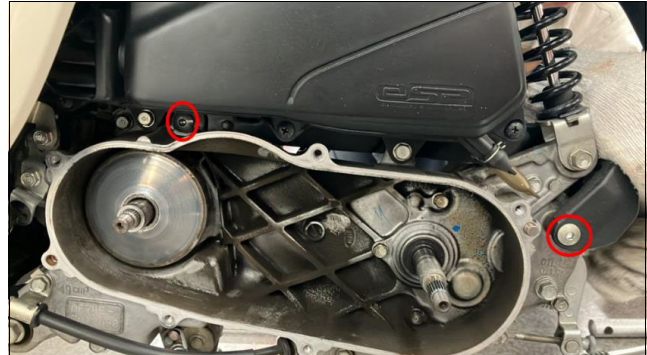
Remove the socket bolt tightening the sensor protector.

Release the wire band boss [2] from the sensor protector [3].

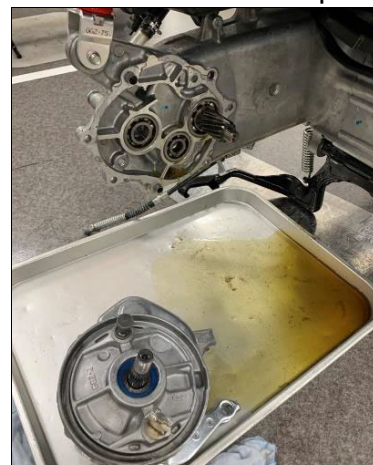
12. Allow transmission oil to drain from the crankcase and transmission case for **one minute** into the oil collection pan.

13. Using a funnel and a graduated cylinder (>100 cc capacity), pour the collected oil into the cylinder allowing **one minute** of time for all oil to drain from the oil collection pan into the funnel and cylinder.

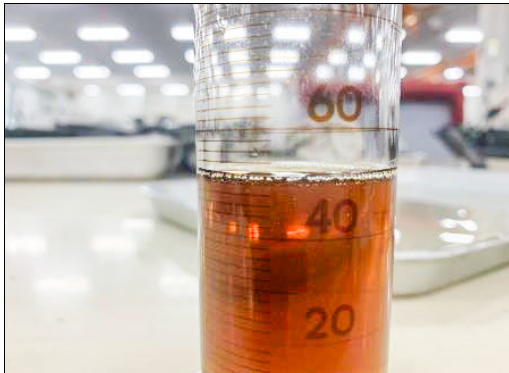
14. Place the graduated cylinder on a level surface and measure the oil level. Document your results for the final conclusion of the inspection.

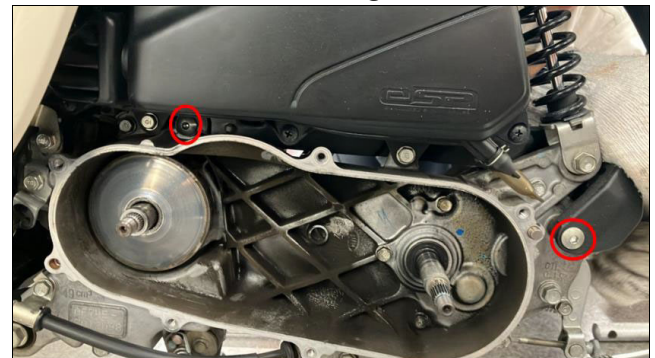
Reinstall the socket bolt onto the sensor protector and tighten to the specified torque.

TORQUE: 10 N-m (1.0 kgf-m, 7 lbf-ft)

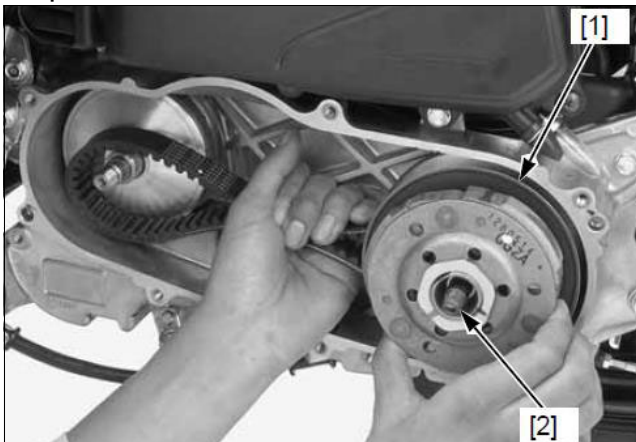
Install the clutch/driven pulley assembly [1] onto the drive shaft [2].

*Do not get grease on the drive shaft splines from the driven face inside.

Install the clutch outer [1] and clutch outer nut [2].

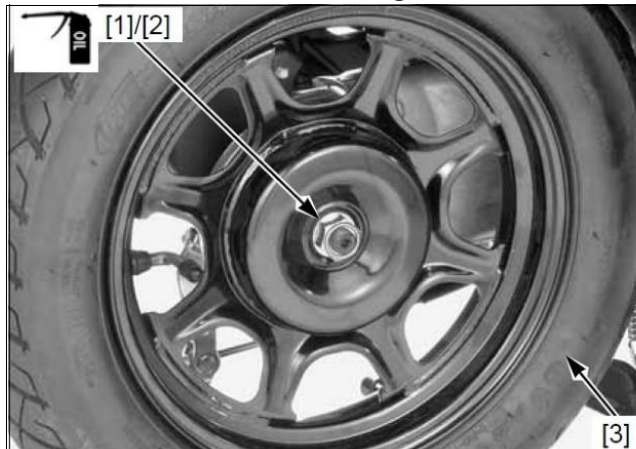
14. Install the rear wheel [3] onto the final gear shaft, aligning its splines with the final gear shaft splines. Apply engine oil to the rear axle nut threads and seating surface [1]. Tighten the axle nut [2] to the specified torque.

TORQUE: 118 N·m (12.0 kgf·m, 87 lbf·ft)

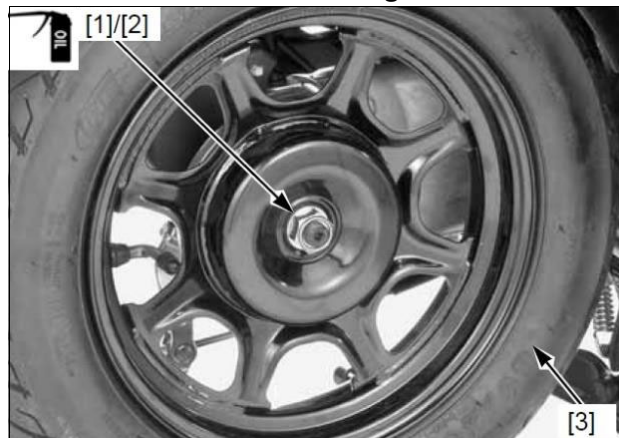
24. Install the rear wheel [3] onto the final gear shaft, aligning its splines with the final gear shaft splines. Apply engine oil to the rear axle nut threads and seating surface [1]. Tighten the axle nut [2] to the specified torque.

TORQUE: 118 N·m (12.0 kgf·m, 87 lbf·ft)
