## IMPORTANT SAFETY RECALL

**NHTSA Safety Recall 24V-826**

**SUBJECT: Campaign # 197 – Remedy B Hood Mounting Bracket(s)**

On certain Winnebago vehicles, the adhesive application may have been done incorrectly on the hood mounting bracket(s). The hood mounting bracket(s) adhesive could potentially fail over time, resulting in the bracket separating from the vehicle.

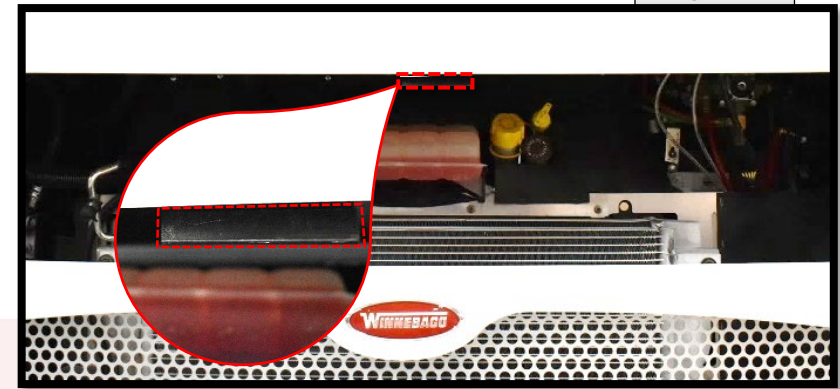
1. Open the front hood to gain access for inspection. The front hood can be opened by pulling the paddle located in the center under the lower edge. (See Figure 1 - Red Dashes.)

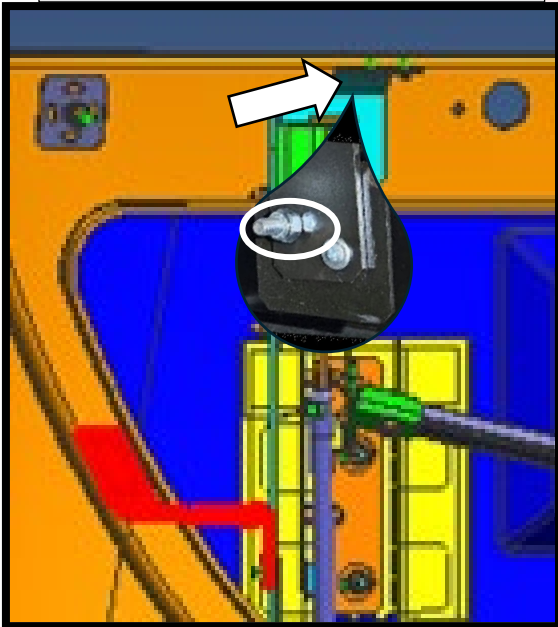
**Figure 2 – Passenger Side**

1. For additional retention, add a bolt at the top of the bracket to replace one of the self-tapping screws in the uppermost mounting location of the bracket (See Figure 2 - White Arrow).
  - a. Remove the outer self-tapping screw.
  - b. Take a 1/4" drill bit and drill out the hole into both brackets where the screw was removed.
  - c. Reach around the bracket and install the supplied bolt down into the newly resized hole.
  - d. Install the Nyloc nut supplied.
  - e. Using a 3/8" backer wrench and torque wrench with a 7/16" deep well socket, torque to 76 In-Lbs. (See Figure 3)
2. Complete the instruction above for both the driver and passenger side. Reference Image 4 and 5 to see bolts properly installed.

Objective: Replace One of the upper self-tapping screws of the upper brackets with a bolt for additional retention, ensuring proper installation and torque on both driver and passenger sides.

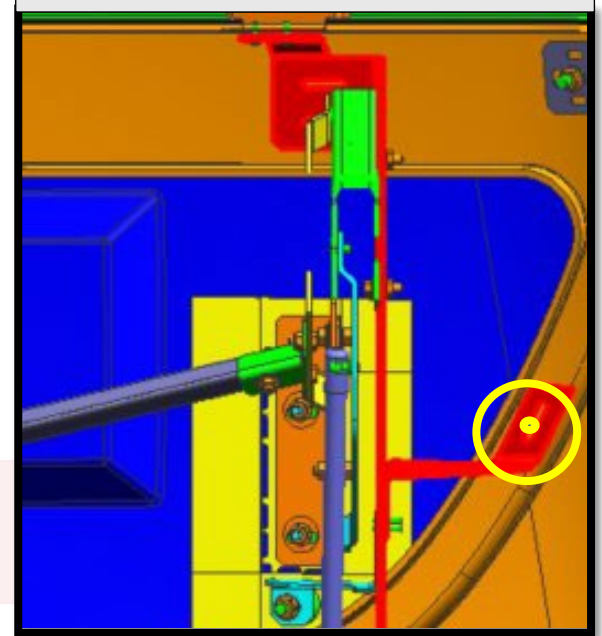
Figure 6 – Passenger Side Interior View

1. Locate the connection point between the side-arm bracket and the fiberglass front cap, as identified in Figure 6 (Yellow Circle) for both the Passenger and Driver's side-arm bracket.
2. Using the rivet guide, mark the position of the hole on the front face of the fiberglass.
  - Ensure the rivet guide is aligned evenly with the fiberglass surface and that the lower end of the guide sits flush on the side-arm bracket. (See Figure 7 – Blue and Green Dashed Arrows)
3. Before proceeding with drilling the hole, ensure that a 1-inch diameter area on the back side of the bracket where the hole will be drilled through, is clear of any preexisting plexus.
  - This will allow for the proper installation of the washer, ensuring it fits flushed against the surface of the backside of the bracket.
4. Using a 13/64" drill bit, drill a hole through both the fiberglass and the bracket.

**NOTE: Do not drill from the backside of the fiberglass, as this may cause the finished surface to chip.**

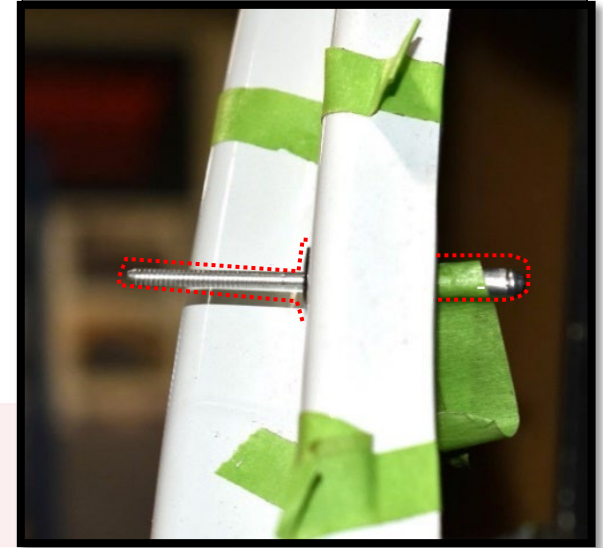
**Figure 8 – Driver Side**

5. Insert the supplied rivet into the new hole. Place a washer on the backside of the rivet.
  - Tape may be necessary to hold the washer in place.
6. Install the rivet (See Figure 8 – Red Dashes).
  - a. Ensure that the rivet and washer securely hold the bracket (See Figure 9 – Green Dashes).
  - b. Verify that the mandrel of the rivet breaks off properly, ensuring no part of it protrudes and poses a potential scratching or poking hazard. Use side cutters to trim off any excess mandrel if necessary.
7. If all critical bracket connection points have either passed inspection or have been reworked, and the supplied bolts and rivets have been properly installed, the rework is complete.

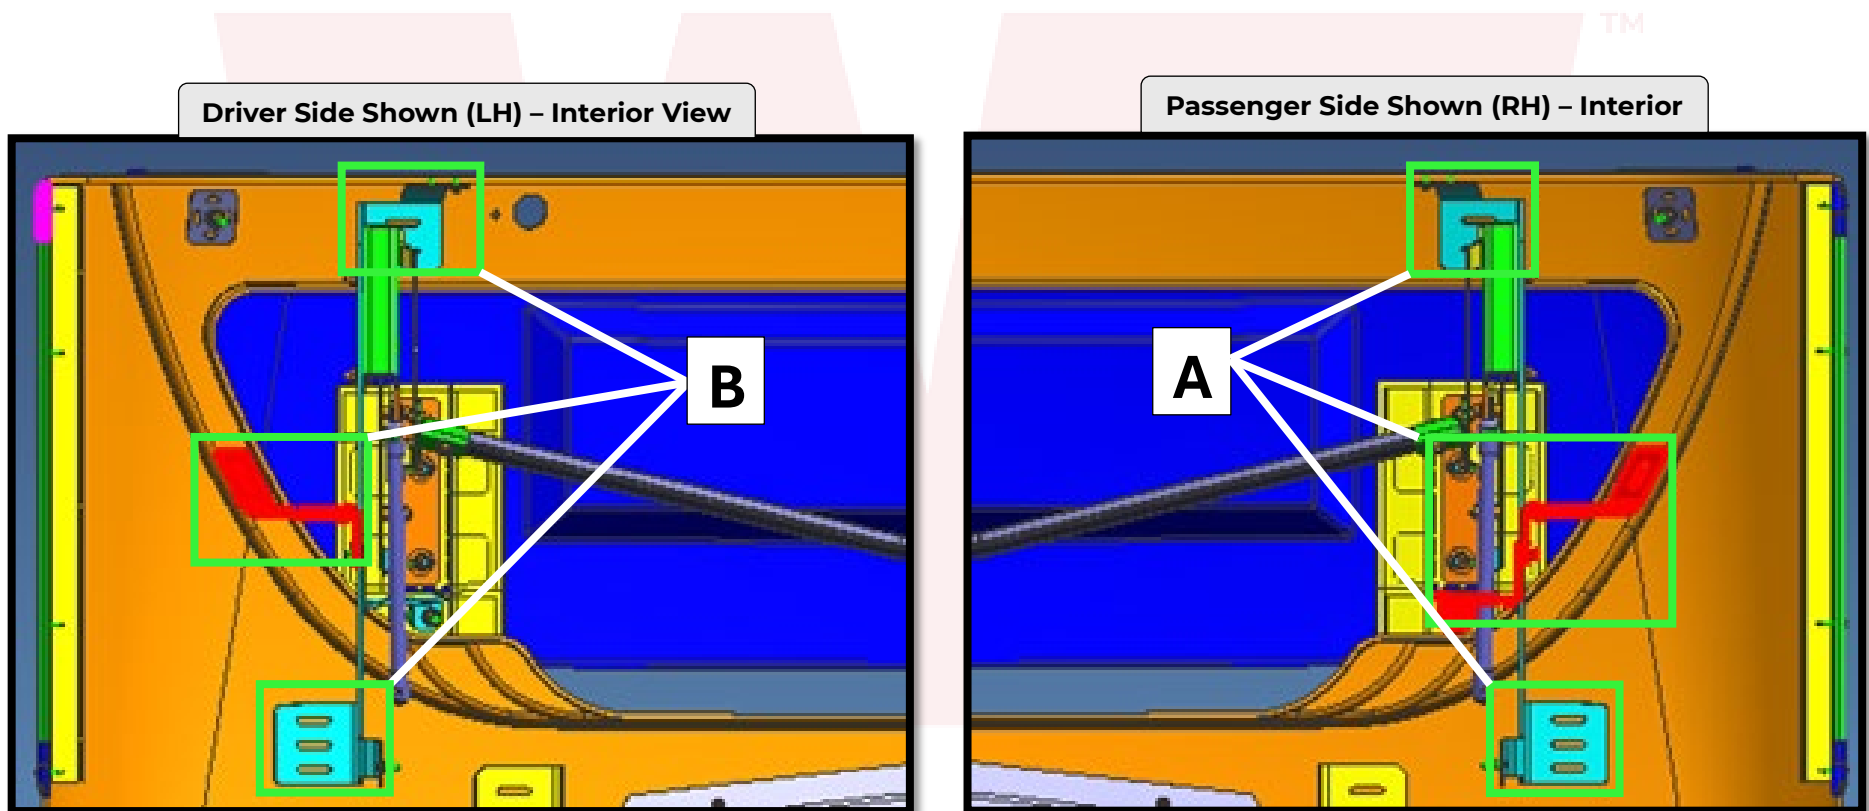
# Critical Brackets Reference

1. There are two critical brackets on the front cap. (Both are considered Singular Hood Bracket Support Assemblies)
  - A total of two hood bracket support assemblies are present (Driver (B) & Passenger Side (A), with one located on each side.
  - Each assembly has three different connection points, as indicated by the 3 green squares in the image below.
  - The lowest connection point on both passenger and driver side will only require plexus for re-adhesion if loose. It will NOT require rivets nor washers like the side-arm brackets that are highlighted red on the images below.

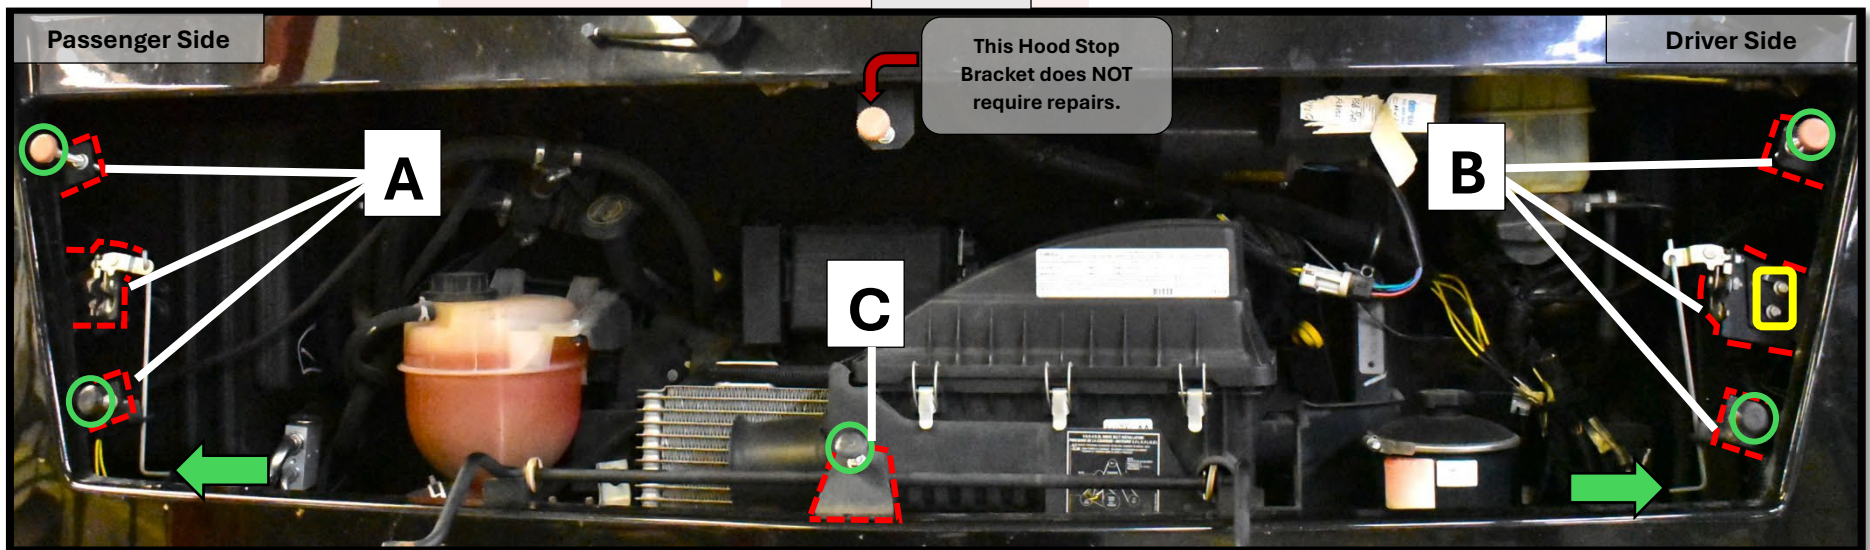
1. Open the front hood to gain access for inspection. The front hood can be opened by pulling the two handles located along the bottom edge of the hood (See Figure 1 – Green Arrows).
2. Identify the critical brackets that require inspection; refer to page 7 for identification instructions.
3. Physically inspect each bracket for any loss of adhesion by attempting to wiggle the bracket. The adhered base of the bracket should remain firmly in place.
4. If any critical brackets are found to be loose or missing, contact Winnebago Technical Service by email at [techservice@wgo.net](mailto:techservice@wgo.net) (See the last page of these instructions for directions on how to send Winnebago the necessary information)
5. If no issues are detected with the adhesion of the critical brackets to the fiberglass, proceed to Step 2 – Rework Bracket Attachment.

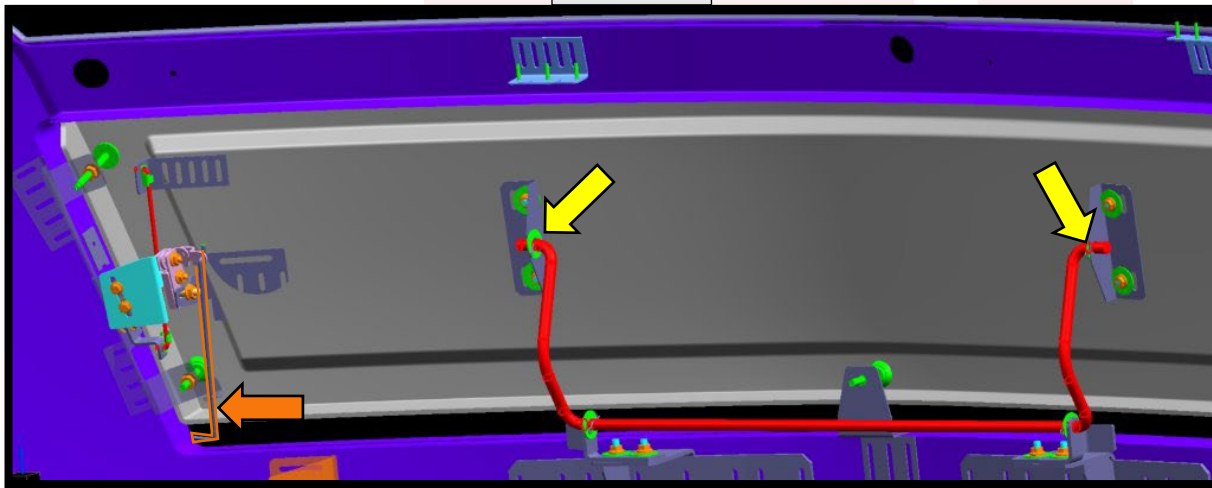
Figure 2

1. Remove the front hood to gain access to the critical brackets.
  - Unclip the hood linkage rod from the hood on the driver's side (Figure 2 - Orange Arrow) and then remove the main support rod from the brackets attached to the hood. (Figure 2 – Yellow Arrows)
2. Using a 3/8" wrench (for the heads of the 2 bolts) and a 7/16" wrench (for the nuts of the 2 bolts), remove the hood linkage rod mounting plate on the driver's side. (See Figure 3 – Highlighted in Yellow)
3. Using a 1/2" wrench, remove the hood adjustment bolt and locking nuts located on the front side of the bracket for each of the five hood stops. (See Pg. 1's - Figure 1 – Green Circles Indicate all 5 Locations and Figure 3 -Highlighted in Green Dashes for full Hood Stop image reference)

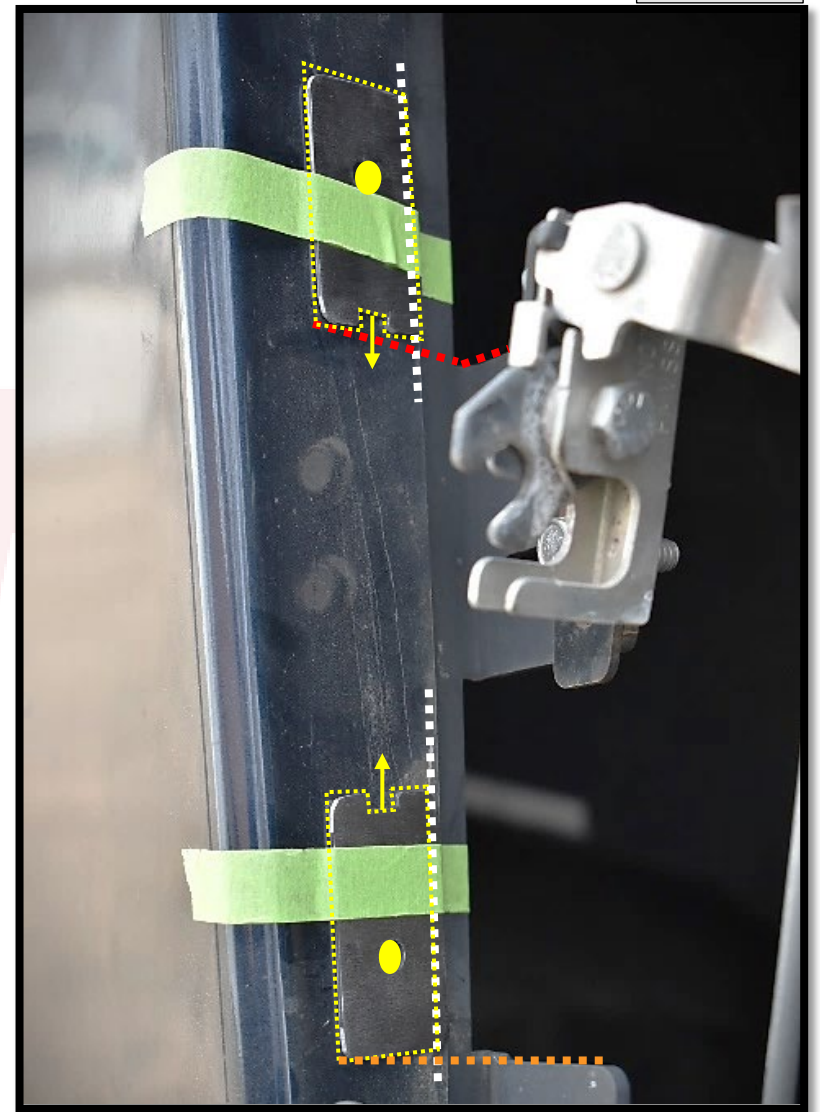
1. Using the provided drilling template, drill a hole through the fiberglass and through the bracket for each critical bracket.
  - a. For the critical brackets on either side of the hood cutout, align the rivet guide so that the long edge is flush with the trimmed edge of the fiberglass (See Figure 4 – White Dashes).

- b. Each side bracket will get two rivets, an upper and a lower (See Figure 4 Highlighted in Yellow Dashes).
    - For the lower rivet, point the notch up. The side without the notch should align with the top edge of the visible portion of the critical bracket with the hood stop. (See Figure 4 – Orange Dashed Line)

- For the upper rivet, point the notch down. The side with the notch should align with the top edge of the visible portion of the critical bracket with the latch mechanism. (See Figure 4 – Red Dashed Line)

- c. Install the supplied rivets with the painted head of the rivet visible in the hood opening.

**Note: Do NOT drill from the backside of the fiberglass, as this may cause the finished surface to chip.**

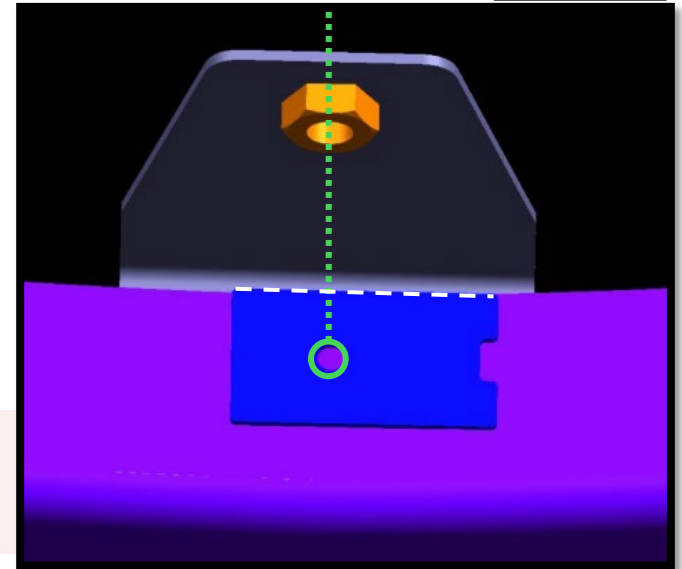
1. For the center critical bracket at the bottom edge of the hood cutout, align the long edge of the guide with the trimmed edge of the fiberglass (See Figure 5 – White Dashed Line). Align the hole with the center of the bracket. (See Figure 5 – Green Circle and Dashed Line) Mark the position of the hole on the front face of the fiberglass.
  - Before proceeding with drilling the hole, ensure that a 1-inch diameter area on the back side of the bracket where the hole will be drilled through is clear of any preexisting plexus. This will allow for the proper installation of the washer, ensuring it fits flushed against the surface of the backside of the bracket.

**Note:** Use a hand chisel to clear this 1-inch diameter area on the back side of the bracket, as it will be more challenging to remove preexisting plexus after drilling the needed hole for the rivet due to the increased temperature near the plexus.

- Using a 13/64" drill bit, drill a hole through both the fiberglass and the bracket.
2. Ensure that the rivets securely hold the brackets.
  - For every installed rivet, verify that the mandrel of the rivet breaks off properly, ensuring that no part of it protrudes and poses a potential scratching or poking hazard. Use side cutters to trim off any excess mandrel if necessary.

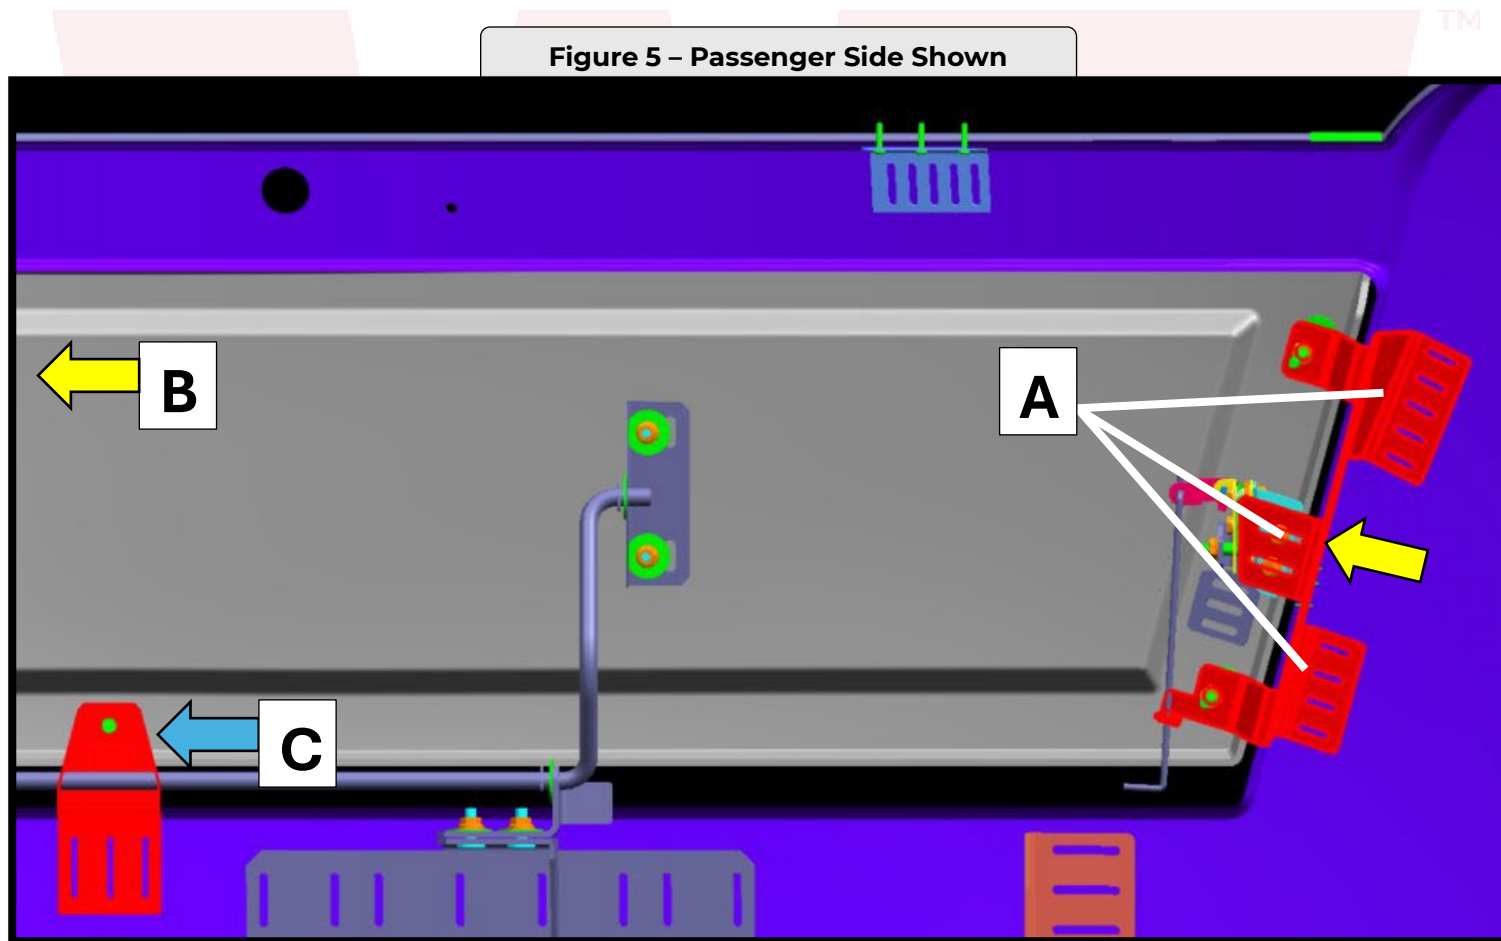
# Critical Brackets Reference – (Adventurer) 2016 - 2018

1. There are 3 total critical brackets on the front cap.
  - a. A total of 2 hood latch brackets: Driver Side (B) & Passenger Side (A), 1 on either side of the hood cutout. (See Figure 5 Yellow Arrow for reference of the hood latch brackets)
  - b. A total of 1 hood stop bracket in the center along the bottom edge of the hood cutout (C). (See Figure 5 Blue Arrow for reference of the single hood stop bracket)

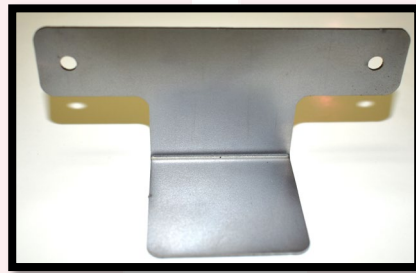
1. Open the front hood to gain appropriate access for inspection. The front hood can be opened by opening 2 locking twist latches with the vehicle ignition key. (See Figure 1 – Green Circles)
2. Identify critical brackets that require inspection, see page 5 for instructions on bracket identification. If any critical brackets are missing, contact Winnebago Tech Service by email: [techservice@wgo.net](mailto:techservice@wgo.net) (See the last page of these instructions for directions on how to send Winnebago the necessary information)
3. Physically inspect each bracket for loss of adhesion by trying to wiggle the bracket. The adhered bases of the bracket should firmly hold its position.
4. If NO issues are found with the adhesion of the critical brackets to the fiberglass (NO loose brackets), move onto **Step 2 –**

- Rework Bracket Attachment.**
5. If the bracket(s) are loose, follow the next sub-steps A-H below carefully.
    - A. **Critical:** Before removing the brackets, use the new rivet guide and masking tape to mark the location of where you need to re-adhere the bracket with new plexus for sub-step G. (See Figure 2- Blue Marks).
      - Do this for both brackets.
      - The Red outline of the bracket in figure 2 shows the alignment of the position of the bracket with the masking tape marks.
      - Leave the masking tape in place to re-adhere in the proper location for both sides.
    - B. Use a hand chisel to gently pry and remove these brackets carefully from the fiberglass.

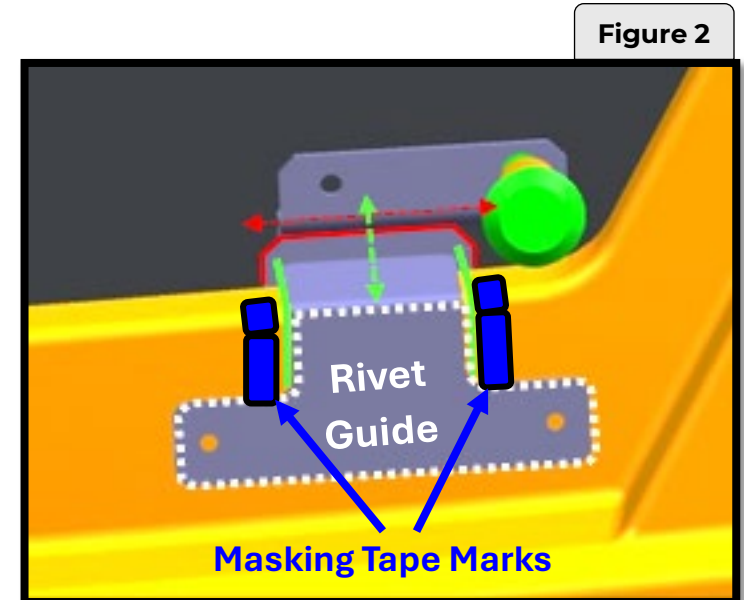
Figure 2

**Critical:** Ensure to NOT damage the fiberglass.

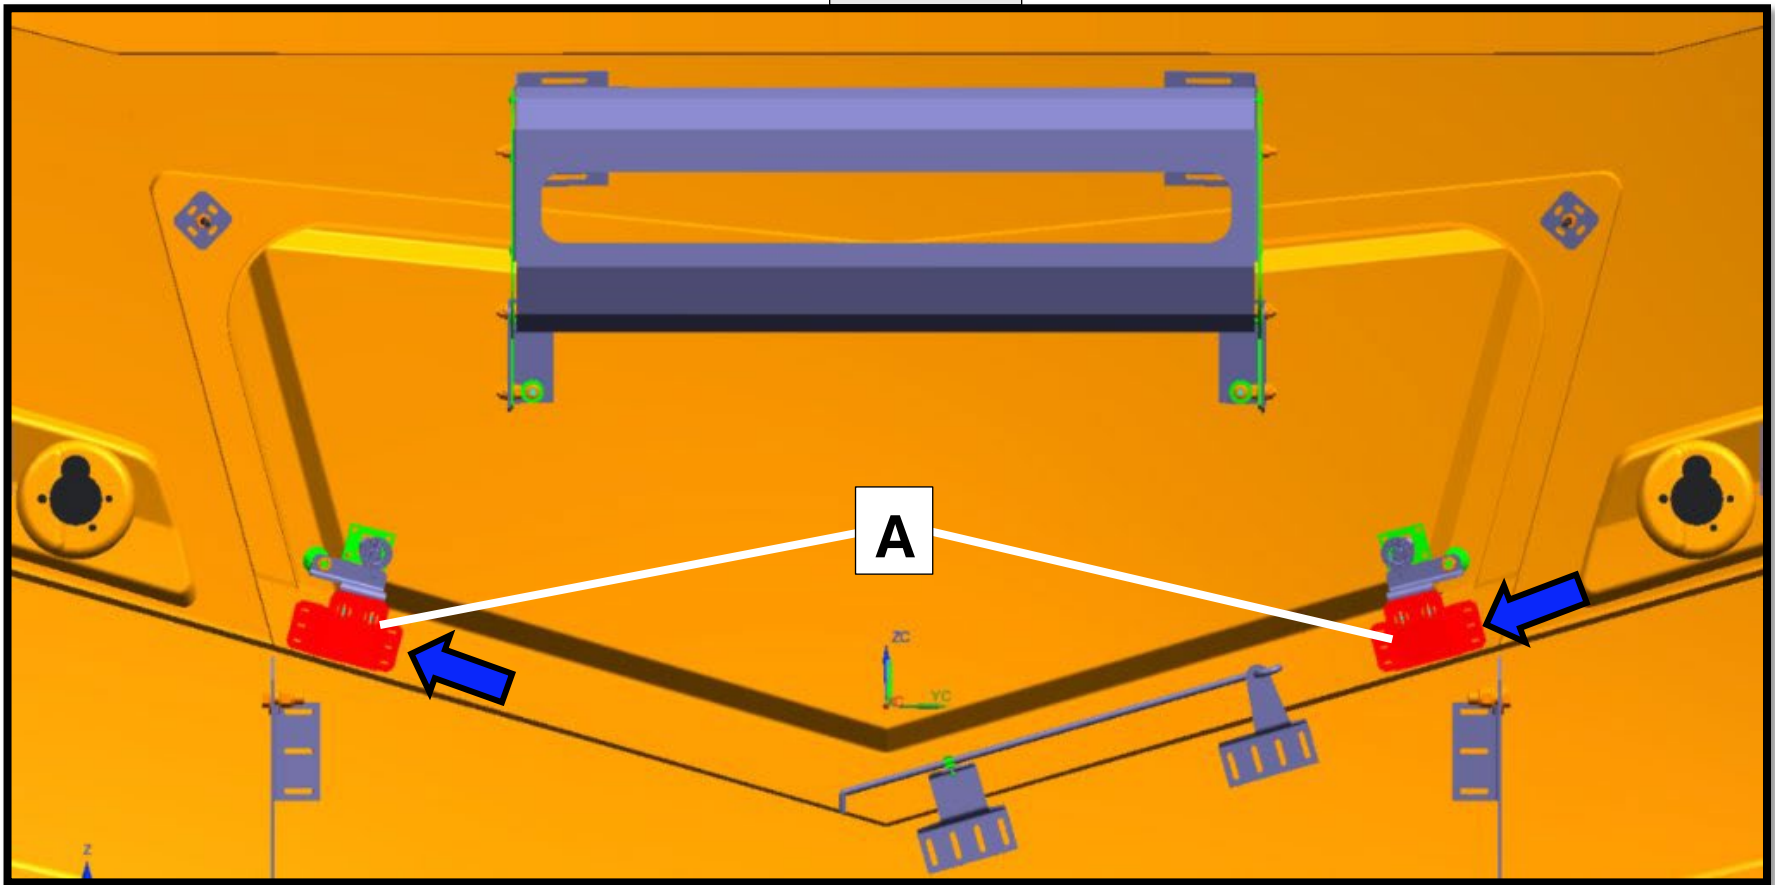
# Critical Brackets Reference – (Forza/Solei) 2016-2017, W2

1. There are 2 critical brackets on the front cap.
- Total of 2 hood latch brackets, 1 on either side (A). (See Figure 4 - Blue Arrows)
