Safety Recall

Code: 69E6

Subject: Safety Recall 69E6 - Driver Frontal Airbag Inflator

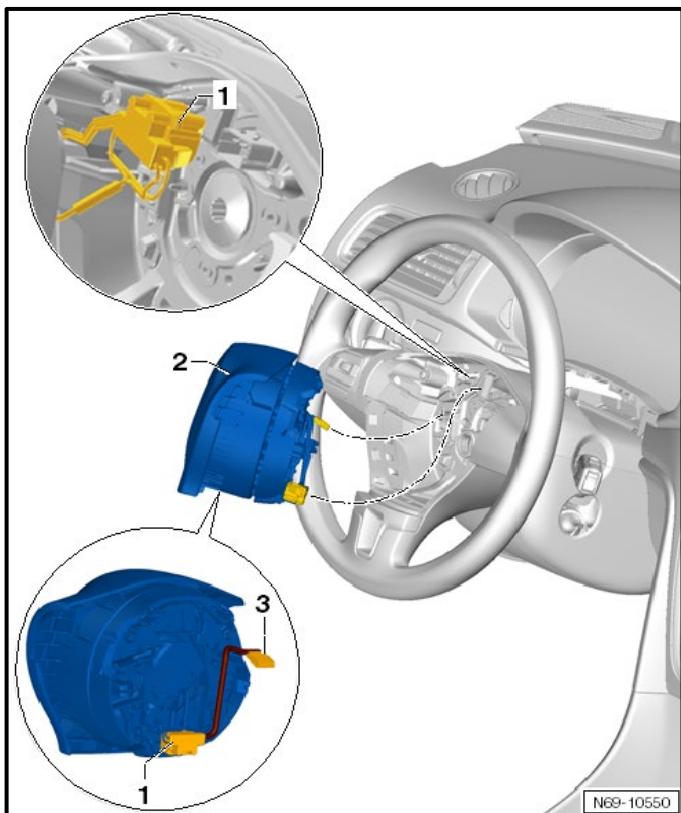
Repair Overview

- Replace driver airbag.

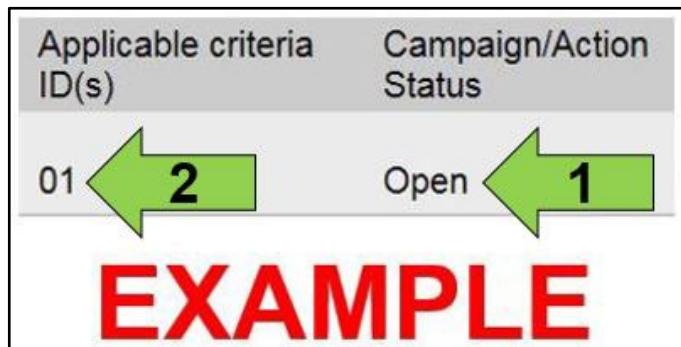
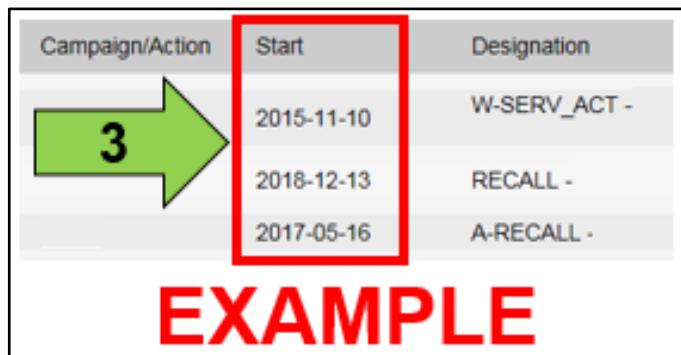
If Campaign Completion label is present, no further work is required.

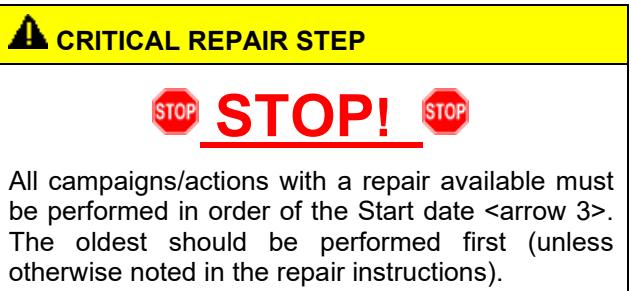
- Enter the VIN in Elsa and proceed to the "Campaign/Action" screen.

- Confirm the Campaign/Action is open <arrow 1>. If the status is closed, no further work is required.
- Note the Applicable Criteria ID <arrow 2> for use in determining the correct work to be done and corresponding parts associated.

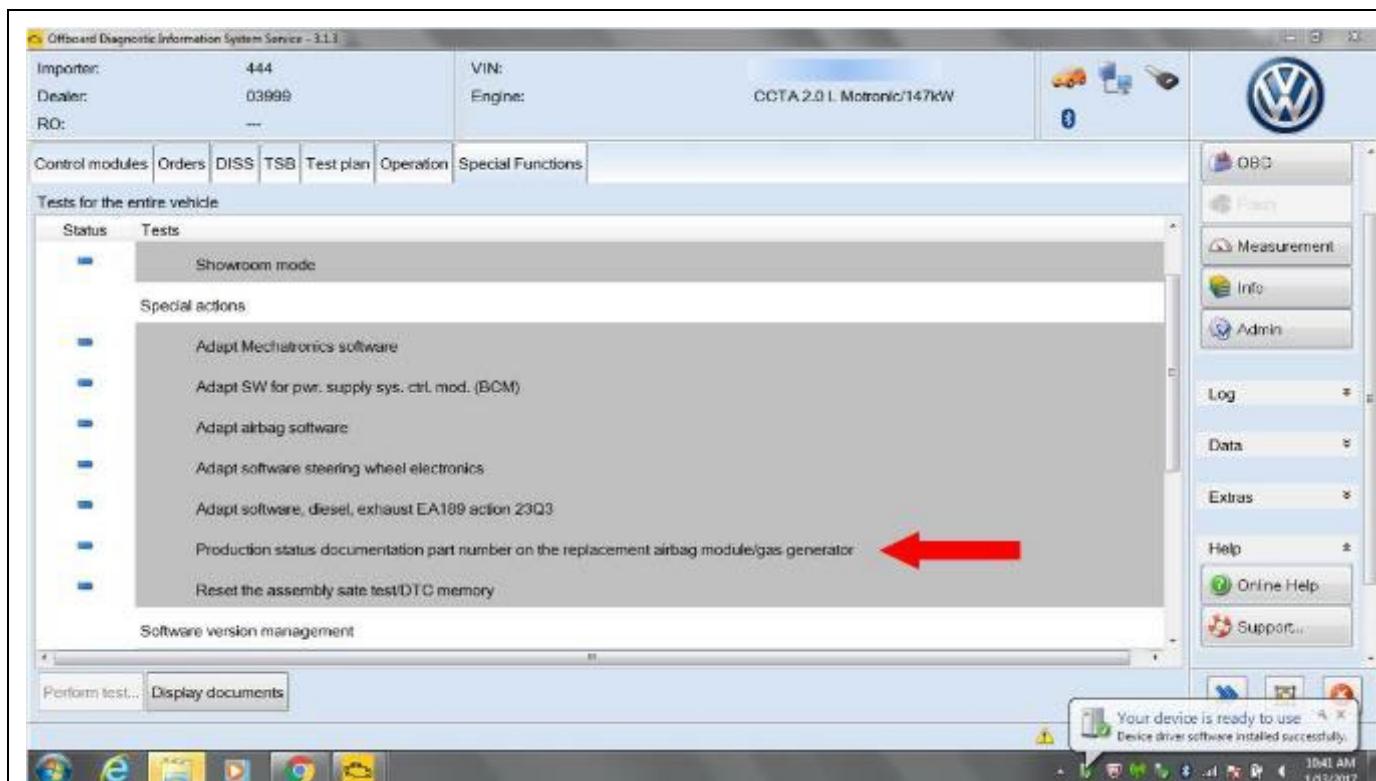
In operating mode Special Functions, Select “**Production status documentation part number on the replacement airbag module/gas generator**” <arrow>.

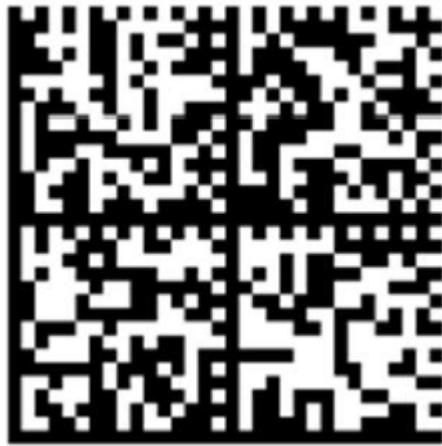
- Scanning the calibrating data matrix code may not have to be done every time (only when the scanner requires calibration). You will know if the scanner needs calibrating if the scanner does not scan the airbag's data matrix code.
- If the airbag data matrix code cannot be scanned, then print out this matrix shown below and scan the printout.

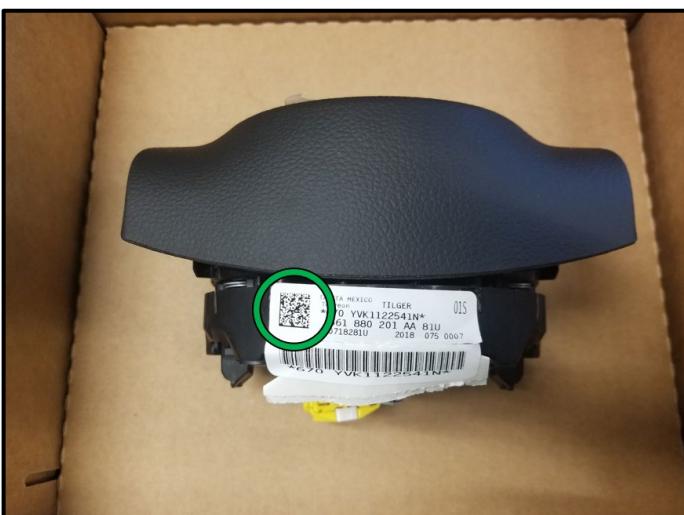
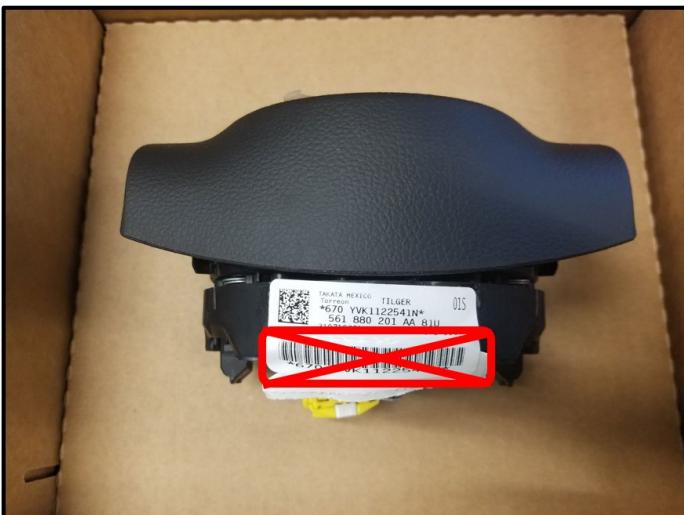
- Place the new airbag on the ESD mat.
- Scan the data matrix code <circle> of the new airbag at a distance of about 15 cm.

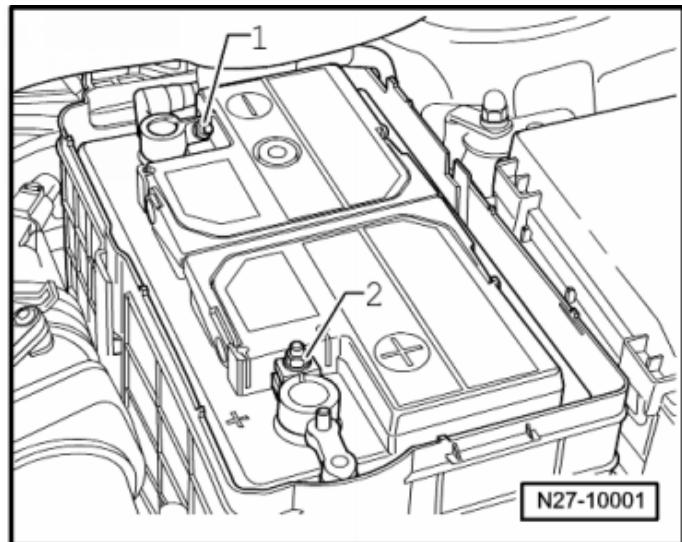
- Open the battery protective covering <1>.
- Loosen the nut <1>.
- Remove and isolate the battery ground cable terminal from the battery terminal.

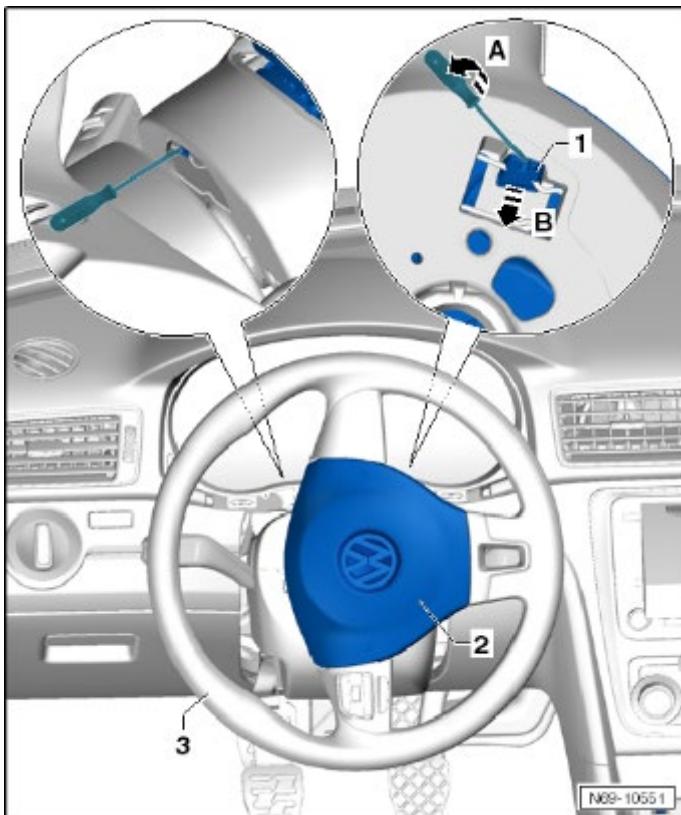
- Lower the steering wheel <3> as far as possible.
- Adjust steering wheel depth (reach) <3> so it is in the fully extended position.
- Turn the steering wheel <3> to the position illustrated.
- Insert a screwdriver all the way into the hole on the back of the steering wheel (approximately 8 mm).
- Turn the screwdriver toward the driver door <arrow A>. This will unlock the airbag unit <2> locking mechanism <1> in direction of <arrow>, on the right side of the steering wheel.
- Turn the steering wheel 180° and repeat the procedure on the opposite side.

The screwdriver previously mentioned should be about 175 mm long and have a blade width of 7 mm.

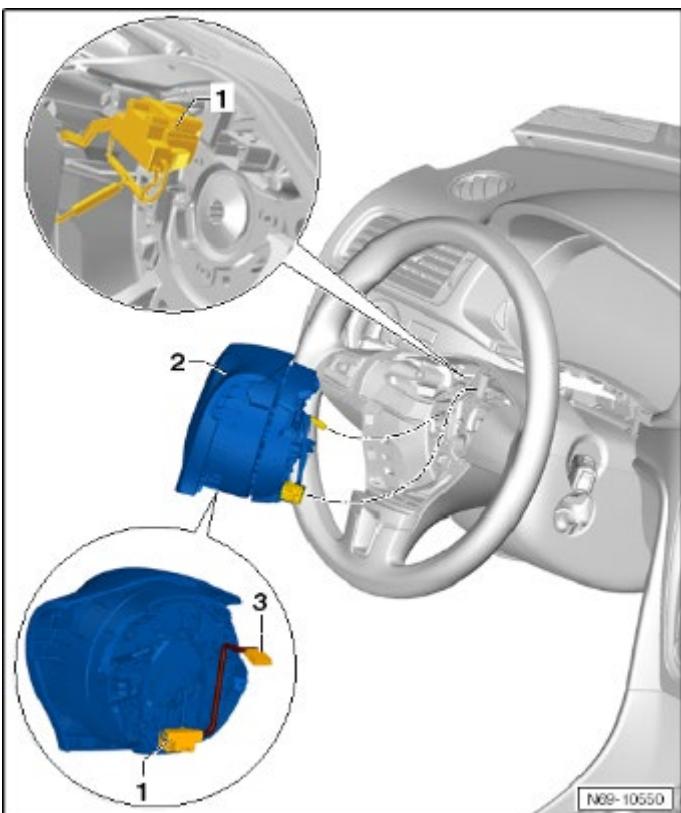
- Turn the steering wheel back to its center position.
- Remove the airbag unit <2> from the steering wheel.
- Release the connector lock on the airbag connector <1> and remove it.
- Disconnect the connector <3> (if equipped).

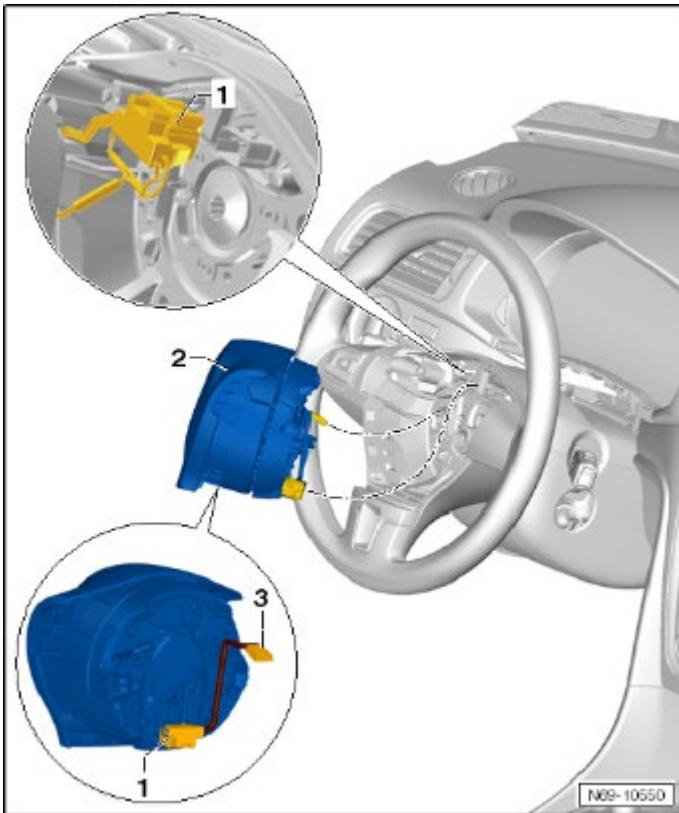
- The battery must be disconnected before installing the airbag back into the vehicle.
- Before handling pyrotechnic components (for example, disconnecting the connector), the person handling it must "discharge static electricity". This can be done by touching the door striker, for example.
- Connect the connector <1>. The connector must click into place.
- Press the connector lock on the connector <1>.
- Connect the connector <3> (if equipped).
- Insert the airbag unit <2> into the steering wheel but do not press on it.

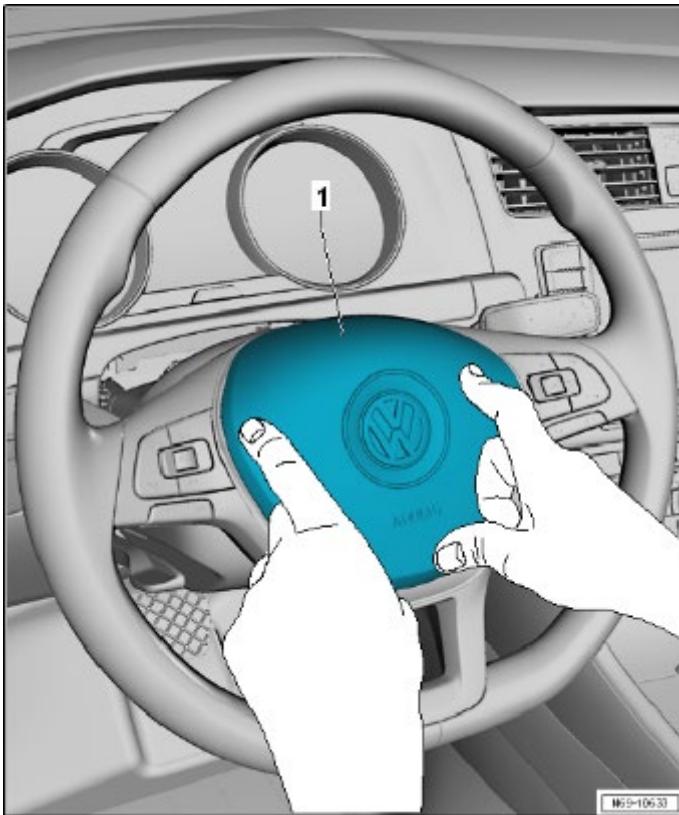
- Press on the edge of the airbag unit <1> with both hands until it locks into place.
- Gently pull on the airbag unit to make sure the airbag unit is secured correctly at all three attachment points in the steering wheel.

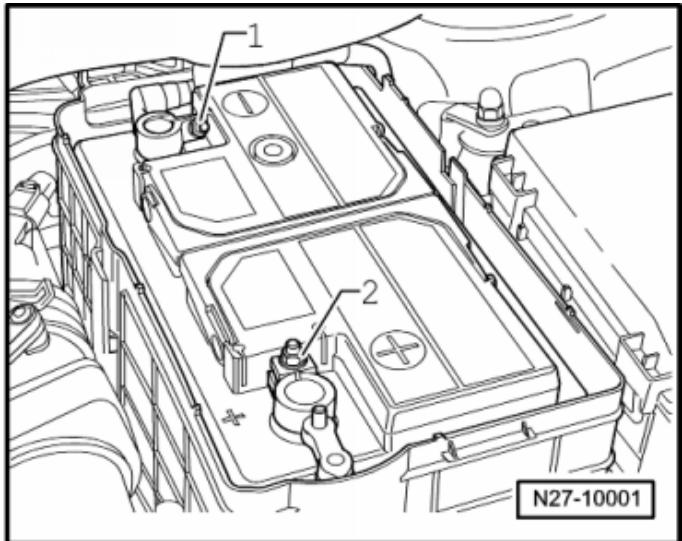
- Connect the battery ground cable terminal by hand to the battery negative terminal.

- Torque the nut <1> to 6 Nm.

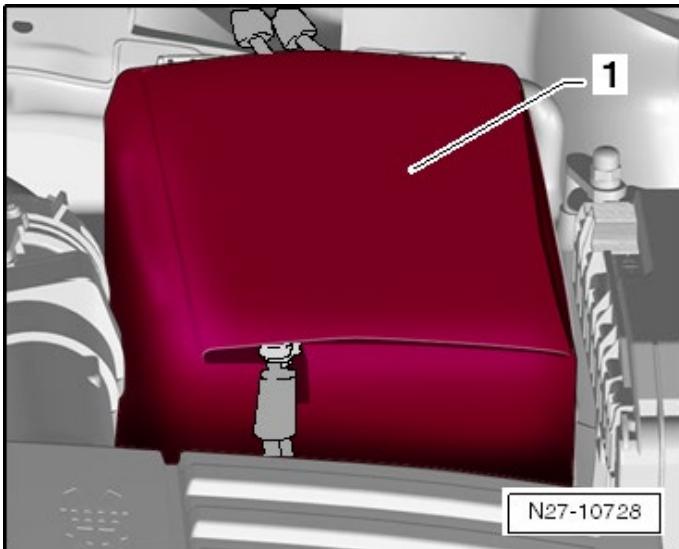
- Close the cover <1>.
- Cycle the ignition off and back on.
- Bring driver seat to an upright position.
- Store previously recorded radio presets (if necessary).
- Set clock to local time.
- Activate the power window regulator one-touch up/down function.
- Check the DTC memories of all the control units and erase under-voltage faults if necessary.
