# Safety Recall

## Code: 69EG

#### Driver Frontal Airbag Inflator

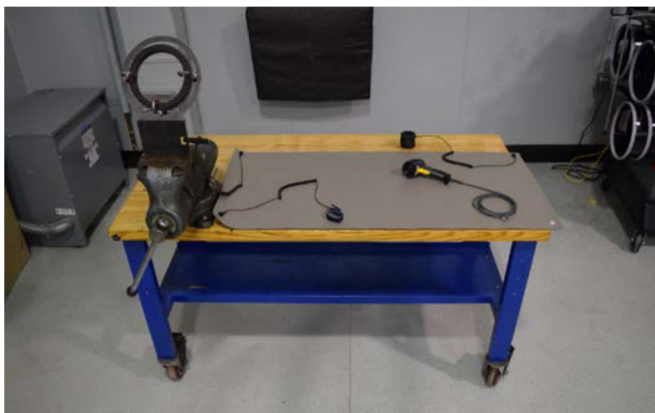
- Workbench that will support a vice.
- Work surface free of unnecessary tools, equipment, and debris.

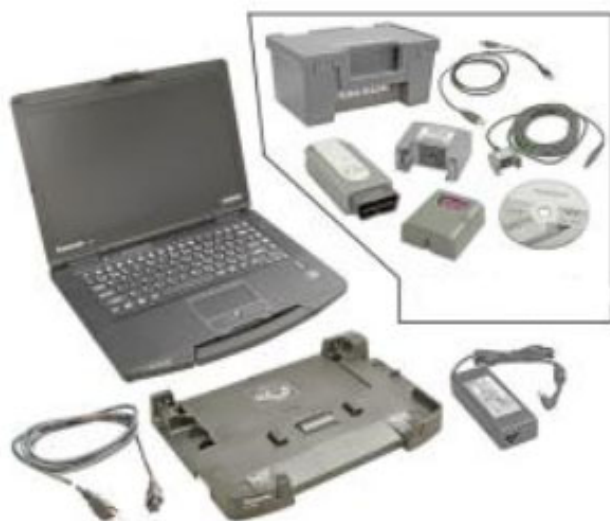
- Ensure ODIS is updated to the latest version.
- Connect vehicle diagnostic tester to the diagnostic head using the USB cable.
- Select Start Diagnosis function and identify vehicle.
- After identification of control units, Guided Fault Finding is started automatically.
- Follow the instructions on screen.

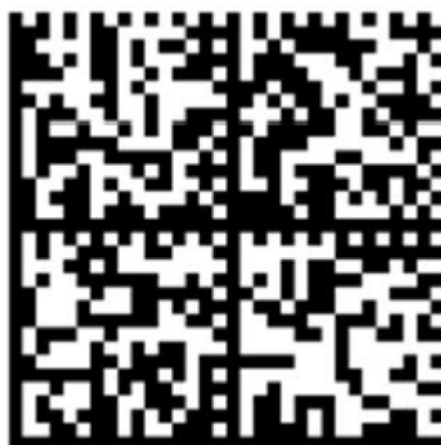
- Scanning the data matrix code during this test plan step calibrates the scanner to avoid error messages.
- Scanning the calibrating data matrix code may not have to be done every time (only when the scanner requires calibration). You will know if the scanner needs calibrating if the scanner does not scan the inflator's data matrix code.
- If the inflator data matrix code cannot be scanned, then print out this matrix shown below and scan the printout.

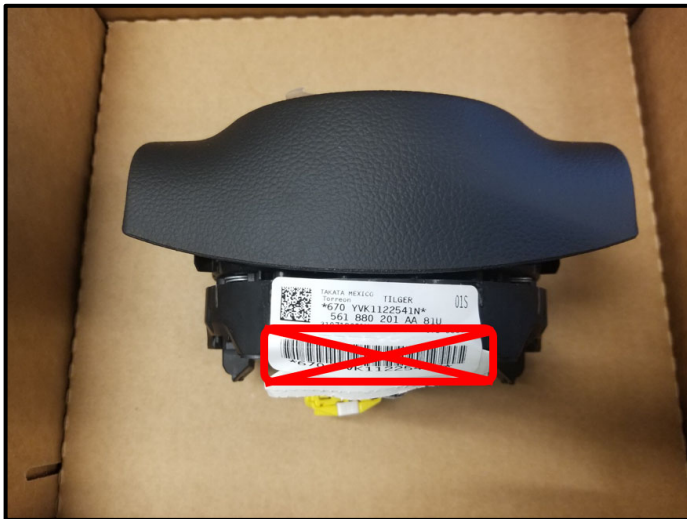
- Place the new airbag on the ESD mat.
- Scan the data matrix code <circle> of the new airbag at a distance of about 15 cm.

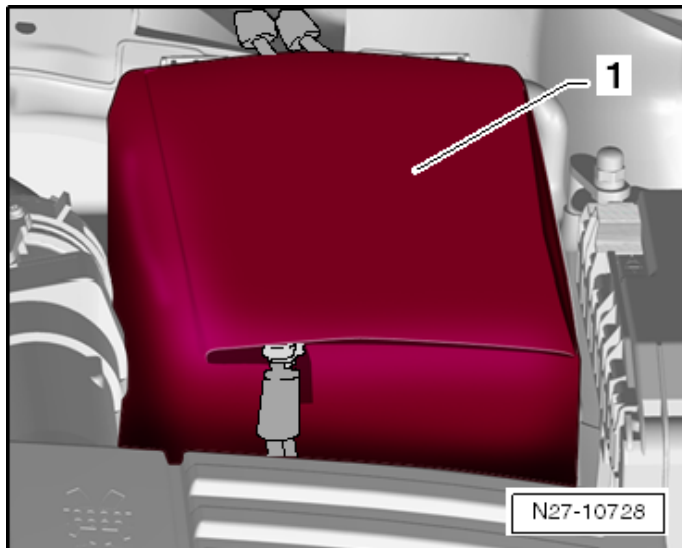
- Open the battery protective covering <1>.
- Loosen the nut <1>.
- Remove and isolate the battery ground cable terminal from the battery terminal.

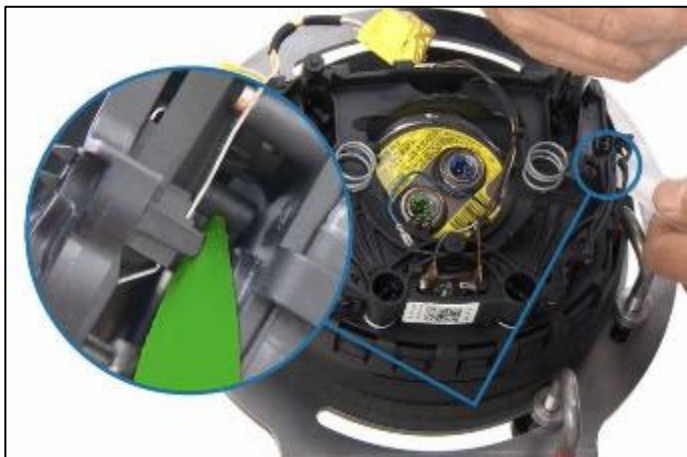
- Apply removal wedge -3409- between horn ring and inflator <1> and press together locking elements using longnose pliers <2>. Lever off horn ring at plastic lugs <3>.

- Position the removal wedge -3409- on the plastic lugs to prevent damage to the conductor strip.
- Insert the removal wedge -3409- between the inflator and horn ring to prevent the horn ring from engaging again.
- Repeat work steps on other side.

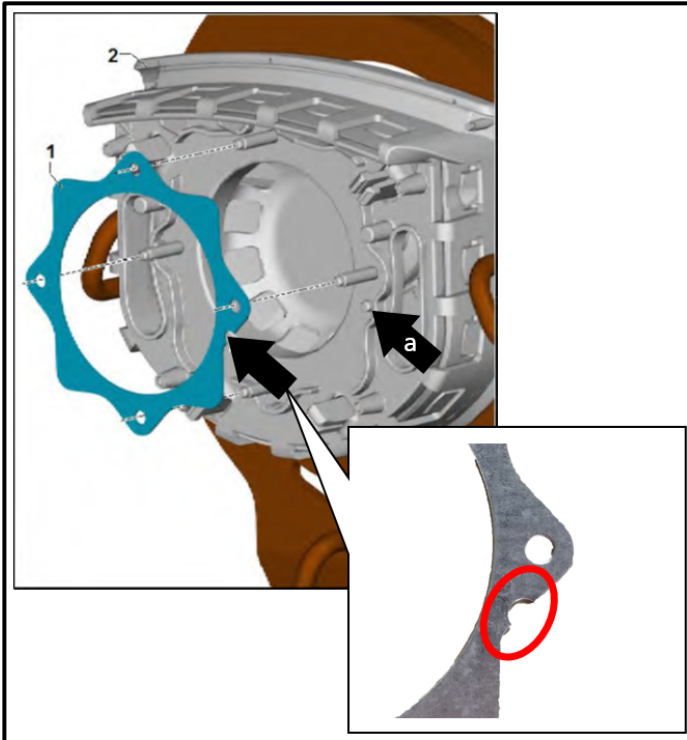
- Included in the replacement parts kit is a baffle plate. This must be used when installing the new inflator.
- Fit baffle plate <1> onto airbag <2> so that the notch <circle> lines up with the pin <arrow a> on the airbag.
