# Safety Recall

## Code: 69GQ

#### Driver Frontal Airbag Inflator

**Subject: Safety Recall 69GQ - Driver Frontal Airbag Inflator**

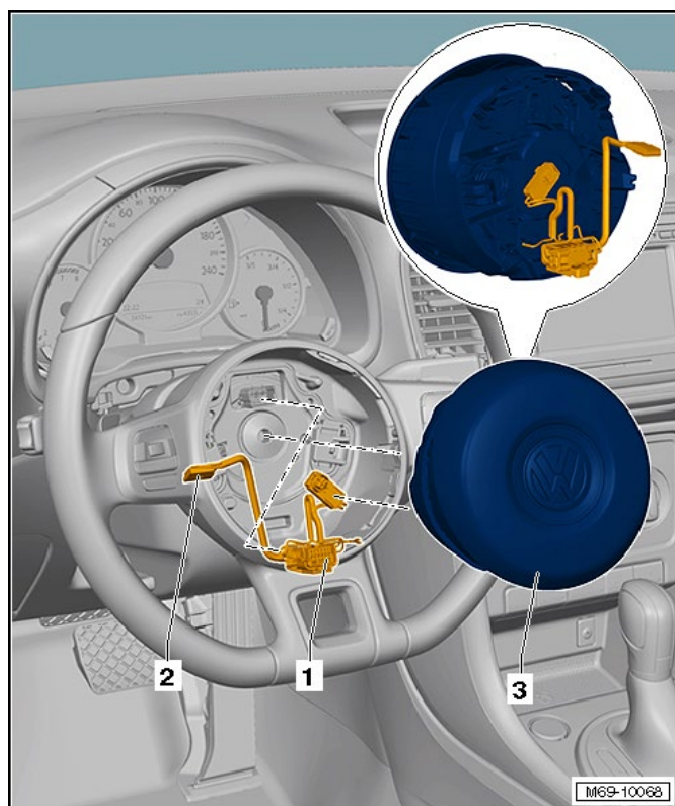
## Repair Overview

- Replace driver's frontal airbag.

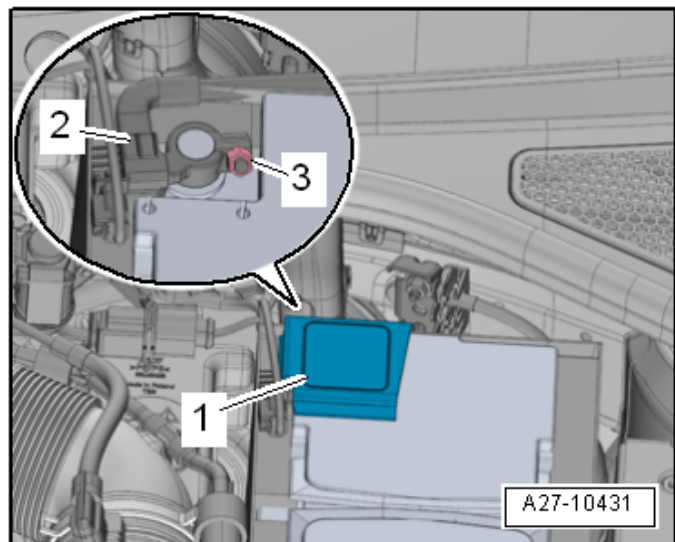
**Disconnect the 12V battery with the ignition switched ON:**

Accident risk. When working on pyrotechnic components (such as airbags and belt tensioners), the battery must be disconnected with the ignition switched **ON**.

- Turn **ON** the ignition.
- Access the battery.
- Loosen the nut <2>.
- Remove and isolate the battery ground cable <2> from the battery terminal.

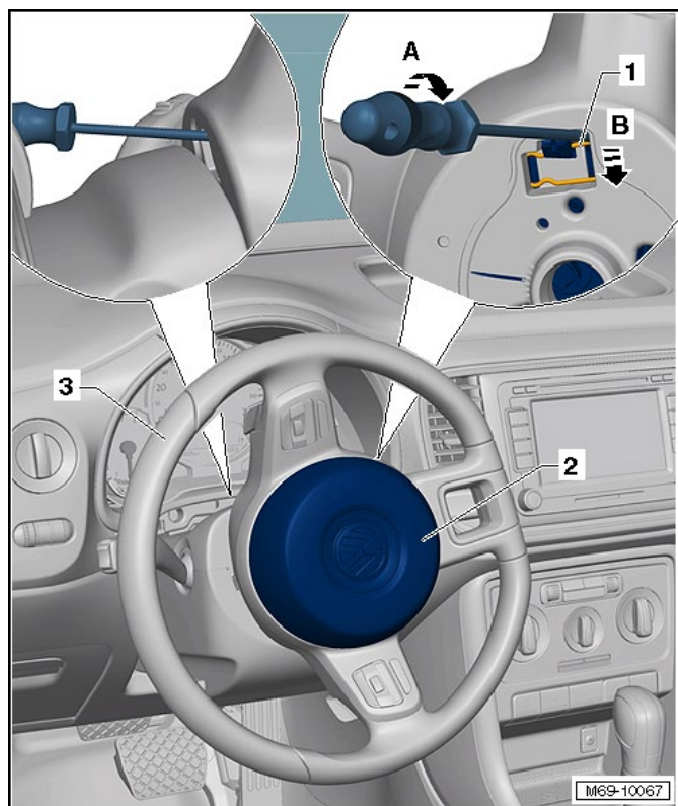
### Replacing driver's frontal airbag:

- The screwdriver mentioned in the following should be about 175 mm long and have a blade width of 7 mm.
- The following describes removing and installing the airbag unit inside a multifunction steering wheel.

- Move the steering wheel to the lowest position.
- Adjust the steering wheel depth (reach) so it is in the fully extended position.
- Turn the steering wheel to the position illustrated.
- Insert a screwdriver all the way into the hole on the back of the steering wheel.
- Turn the screwdriver 90° <arrow A>.
- This will release the retainers <1> in the direction of the <arrow B> for the airbag unit on the right side of the steering wheel.

If it is not a multifunction steering wheel, then the airbag must be removed from the steering wheel bezel on the upper edge after actuating the lock.

- Turn the steering wheel 180°.
- Open the retainer for the airbag unit on the left side of the steering wheel, as described.
- Turn the steering wheel back to its center position.
- Loosen the airbag unit from the steering wheel.

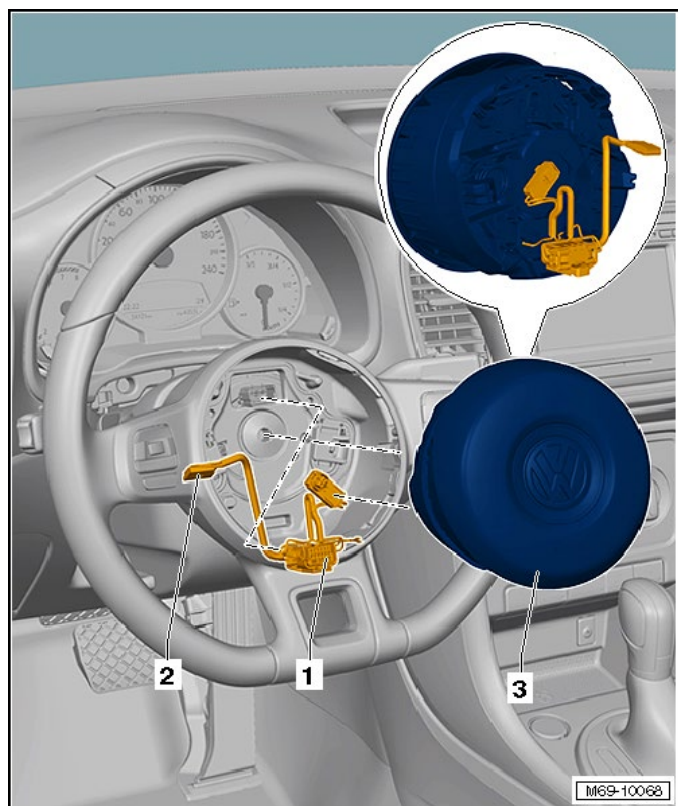
Before handling pyrotechnic components (for example, disconnecting the connector), the person handling it must “discharge static electricity”. This can be done by touching the door striker, for example.

- Release the connector lock and disconnect the airbag connector <1>.
- Vehicles with multifunction steering wheel: Release the connector lock and disconnect the connector <2>.
- Install new airbag in the reverse order of removal.

- Connect the airbag connector <1> with the wiring harness to the back of the airbag unit <3>.
- The airbag connector must click into place.
- Insert the connector <2> in the connector lock. This is required only on the multifunction steering wheel.
- Press the airbag unit <3> into the steering wheel until it audibly engages.
- Gently pull on the airbag unit to make sure it is locked securely inside steering wheel on the left and right sides.

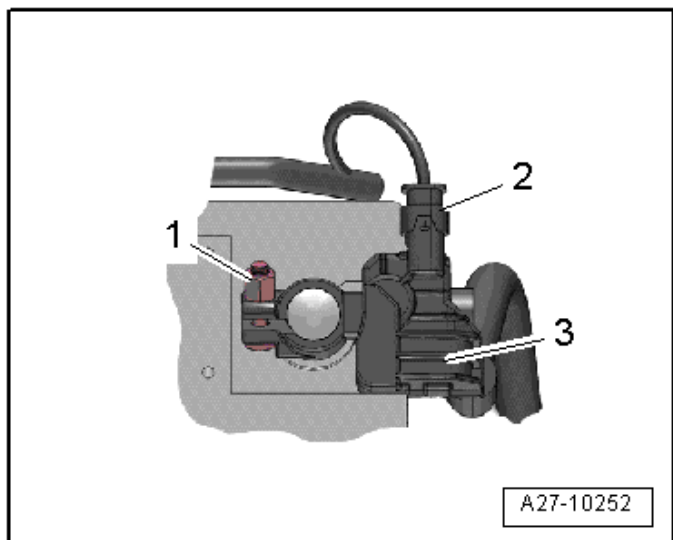
### Reconnect 12V battery:

Ignition must be **ON** when connecting battery. If pyrotechnic components (e.g. airbag, belt tensioner) are not repaired correctly, they may deploy unintentionally after connecting battery. There must not be anyone inside the vehicle when connecting the battery.

- Disconnect the connector <2> from the Battery Monitoring Control Module -J367- <3> (if equipped).
- Attach the battery ground cable clamp by hand to the battery negative terminal and torque the nut <1> to 6 Nm.
- Reconnect the connector to the Battery Monitoring Control Module -J367- (if equipped).
- Cycle the ignition off and back on.
- Set clock to local time.
- Activate the convenience open/close functions.
- Check the DTC memories of all the control units and erase under-voltage faults if necessary.
