<b>HYUNDAI</b> <b>Technical Service Bulletin</b>	<b>GROUP</b> <b>RECALL</b>	<b>NUMBER</b> <b>24-01-082H</b>
	<b>DATE</b> <b>NOVEMBER 2024</b>	<b>MODEL(S)</b> <b>SANTA FE (MX5A)</b> <b>SANTA FE HYBRID</b> <b>(MX5A HEV)</b>
<b>SUBJECT:</b> SUNROOF AND REAR SUNROOF SHADE SWITCH KNOBS REPLACEMENT (RECALL 270)

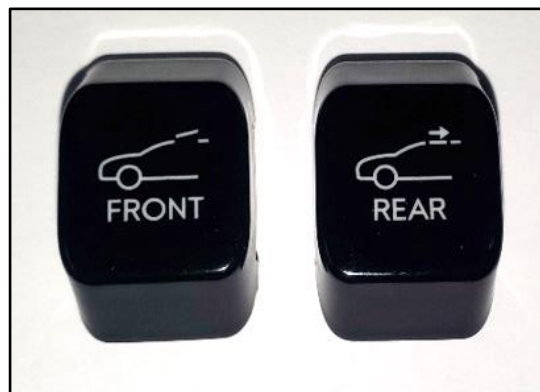
**Description:** Certain 2024 Santa Fe (MX5A) and Santa Fe Hybrid (MX5A HEV) vehicles equipped with an Overhead Console Sunshade Switch may not be fully recessed, increasing the risk of inadvertent sunshade activation. As such, the subject vehicles do not meet the test requirements of Federal Motor Vehicle Safety Standard No. 118 “Power-Operated Window, Partition and Roof Panel Systems.” Inadvertent sunshade activation could increase the risk of minor pinch point injury occurring from unexpected closure of the fabric sunshade. Follow the procedure outlined in the TSB to replace the sunroof and rear sunroof shade switch knobs.
