SAFETY RECALL
NORTH AMERICA
Tire Certification Label

Reference: C3B / NHTSA 24V-857

FCA US LLC

2023 (GU) Alfa Romeo Stelvio

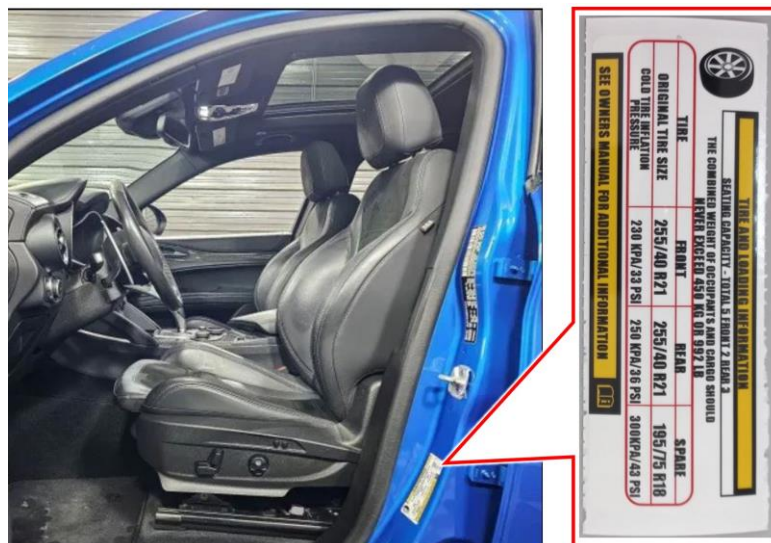
Figure 2 – Tire Placard Label Location

3. Locate the Tire placard label on the vehicle driver side B-pillar (Figure 2).

9. Apply the NEW label to the driver side B-pillar surface, in the original position, with the same text orientation.

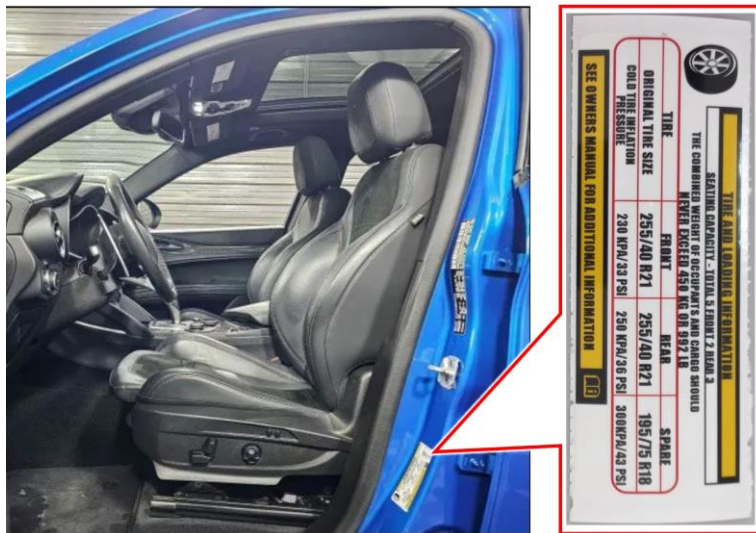
Figure 1 – Tire Placard Label Location

1. A **NEW** tire placard overlay label is enclosed with this letter for your vehicle.
 - If you believe you received an incorrect label, please contact your dealer.
2. Open the driver door then locate the tire placard label on the vehicle driver side B-pillar (Figure 1).
