November 15, 2024

Version 1

Safety Recall: 2023–24 Accord and Accord Hybrid Driver’s Seat Lift Link Bolt Loose

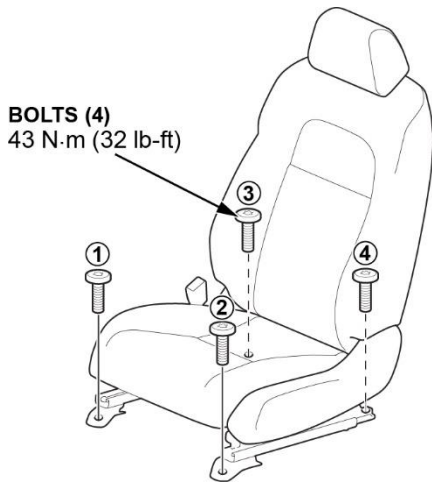
1. Remove the seat bolts using a 50 IP TORX Plus socket driver.

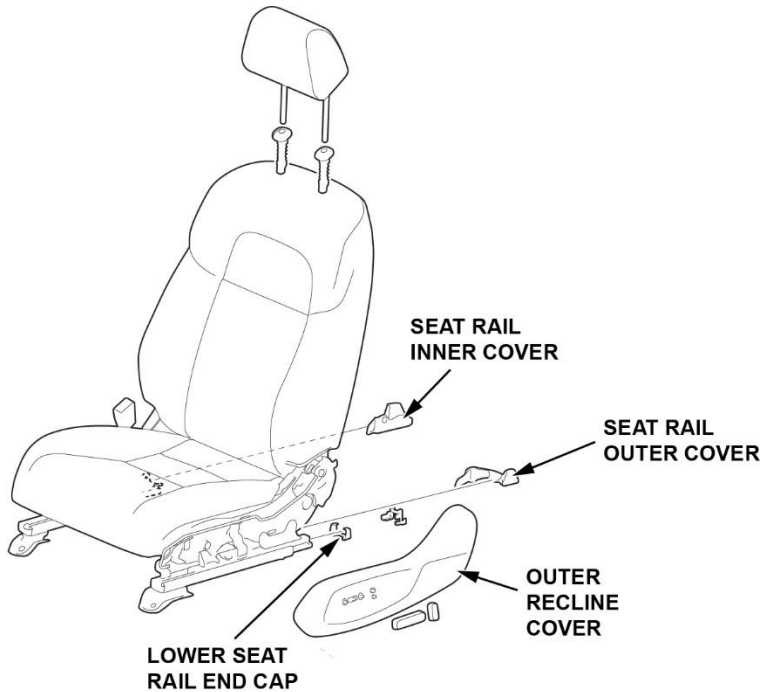
5. Remove the following:

1. [Outer recline cover](#)
2. [Seat rail inner and outer covers](#)
3. [Lower seat rail end cap](#)

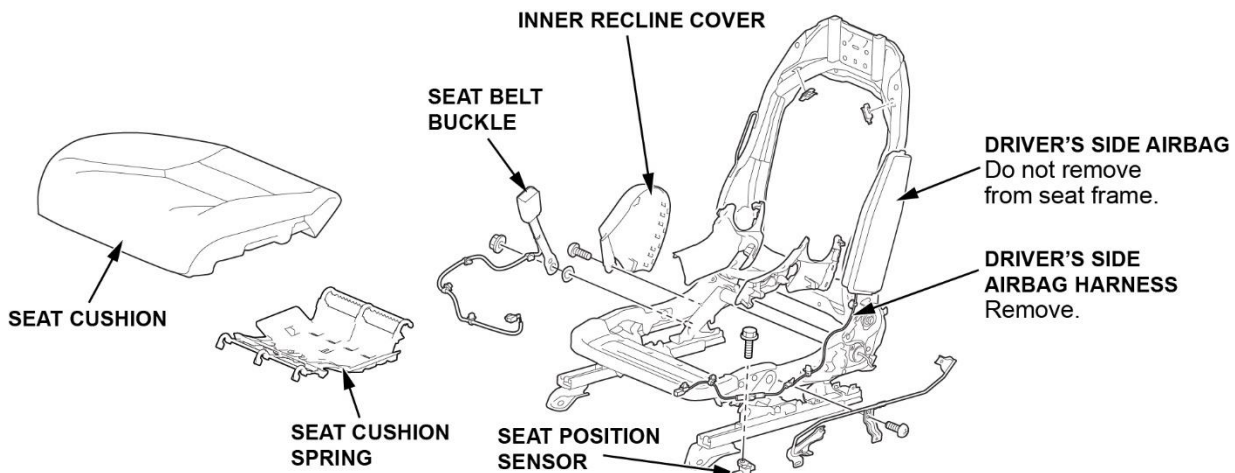
7. Remove the following:

1. [Inner recline cover](#)
2. Harness for [driver's side airbag](#) (do not remove airbag)
3. [Seat cushion](#)
4. Seat harness
5. [Seat cushion spring](#)
6. Disconnect the seat position sensor
7. Disconnect the [seat belt buckle](#)

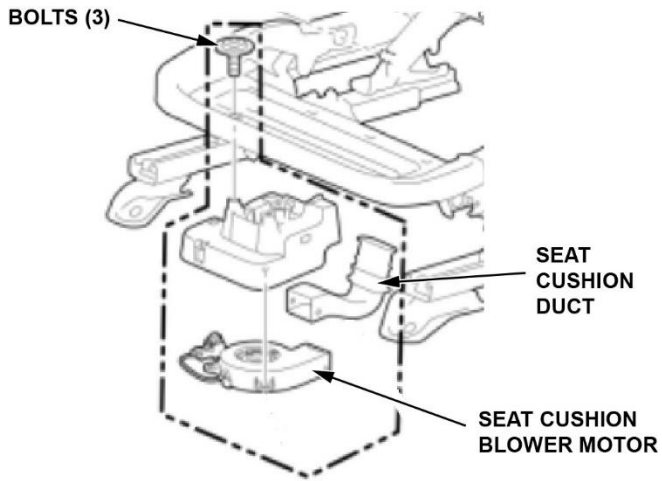
8. If equipped with seat ventilation, remove the [seat cushion blower motor](#) and [seat cushion duct](#).

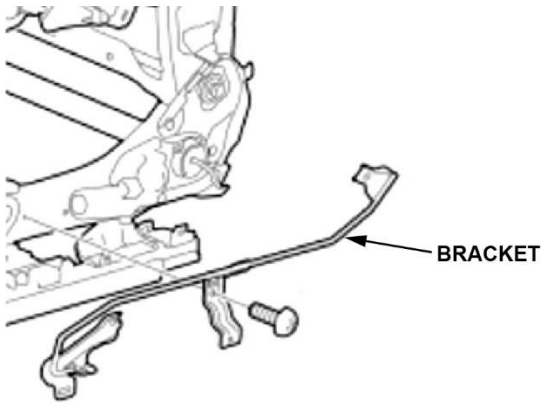
9. Remove the 3 mounting screws, then remove the bracket.

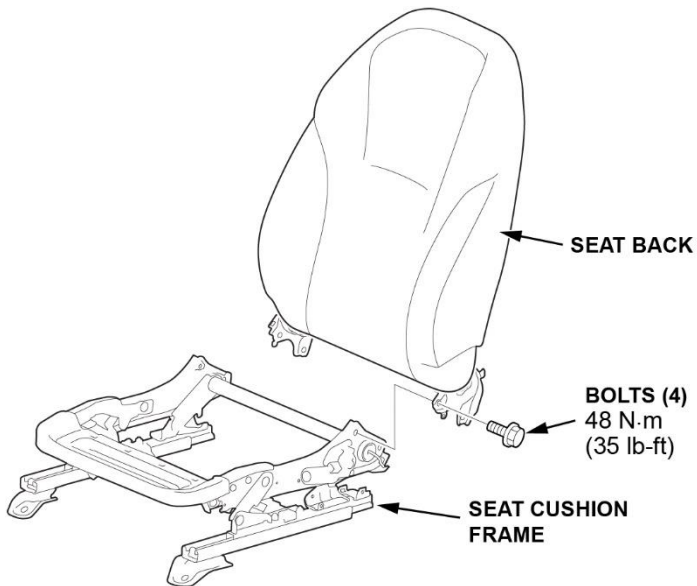
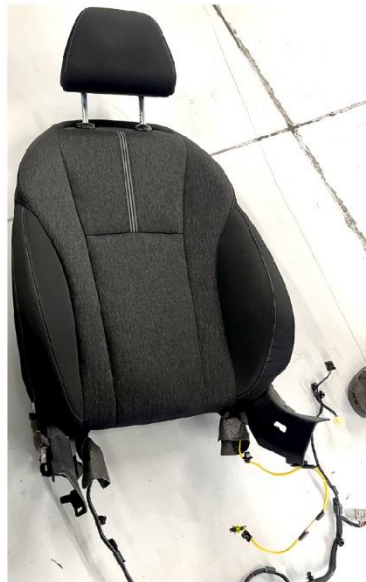
10. Remove the four bolts holding the seat back to the seat cushion frame, then remove the seat back assembly.
NOTE: **Do not** disassemble the seat back assembly.

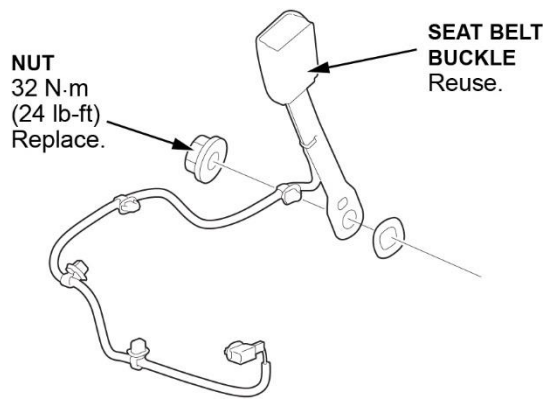
11. Transfer the [seat belt buckle](#) to the new seat cushion frame.

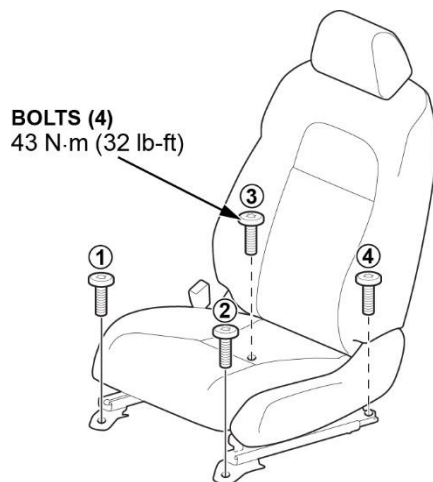
14. Install the driver's seat into the vehicle. Hand tighten the bolts, then torque the bolts, in sequence, using a 50 IP TORX Plus socket driver.
