Remedy available for  
 2024 (JL) Jeep® Wrangler

**SYMPTOM DESCRIPTION**

**REPAIR TO BE PERFORMED**

Inspect and, if necessary, replace the dash wiring harness.

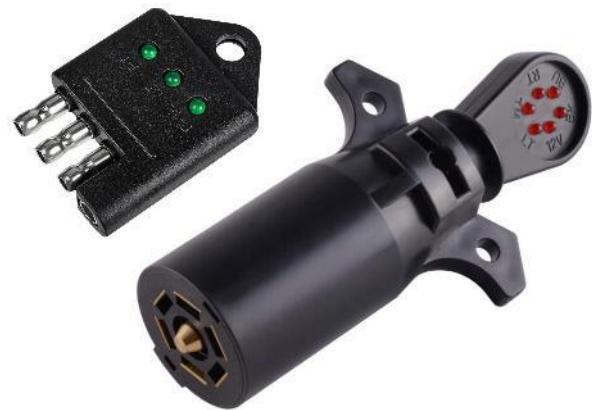
**Figure 1 – Trailer Wiring Tester Tools**

1. Turn the ignition switch to the “**RUN**” position.
2. Turn the headlamps to “**ON**” position and verify the vehicle lamps are illuminated.
3. Plug a trailer wiring tester tool as shown in (Figure 1) into the trailer wiring connector on the vehicle as shown in (Figure 2). Verify that the tester tool illuminates indicating there is power at the vehicle trailer wiring harness connector. A voltmeter or 12-volt test light may also be used to test for power at the connector. Place one tester lead on the ground terminal (number 4) and the other tester lead on the taillights terminal (number 3) to test for power.

**NOTE: Does not matter which type of tester is used or which trailer wiring connector is tested. Only need to determine if lamp circuit on either connector has power or not.**

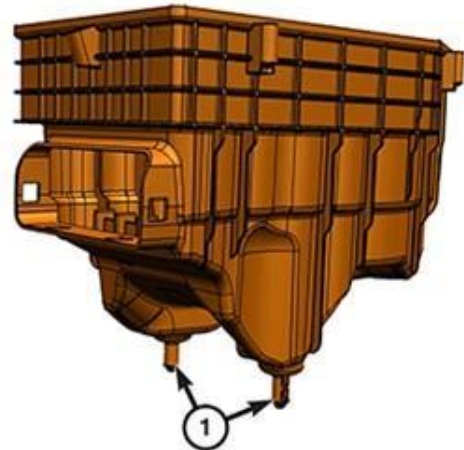
**Figure 12 – Air Cleaner Housing**

16. Disengage the locating pins from the grommets and remove the air cleaner housing (Figure 12).

- 1 - Locating Pins

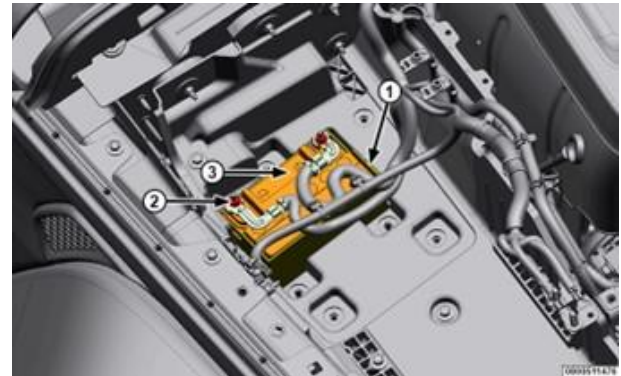
**Figure 19 – Auxiliary Battery**

29. Remove the nuts securing the battery cables from the auxiliary battery (Figure 19).

30. Remove the auxiliary battery thermal cover and remove the battery from the battery tray (Figure 19).

- 1 - Auxiliary Battery Thermal Cover
- 2 - Auxiliary Battery Cable Nus
- 3 - Auxiliary Battery

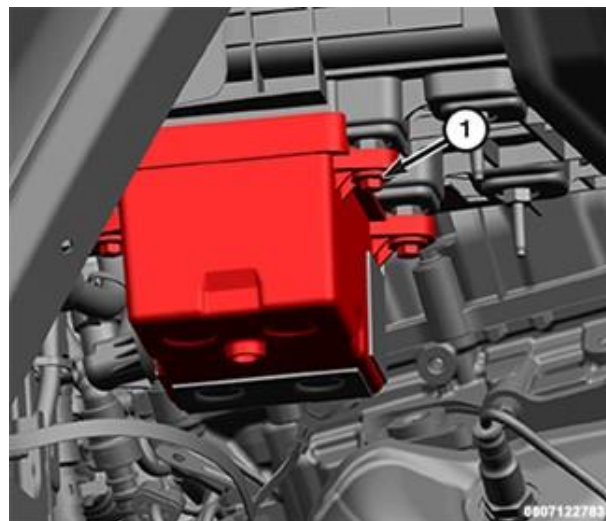
**Figure 21 – Auxiliary Battery Tray**

36. Remove the 3 bolts from the bottom of the auxiliary battery tray then remove the auxiliary battery tray (Figure 21).

1 - Battery Tray Bolts

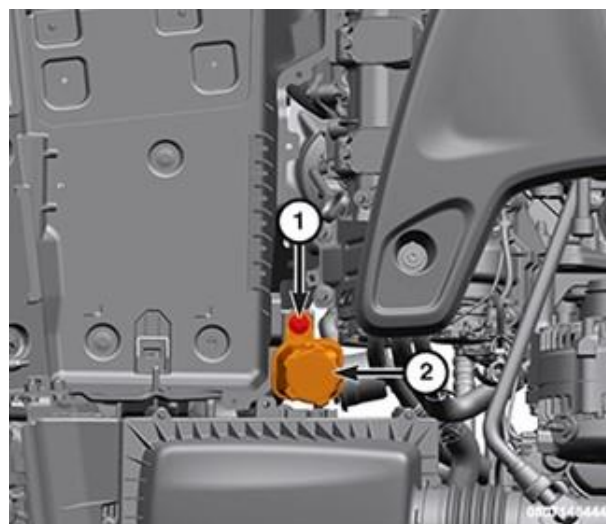
**Figure 22 – Power Steering Reservoir**

37. Remove the bolt and position power steering reservoir aside (Figure 22).

1 - Power Steering Reservoir Bolt

2 - Power Steering Reservoir

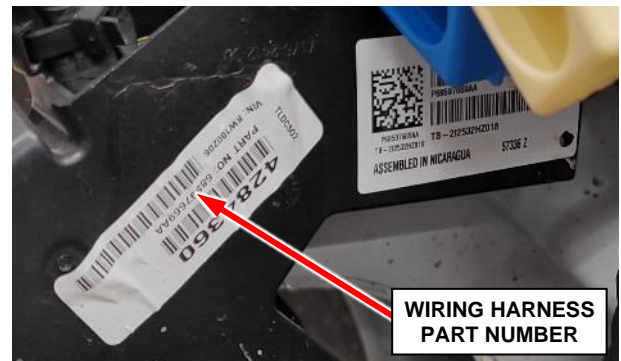
**Figure 25 – Inspect Part Number**

42. With battery tray removed, inspect the part number printed on the wire harness label (Figure 25).
43. Is the suspect part number **68597668AB** printed on the label?
- **YES:** The suspect part number **68597668AB** is printed on the label. Proceed with **Section C** to replace the wire harness.
  - **NO:** If the part number is different than the suspect part number and there was no power at the trailer wiring connector when tested, there is another issue with the vehicle. Reassemble the vehicle. Further diagnosis will be necessary to determine the issue but is **NOT** part of this recall remedy.

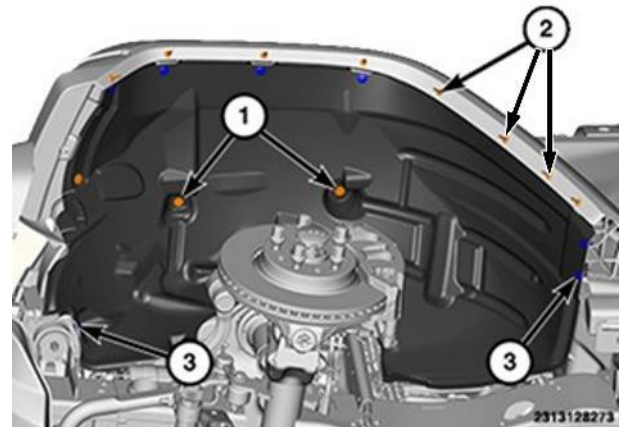
**Figure 26 – Splash Shield**

1. Remove the left front tire and wheel assembly.
2. Remove the screws from the left front splash shield (Figure 26).
3. Remove and DISCARD the push pin fasteners from the right front splash shield (Figure 26).
4. Remove and DISCARD the three rivets securing the right front splash shield to the flare molding (Figure 26).
5. Remove the splash shield (Figure 26).

- 1 - Screws
- 2 - Rivets
- 3 - Push Pin Fasteners

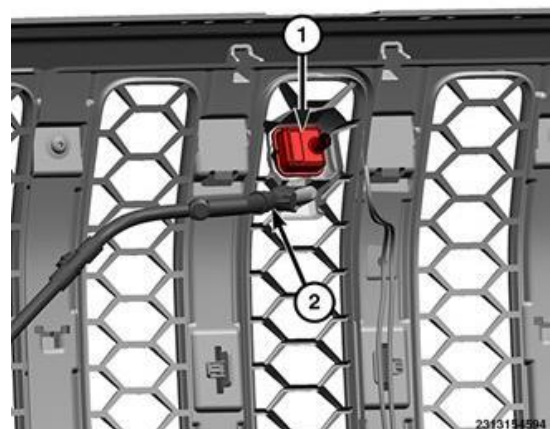
**Figure 30 – Front Camera and Washer**

9. Disconnect the camera wire harness connector and washer hose, if equipped (Figure 30).

1 - Camera Wire

2 - Washer Hose

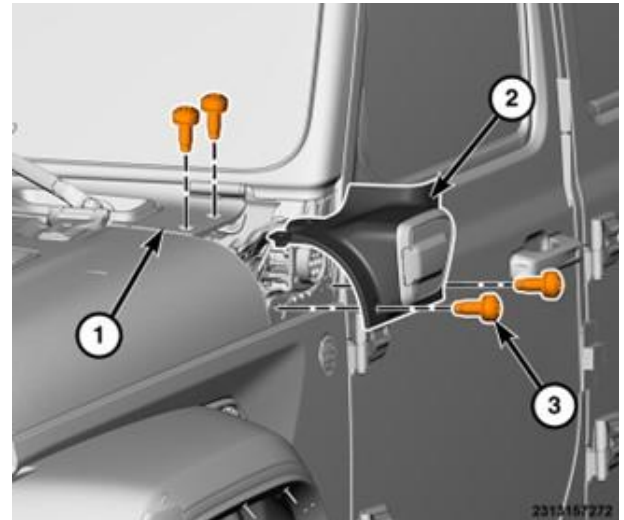
**Figure 35 – Cowl Panel Side Cover**

20. Remove the bolts and remove the cowl panel cover. (Figure 35).

1 - Upper Cowl Panel Cover

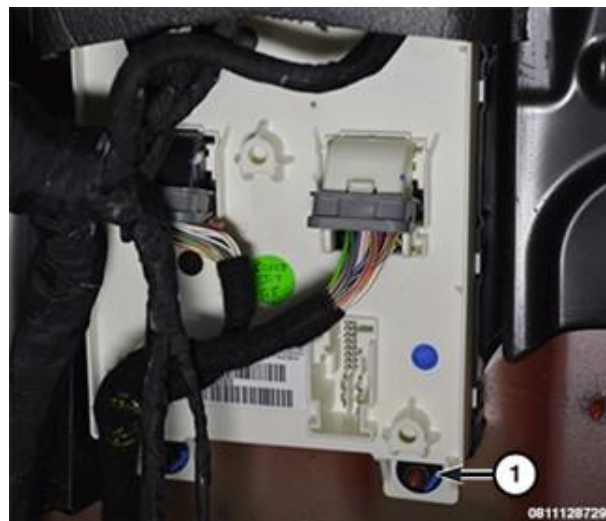
**Figure 49 – Body Control Module (BCM)**  
1 - Mounting Bracket Fastener

- 41. Remove the BCM from the vehicle mounting bracket (Figure X).

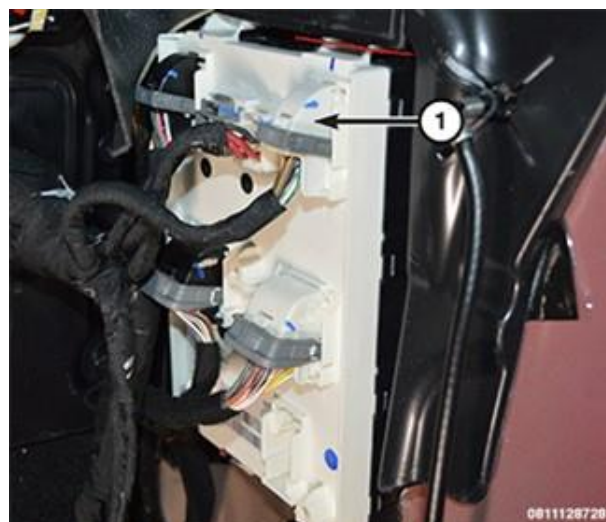
**Figure 50 – Body Control Module (BCM)**  
1 - Wire Harness Connector

- 42. Disconnect the BCM wire harness connectors and remove the BCM from the vehicle (Figure X).

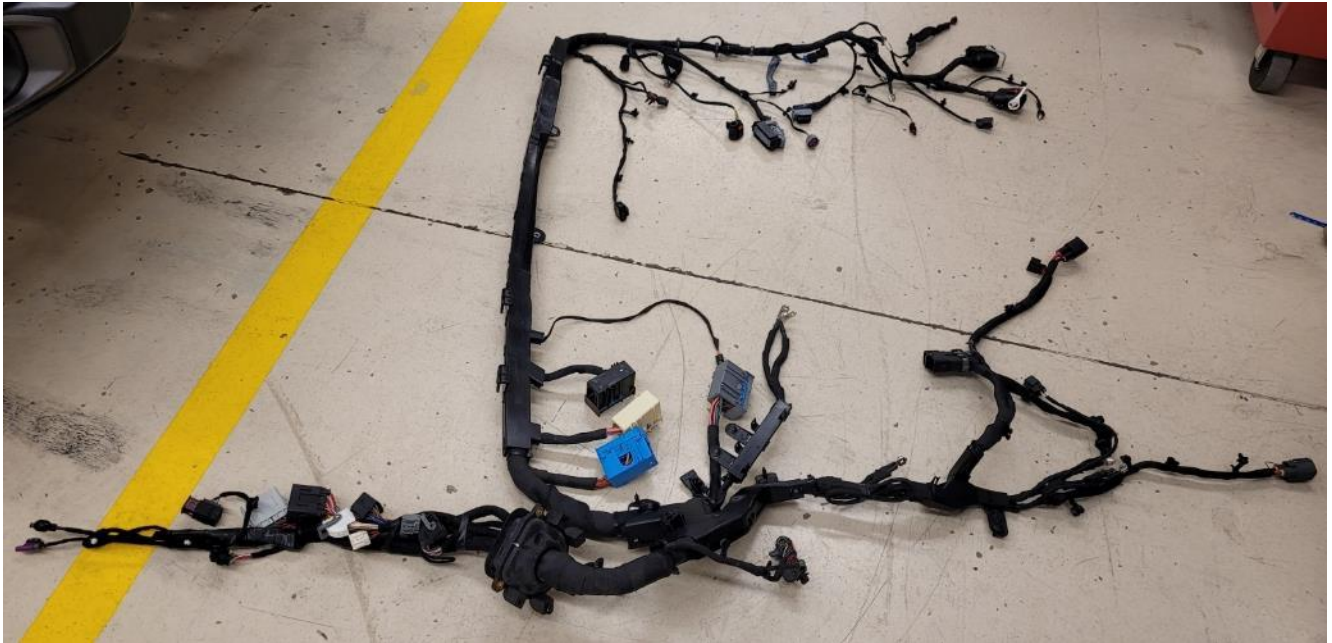
**Figure 54 – Wire Harness Assembly**

49. Remove the old wire harness assembly from the vehicle and **DISCARD** (Figure 54).
50. Obtain the **NEW** wire harness assembly.
51. Install the **NEW** wire harness assembly **in reverse order** of removal procedure. Only specific instructions and torque specifications are identified in the following steps, otherwise harness installation is reverse of removal.
